> Prepared For Architectural Services Department

> > By Heritage Consultant AGC Design Ltd

> > > Aug 2017

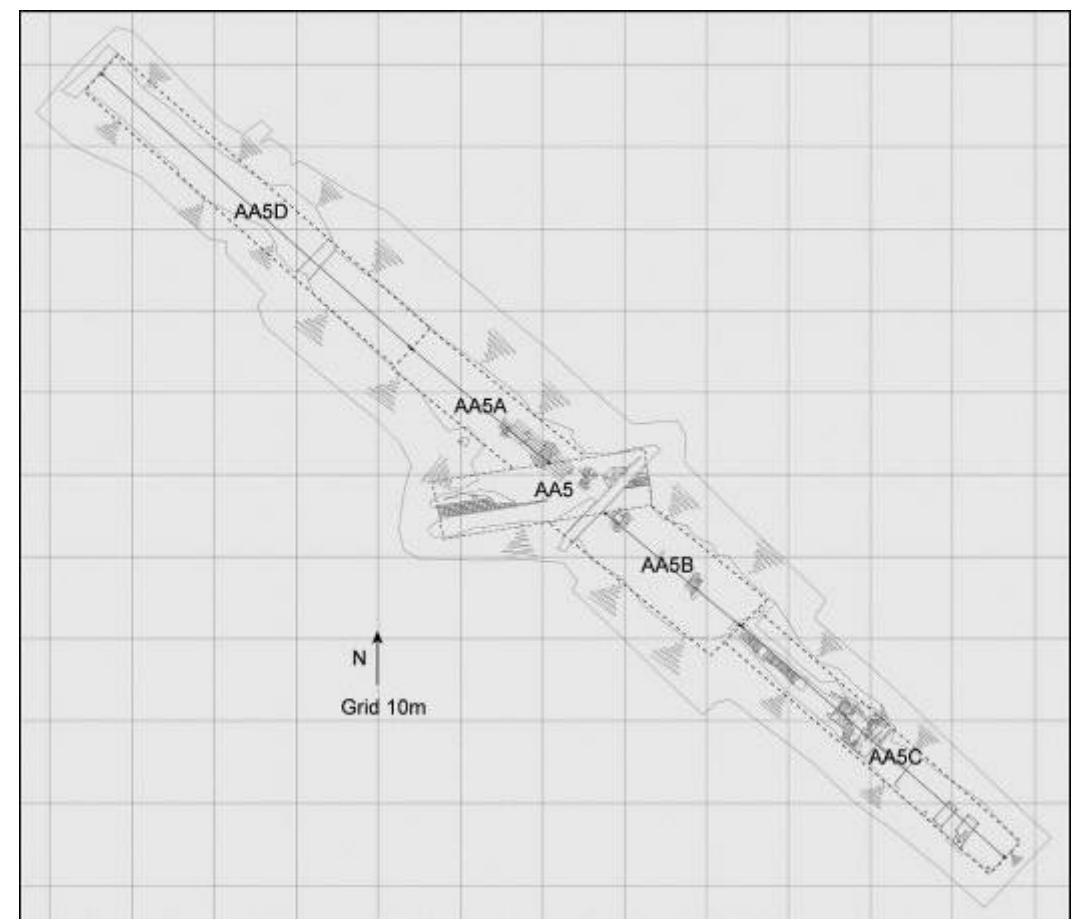
Fig. 9: LTSB remnants were found in AA5 trench and its extension AA5A to AA5D.

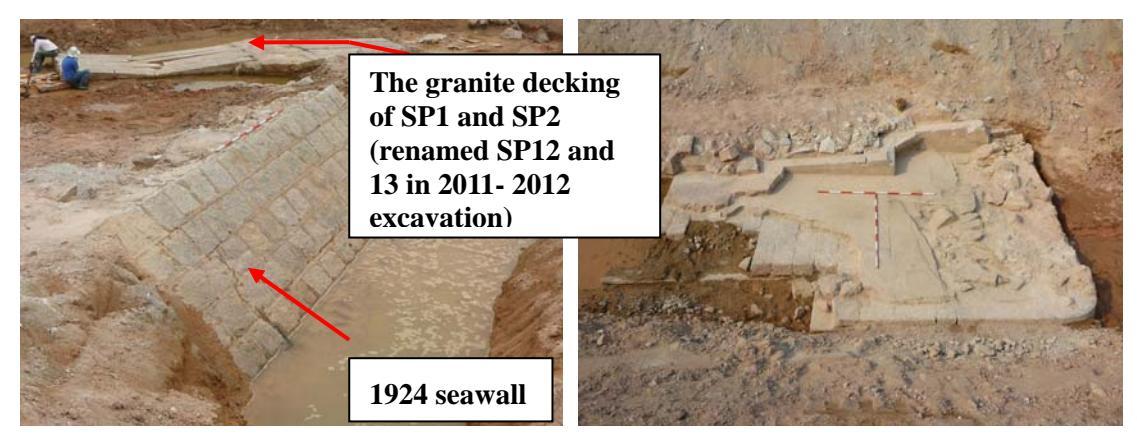
Fig. 10: LTSB granite decking near 1924 seawall.

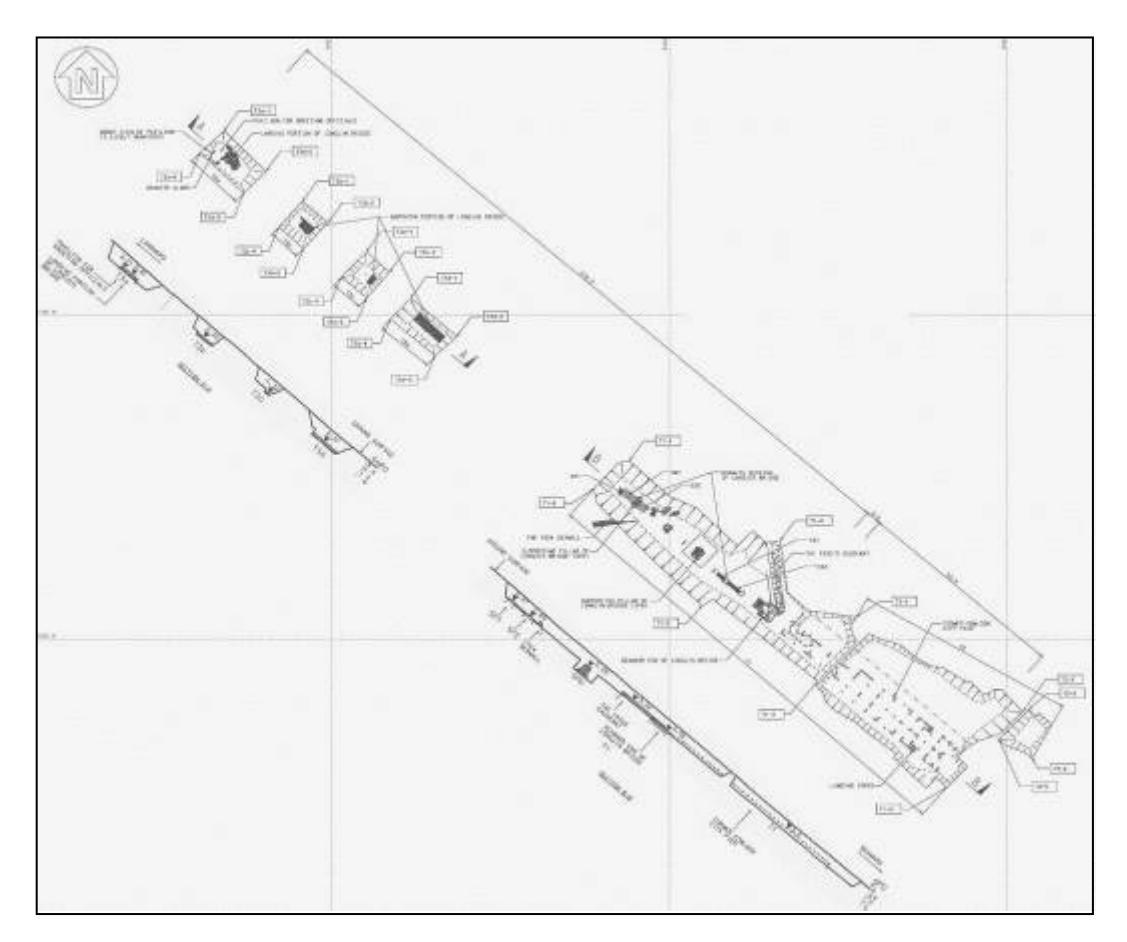
Fig. 14: Layout plan of 2008-2009 Further Archaeological Excavation of Lung Tsun Stone Bridge.

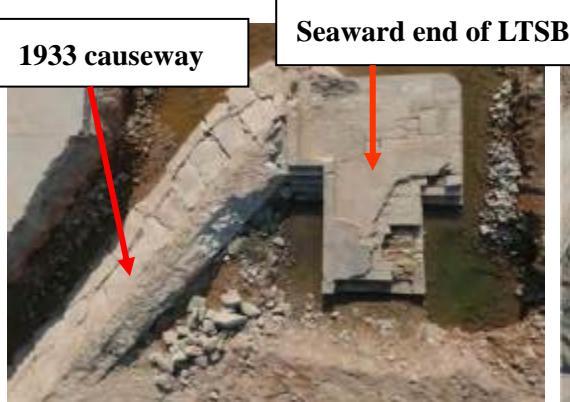
Fig. 17: Seaward end of the LTSB in connection with 1933 built causeway.

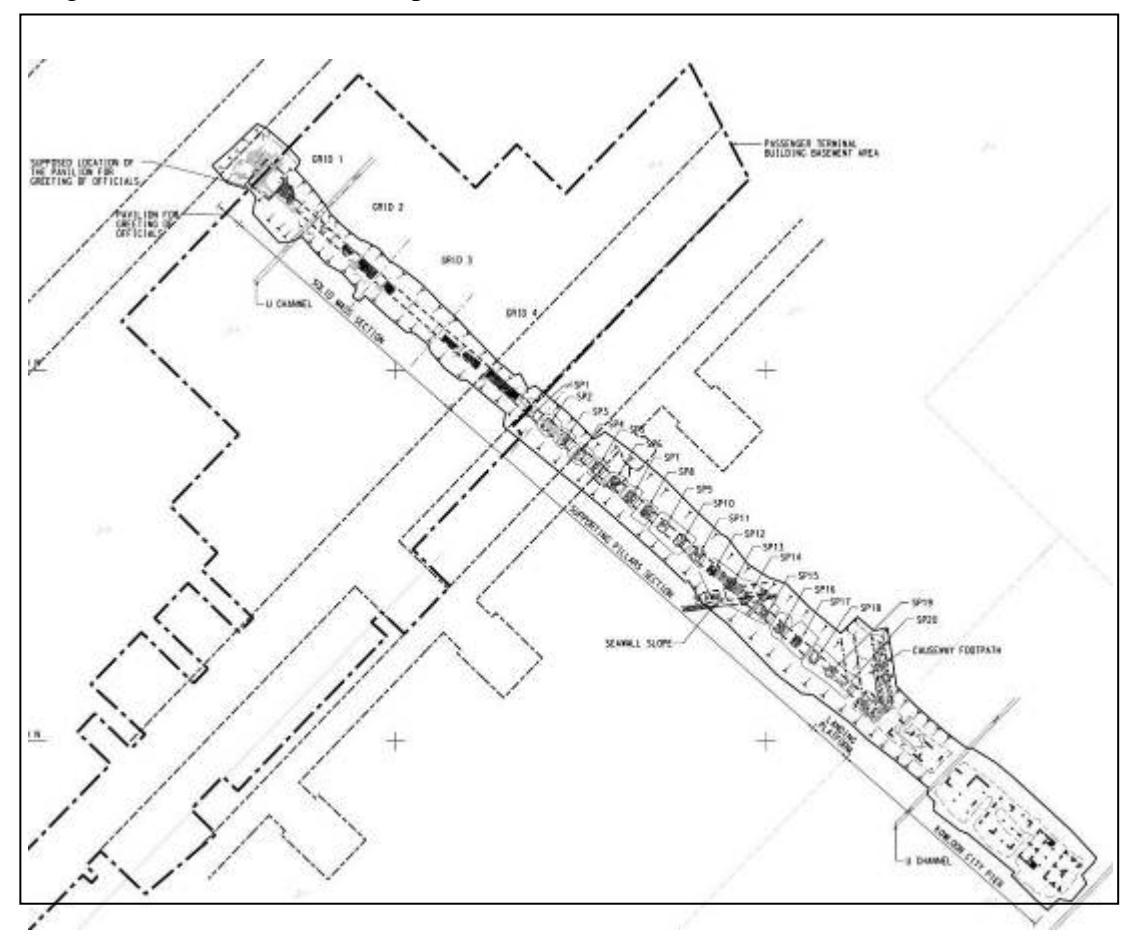
Fig. 23: Layout plan of 2011-2012 Full Archaeological Excavation of Lung Tsun Stone Bridge.

A full archaeological excavation was conducted by a qualified archaeologist commissioned by the CEDD in 2011-12 to unearth the remnants of LTSB (Fig. 23) in order to expose all the uppermost surface of the remnants and record the conditions as much as possible. All the remnants were backfilled after the full excavation. The archaeological excavation unearthed the remnants of the Pavilion for Greeting Officials (Fig. 30), solid mass section, 20 supporting pillars (For example, supporting pillar SP17 in Fig. 27), partial concrete decking (Fig. 28) and the landing platform of LTSB (Fig. 29) as well as the 1924 seawall and 1933 causeway. All remnants of LTSB had been subjected to various degrees of destruction of top five tiers except for SP13 and the landing platform. The decking remains among SP12, SP13 and SP14 (Fig. 26) were the only surviving original granite decking. The broken concrete decking was found from SP18 to SP20. At the northern portion, the exposed solid mass section was truncated into eight sections by the pile caps and concrete beams of Kai Tak Airport (Fig. 25), while most of the top tiers were also destructed.

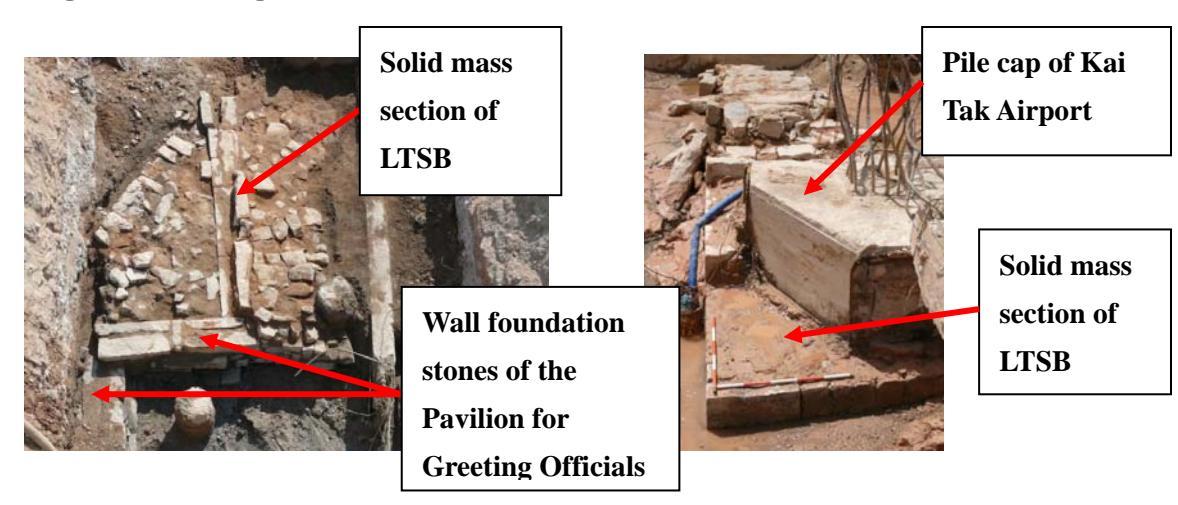
Fig. 24: Wall foundation stones of the Pavilion for Greeting Officials and northern end of solid mass section of LTSB;

Fig. 25: Solid mass section was truncated into eight sections by the pile caps and concrete beams of Kai Tak Airport.

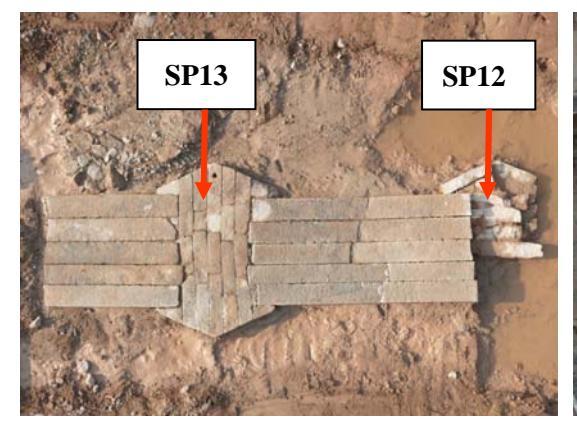
Fig. 26: The decking remains among SP12,

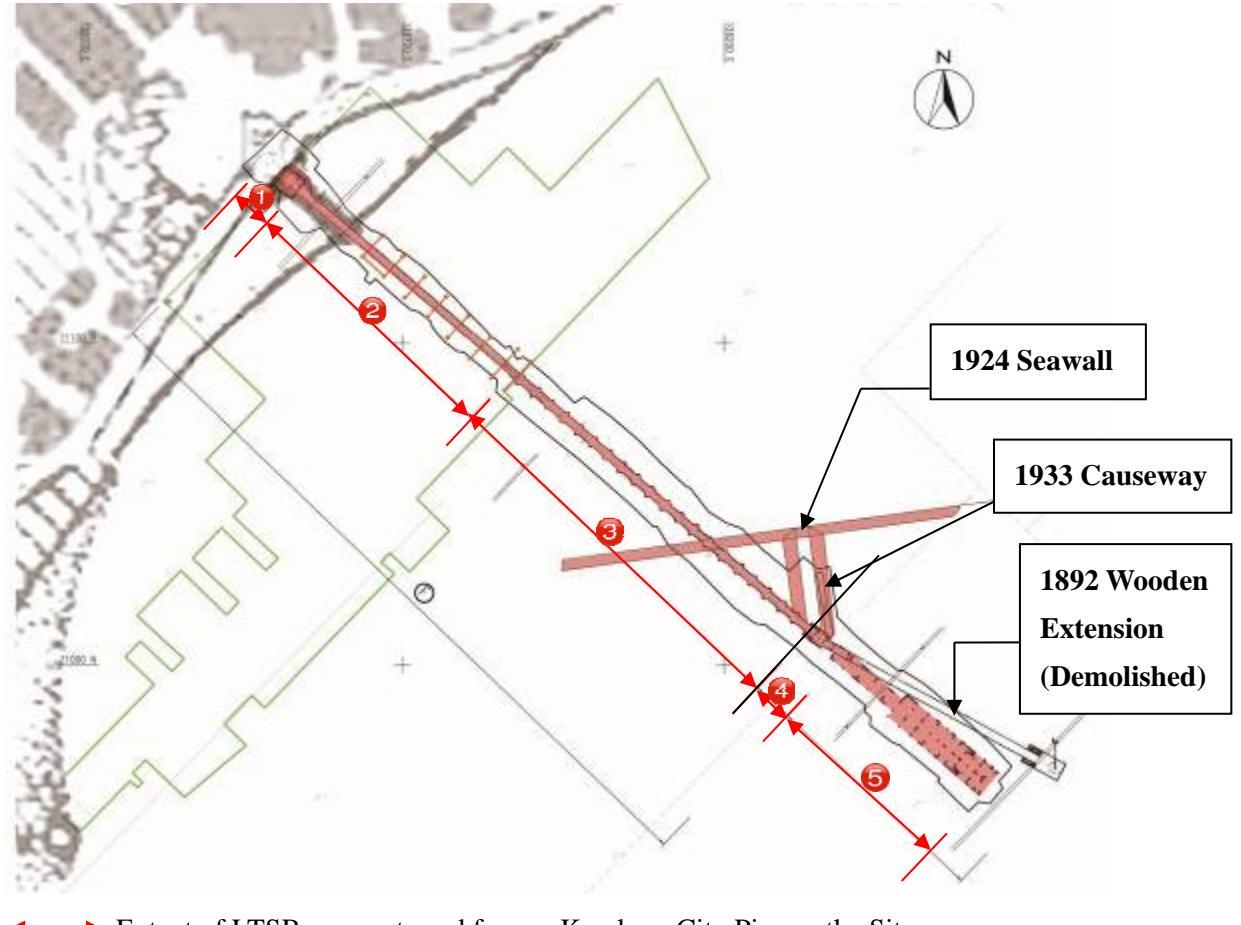
Extent of LTSB remnants and former Kowloon City Pier on the Site
Foundation Structure of Kai Tak Airport (Passenger Terminal Building Basement Area)

Fig. 31: Summary of locations and extents of major archaeological findings: (1) Pavilion for Greeting Officials, (2) solid mass section, (3) supporting pillar section, (4) landing platform, (5) former Kowloon City Pier. The archaeological excavation map has overlaid with historical map at the early 20<sup>th</sup> century to show the original setting. (Remarks: The remnants of 1924 seawall and 1933 causeway were not

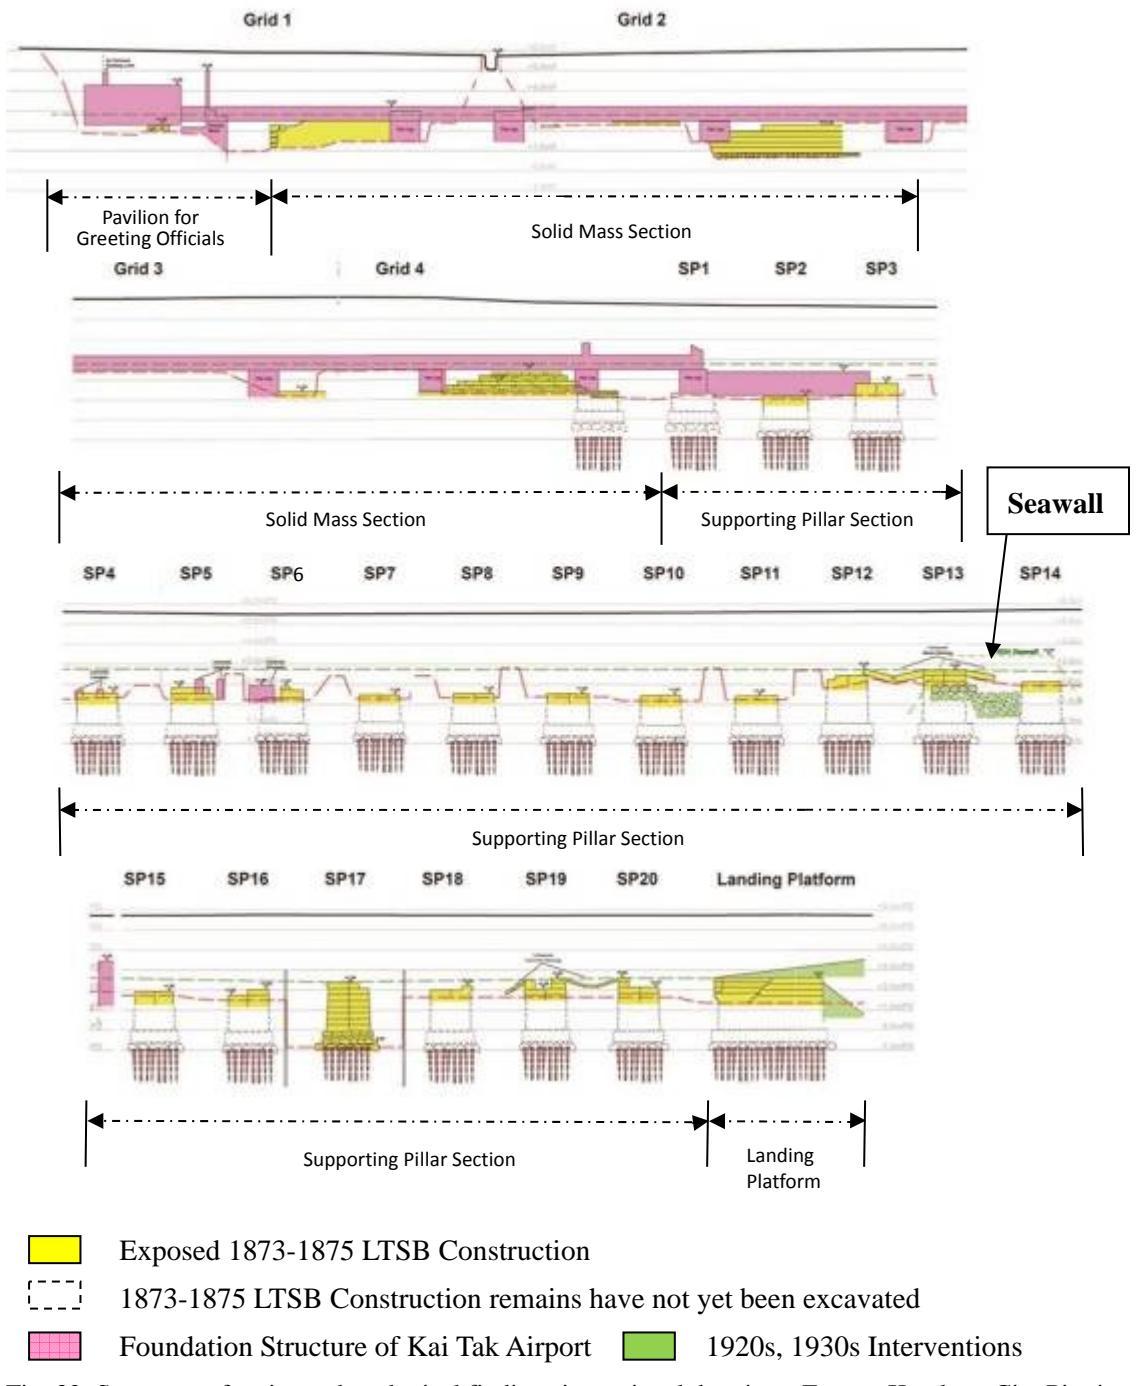
Fig. 32: Summary of major archaeological findings in sectional drawings. Former Kowloon City Pier is not shown in this drawing. (Source: *Full Excavation for Defining the Preservation Approach of Lung Tsun Stone Bridge Remnants.*) **\*The names of remnants are based on the** *Full Excavation for Defining the Preservation Approach of Lung Tsun Stone Bridge Remnants* **(2013) if not specified.**

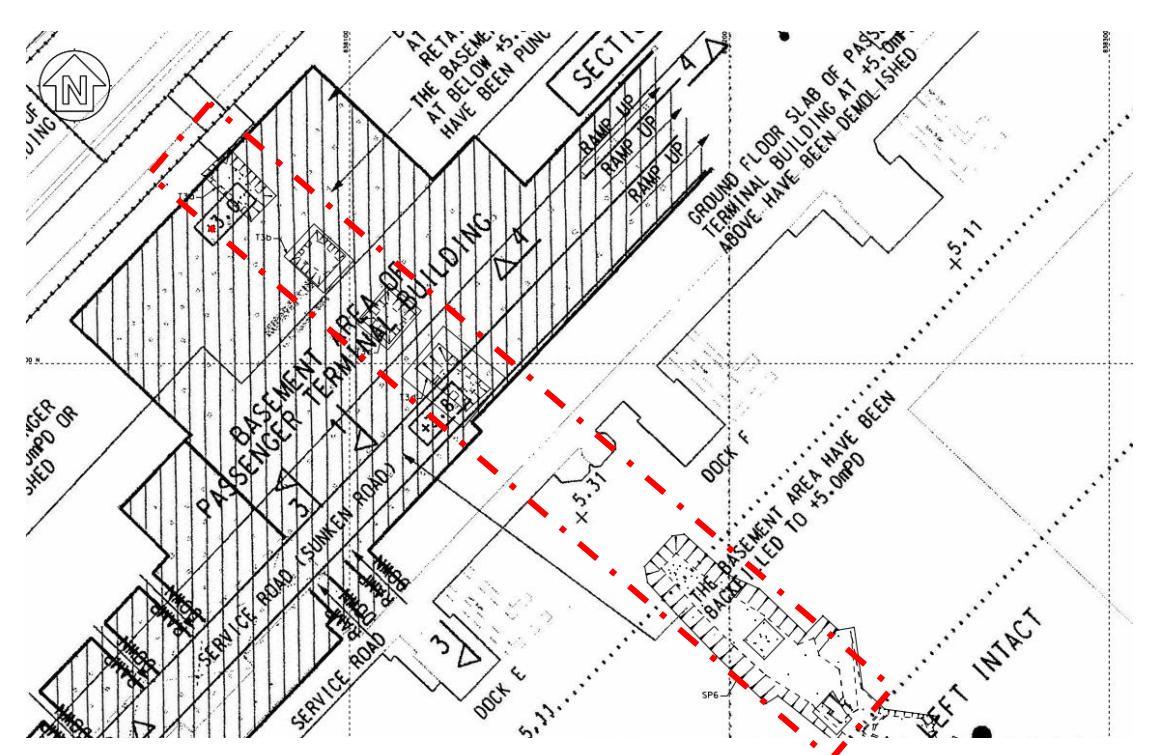
Fig. 48: Plan of Kai Tak airport basement was overlapped with the plan of LTSB archaeological excavation. The edged-red area indicates the original location of LTSB. (Source: *Full Excavation for Defining the Preservation Approach of Lung Tsun Stone Bridge Remnants.*)

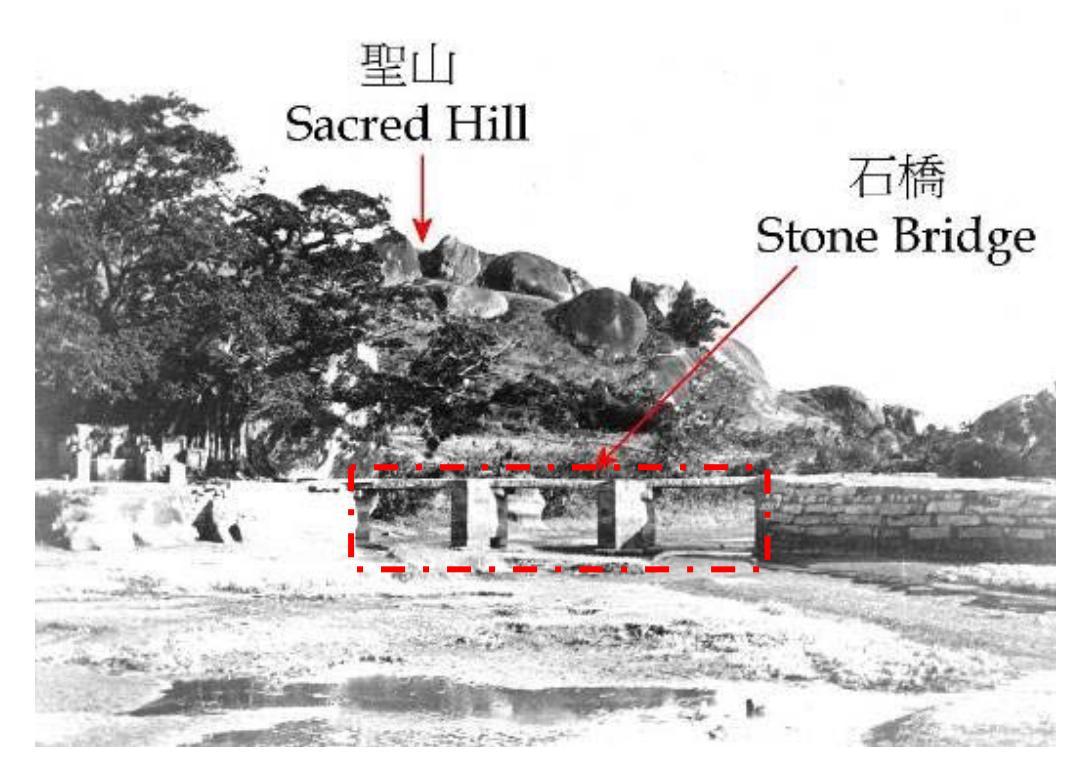
Fig. 59: Stone bridge at Kowloon City area. LTSB shares the similar construction style with supporting pillars in hexagonal shape. (Source: *Conservation Management Plan for Lung Tsun Stone Bridge*.)

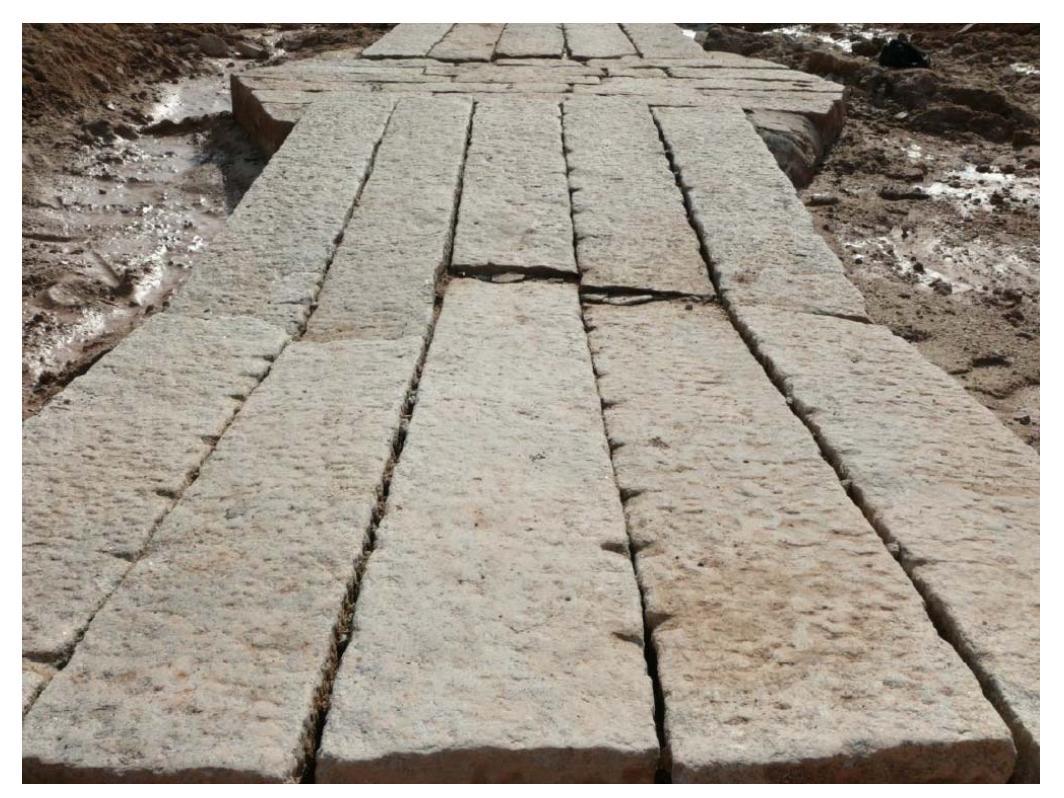
Fig. 62: Granite decking between SP12 and 13. (Source: *Full Excavation for Defining the Preservation Approach of Lung Tsun Stone Bridge Remnants.*)

According to the archaeological excavation reports from 2008 to 2013, the solid mass section of LTSB and the Pavilion at the northern end were seriously damaged while some parts of the southern end, i.e. the granite decking between SP12 and SP13 as well as SP13 and SP17 were in better condition.

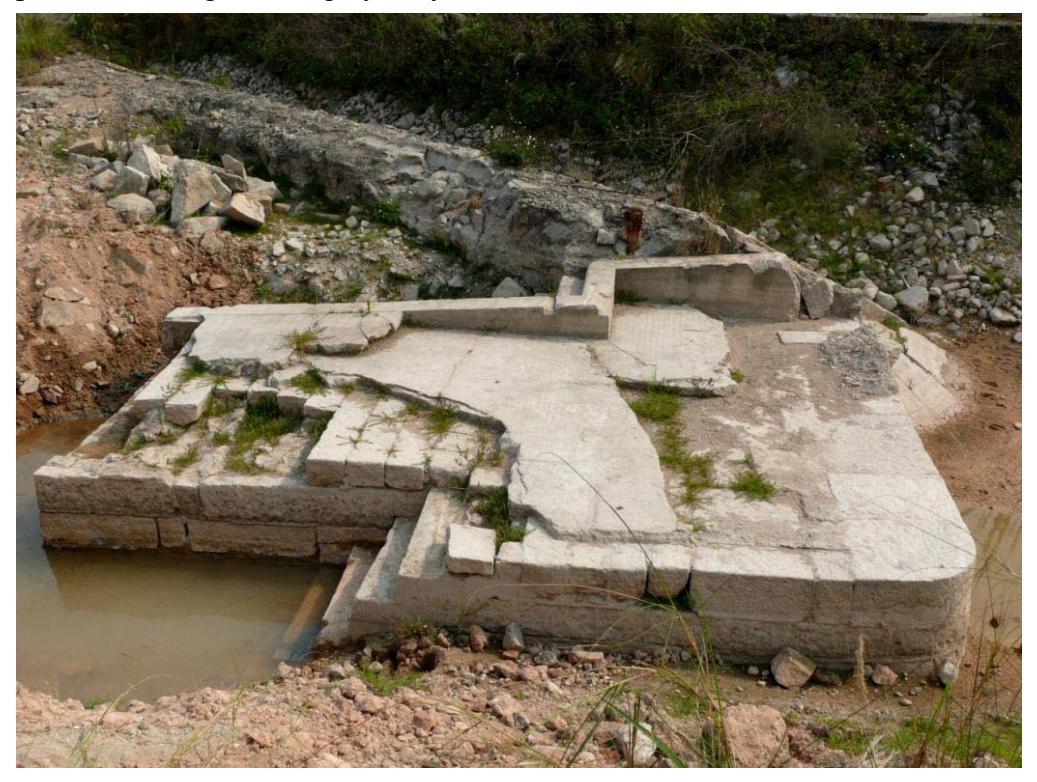
Fig. 65: Remains of the LTSB Landing Platform. (Source: *Full Excavation for Defining the Preservation Approach of Lung Tsun Stone Bridge Remnants.*)

Landing Platform at the seaward end of LTSB was constructed using pre-shaped dressed granite blocks with two passenger boarding steps on both NE and SE sides. It is a solid mass structure built of granite slabs (Fig. 65). Similar forms of seaward ends were observed in masonry piers of Sheung Wan (Fig. 67), Central (Fig. 66), Admiralty and Wan Chai.

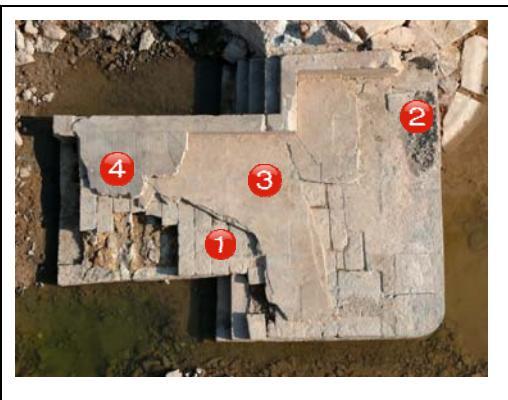
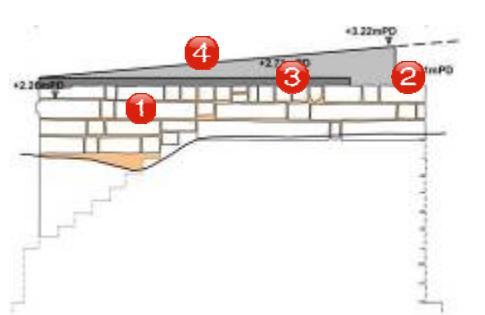
Fig. 96 - 97: Pavements of the landing platform:(1) Original granite slabs, (2) 1892 concrete repair,(3) 1910 concrete repair, (4) 1930s concrete ramp to former Kowloon City Pier.

The LP has the same alignment to the LTSB, which was connected to SP20 with a slab for access (Fig. 95). Three layers of concrete pavement were found on top of the original granite structure illustrating the later modifications in 1892, 1910s, 1920s and 1930s (Fig. 96-97).

The construction of the LP is similar to the stone supporting pillar with the use of granite slabs. The slabs were laid in a cross-alternative ways in a T-shaped plan, and two sets of stairs for passenger boarding were observed on the northeast and southeast sides of the LP. A total of at least six steps of stairs exist on the eastern and western sides were excavated in previous archaeological work.

The 1892, 1910s, 1920s and 1930s layers of concrete pavement were found on top of granite structures that illustrate the Kowloon development from 19<sup>th</sup> to the early 20<sup>th</sup> century.
