Revitalising Historic Buildings Through Partnership Scheme Batch V Project

# Watervale House, Former Gordon Hard Camp into Tuen Mun Soul Oasis

Heritage Impact Assessment Report

**The Tuen Mun Soul Oasis Foundation** P.K. Ng & Associates (H.K.) Limited and The Team Consultant

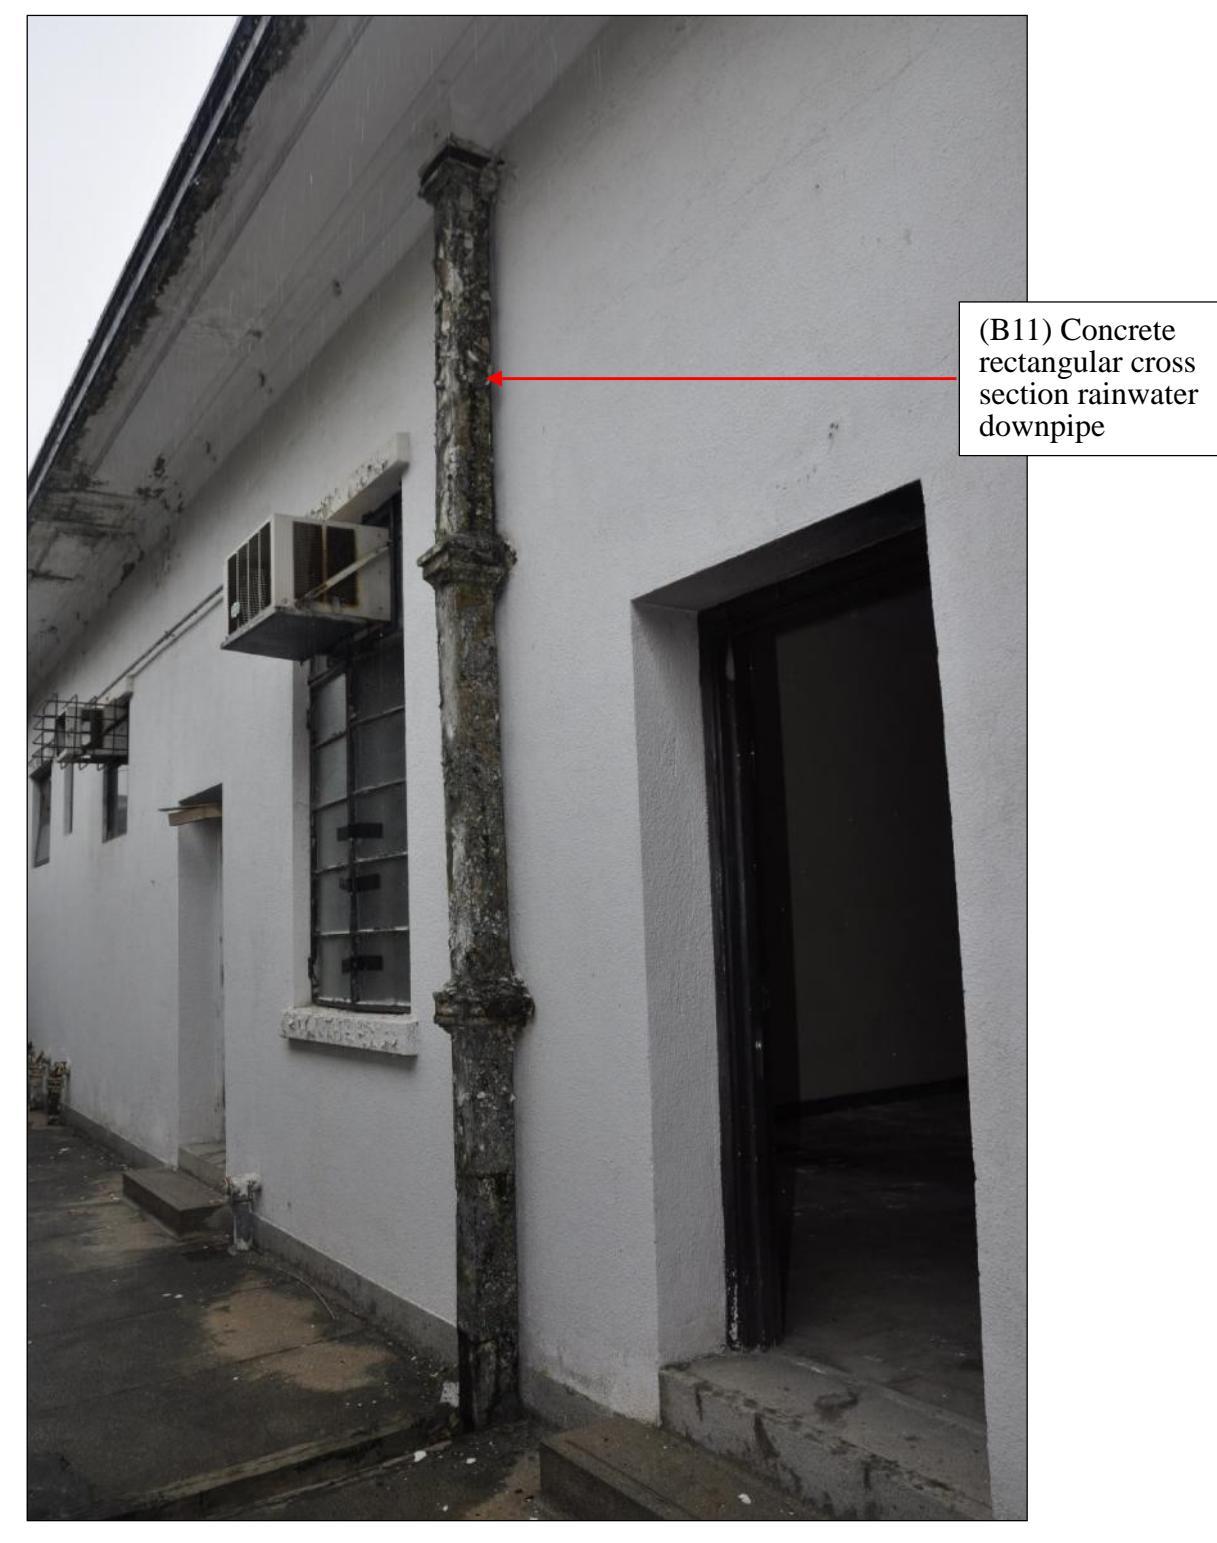
<u>Photo 2-29 – (B11) Concrete rectangular cross section rainwater downpipe</u> including hopper at open corridor adjoining Extension,(13<sup>th</sup> June, 2020)

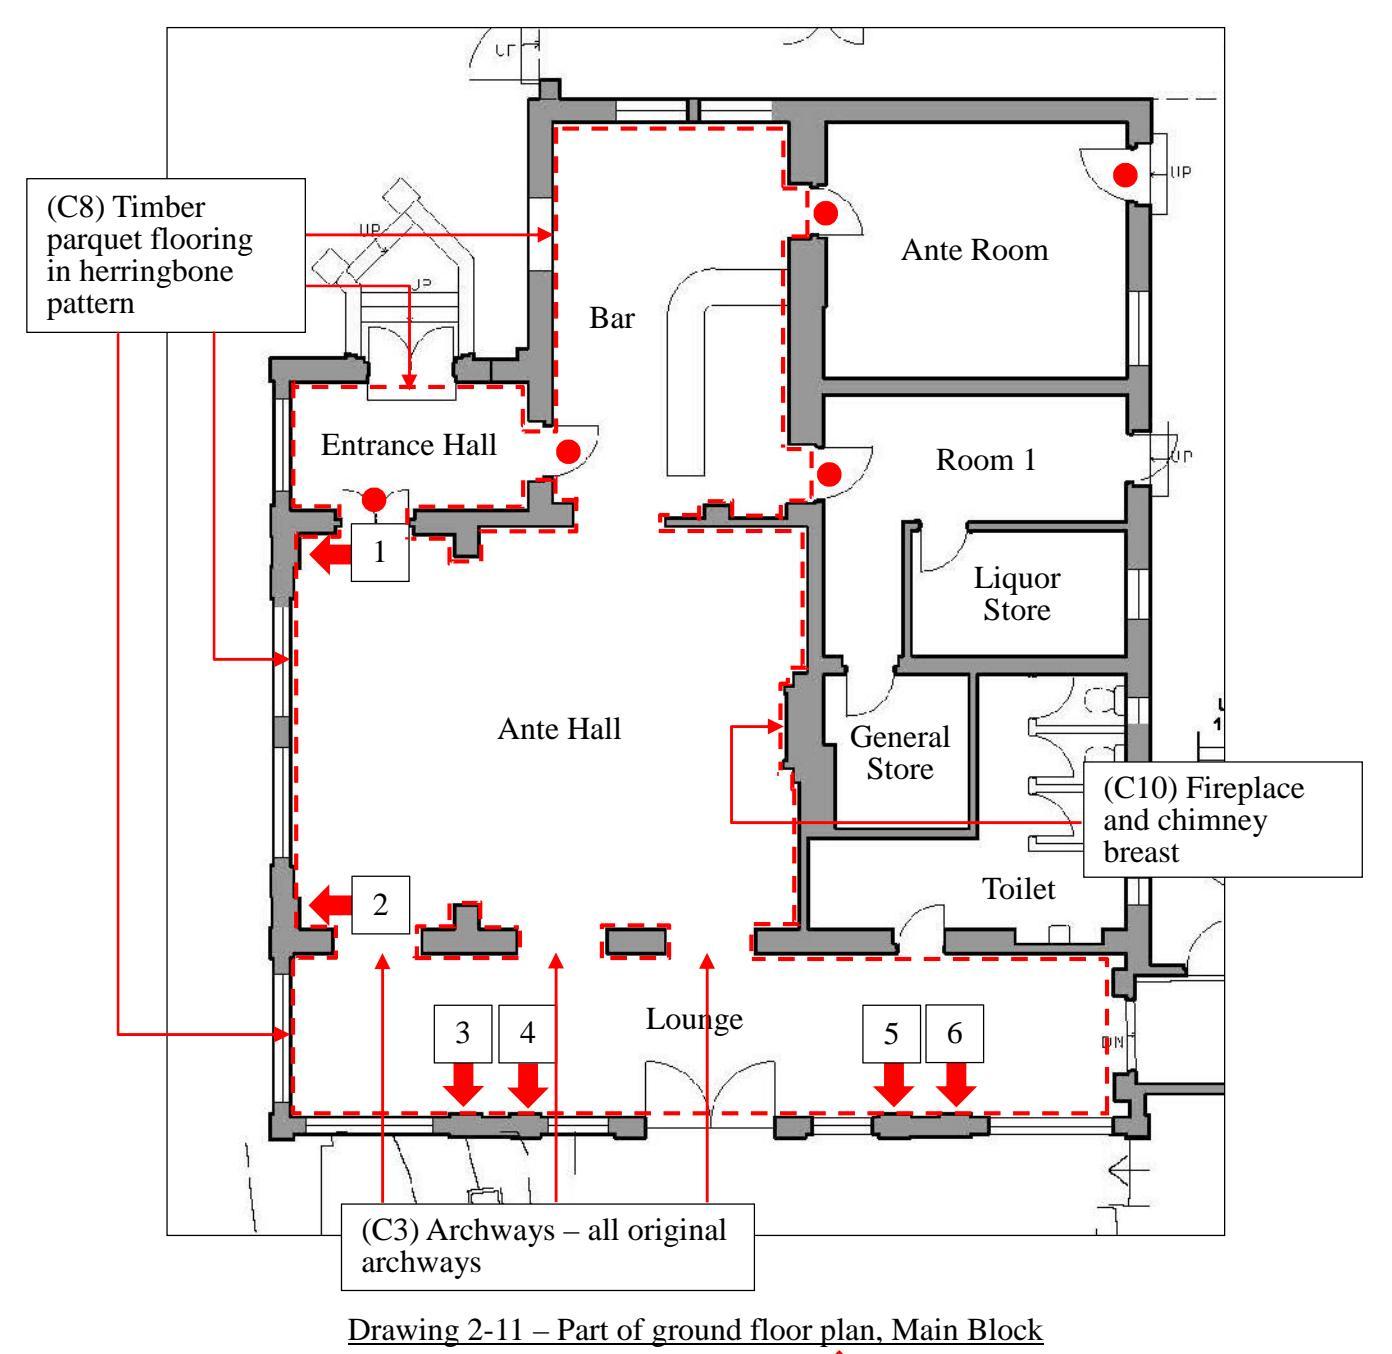
- (C4) "Interior pilasters" (6 nos.) indicated by **1**, and
- (C11) "Interior door timber paneled door" (5 sets), indicated by  $\bigcirc$ ,

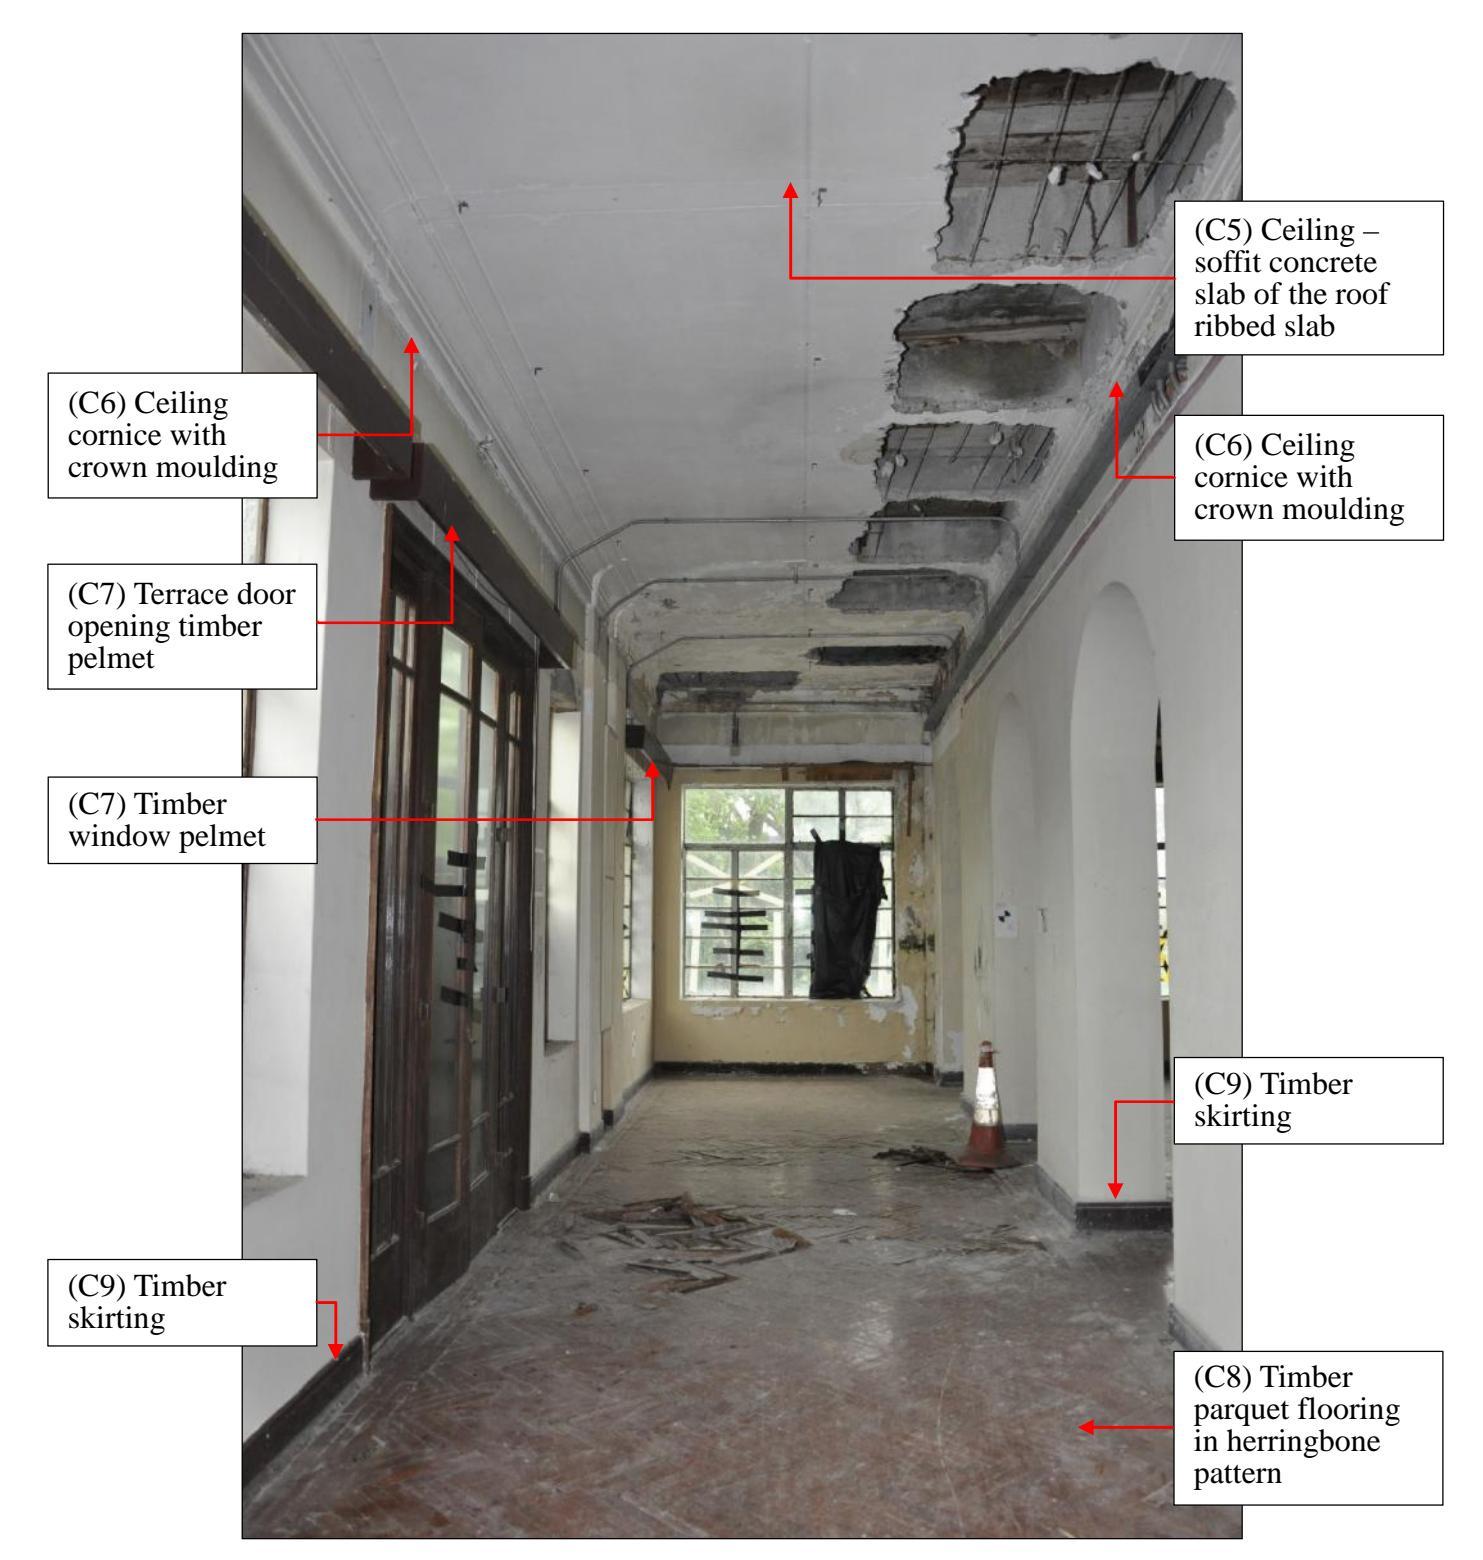
Photo 2-38 - Internal (original Lounge), (7th April, 2020), showing -

- <u>(C5) Ceiling</u>,
- (C6) Ceiling cornice including the crown moudling,
- (C7) Terrace door opening timber pelmet and all timber window pelmet,
- (C8) Timber parquet flooring in herringbone pattern, and
- <u>(C9) Timber skirting</u>.

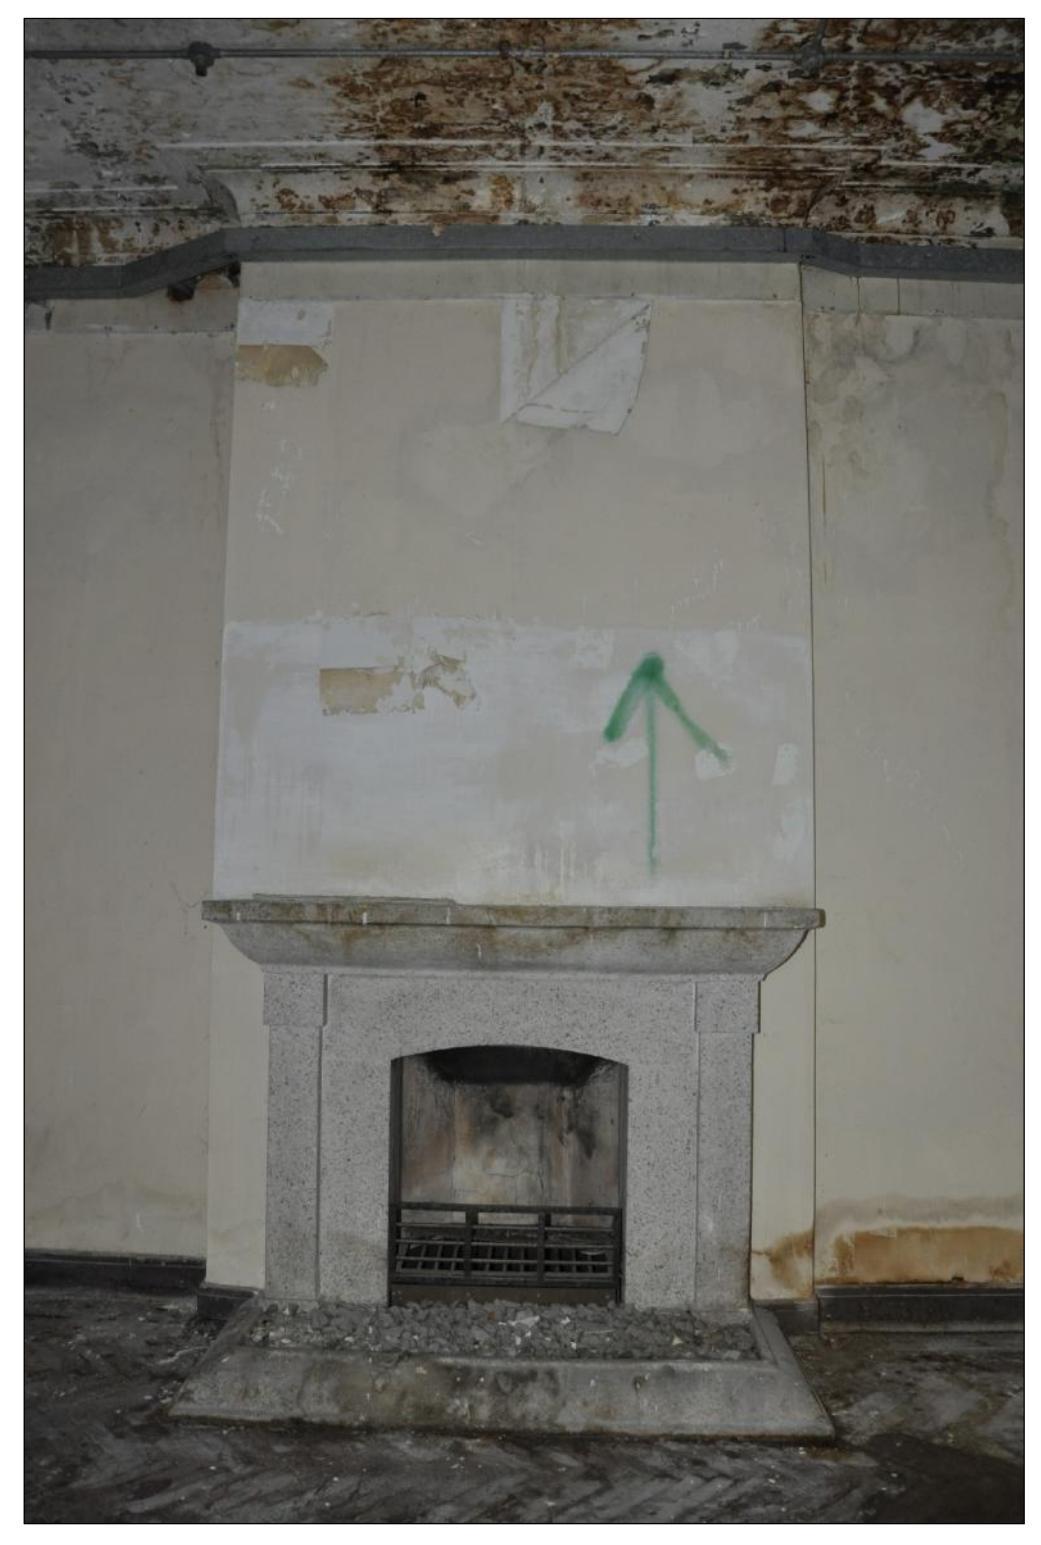
Photo 2-39 – (C10) Fireplace and chimney breast, (7th April, 2020)

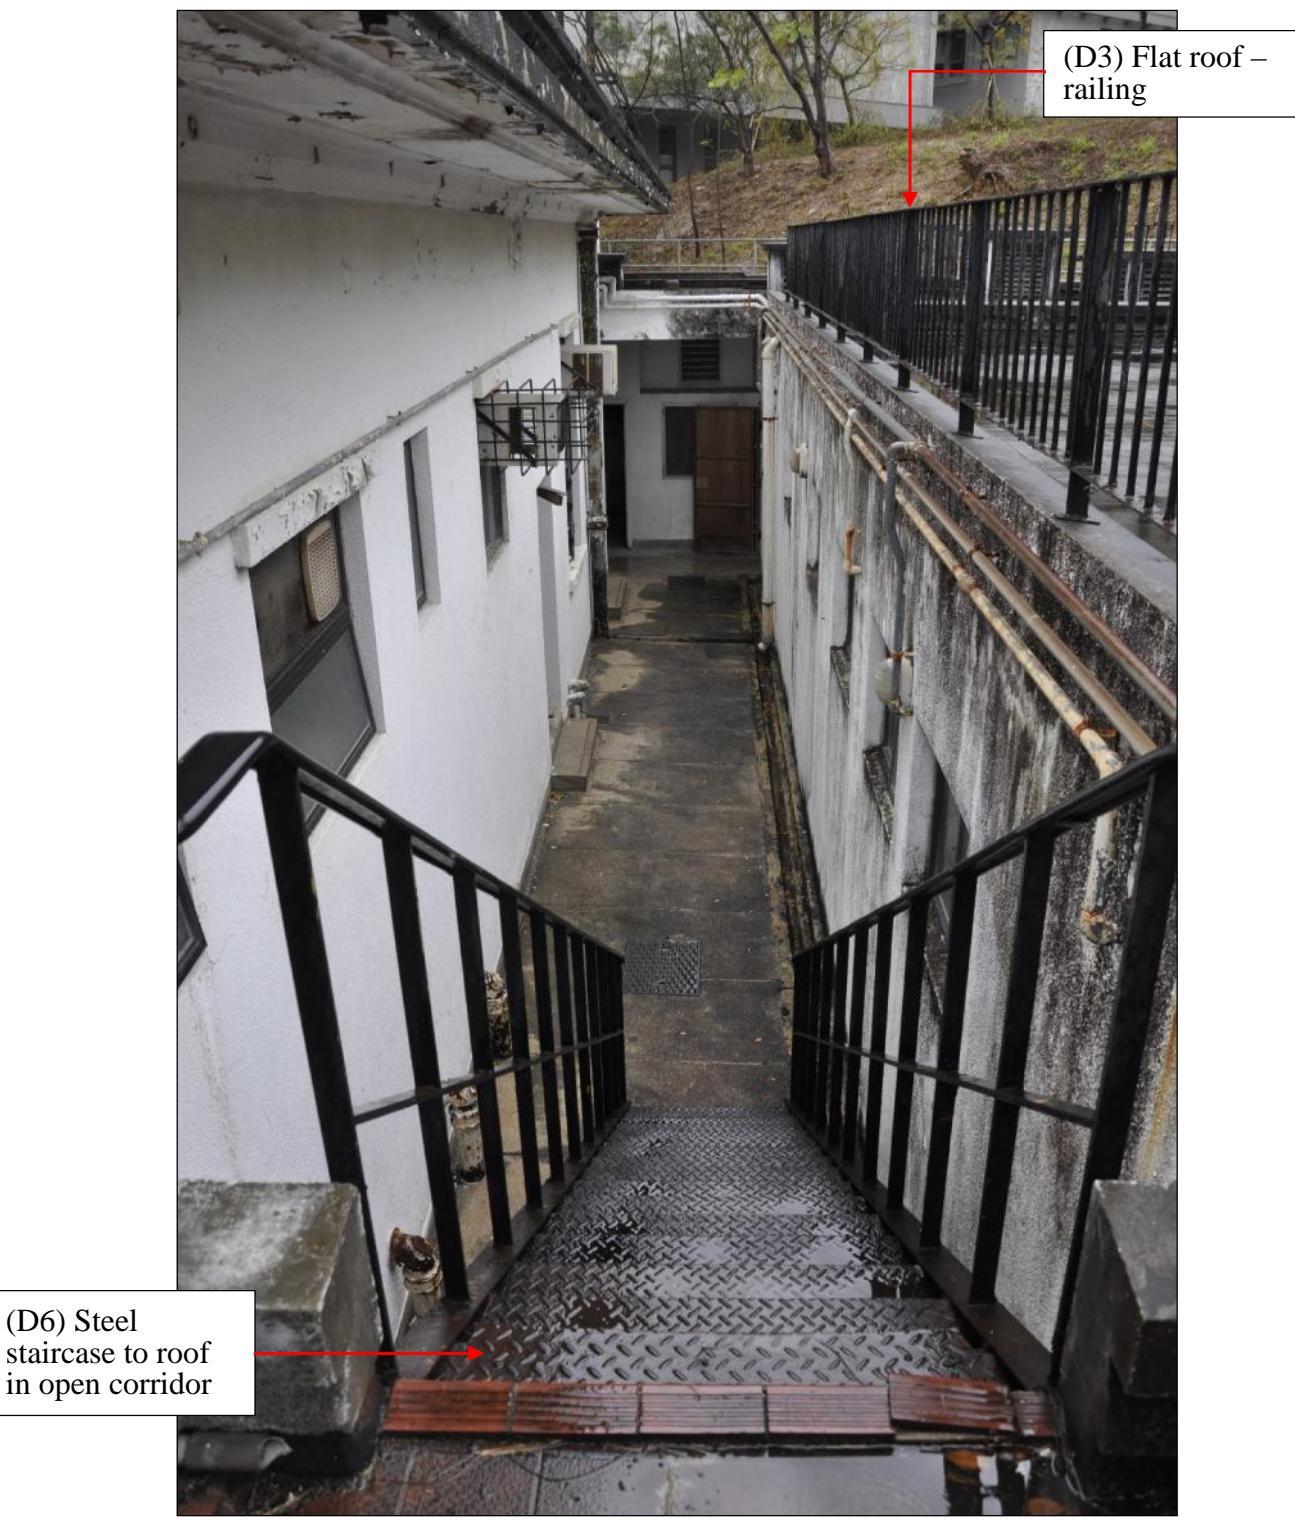
Photo 2-51 – (D3) Flat roof – railing, (D4) Open corridor adjoining the Main Block, view from south end towards north end, (D6) Steel staircase to roof in open corridor, (13<sup>th</sup> February, 2020)

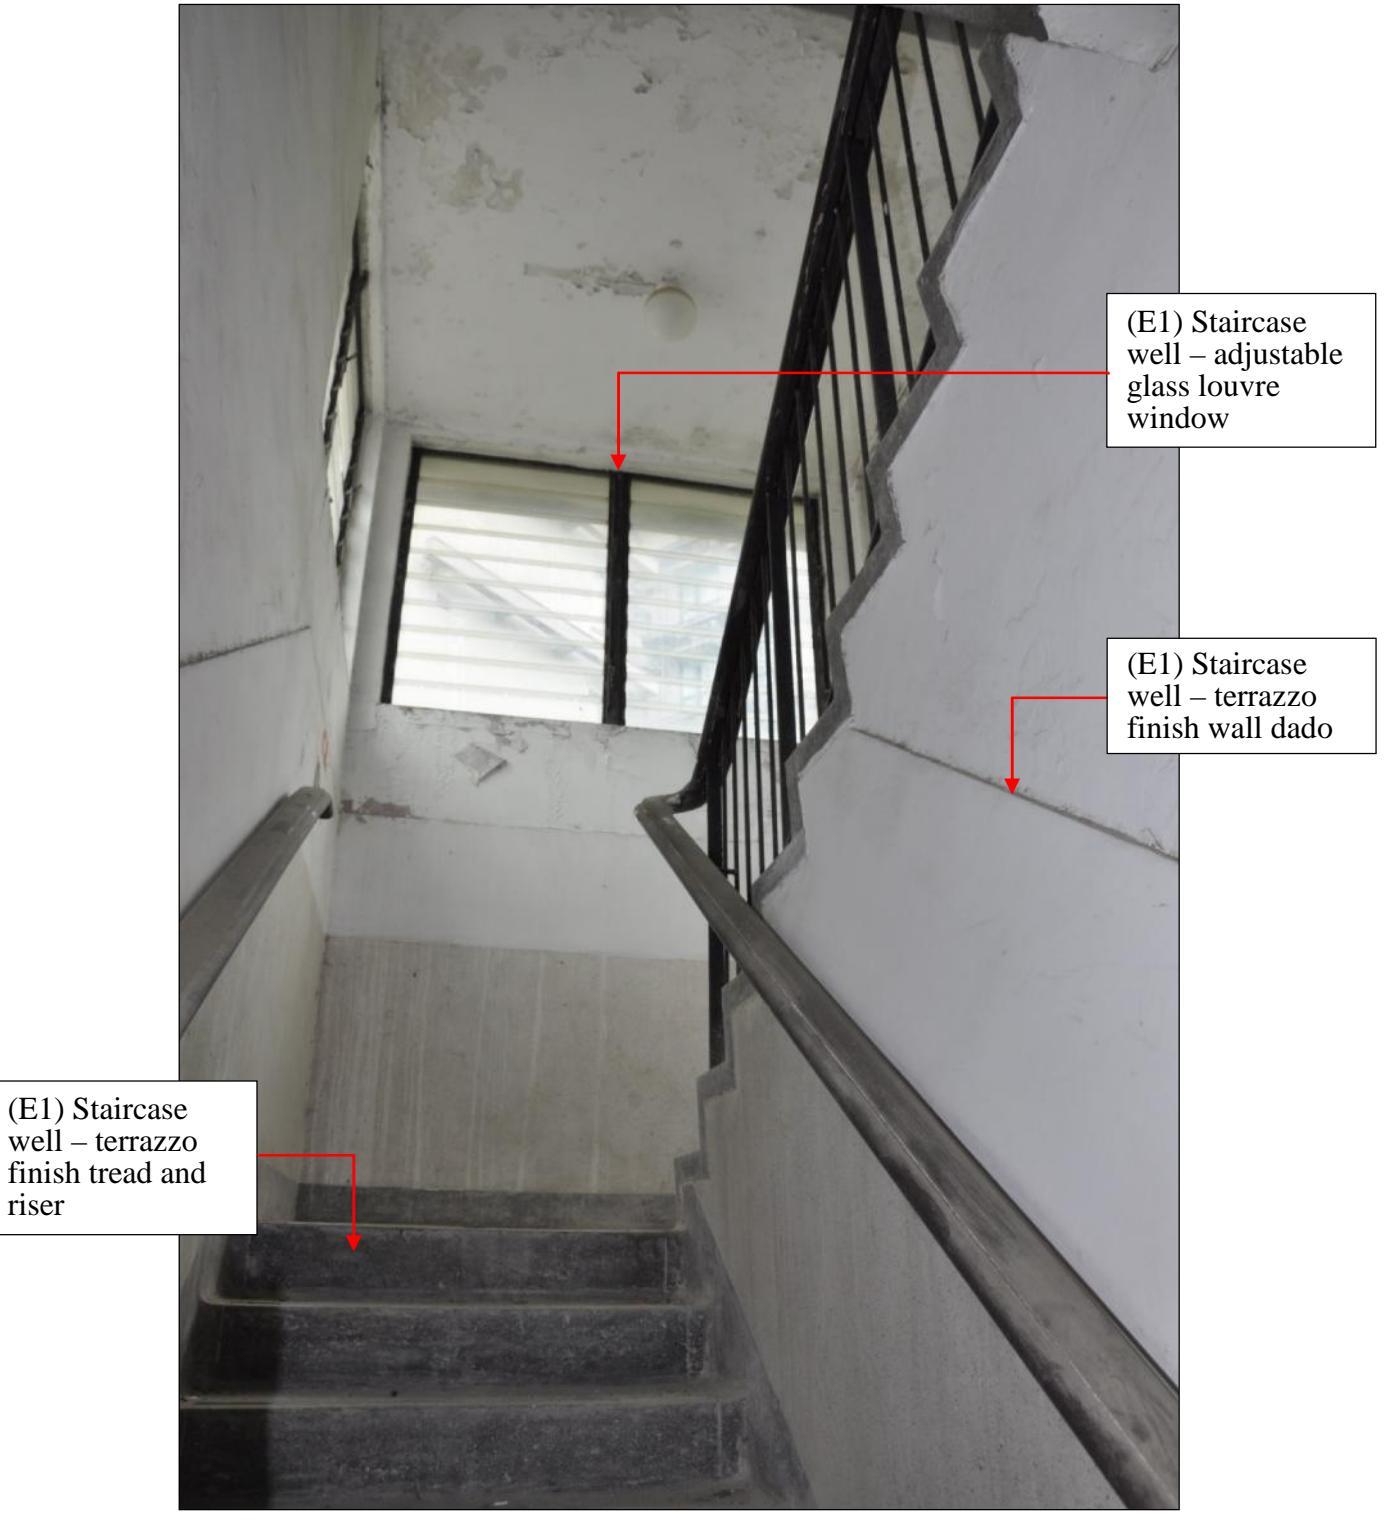
Photo 2-54 - (E1) Staircase and staircase well, (looking upwards from ground floor landing towards intermediate landing, (13<sup>th</sup> June, 2020)

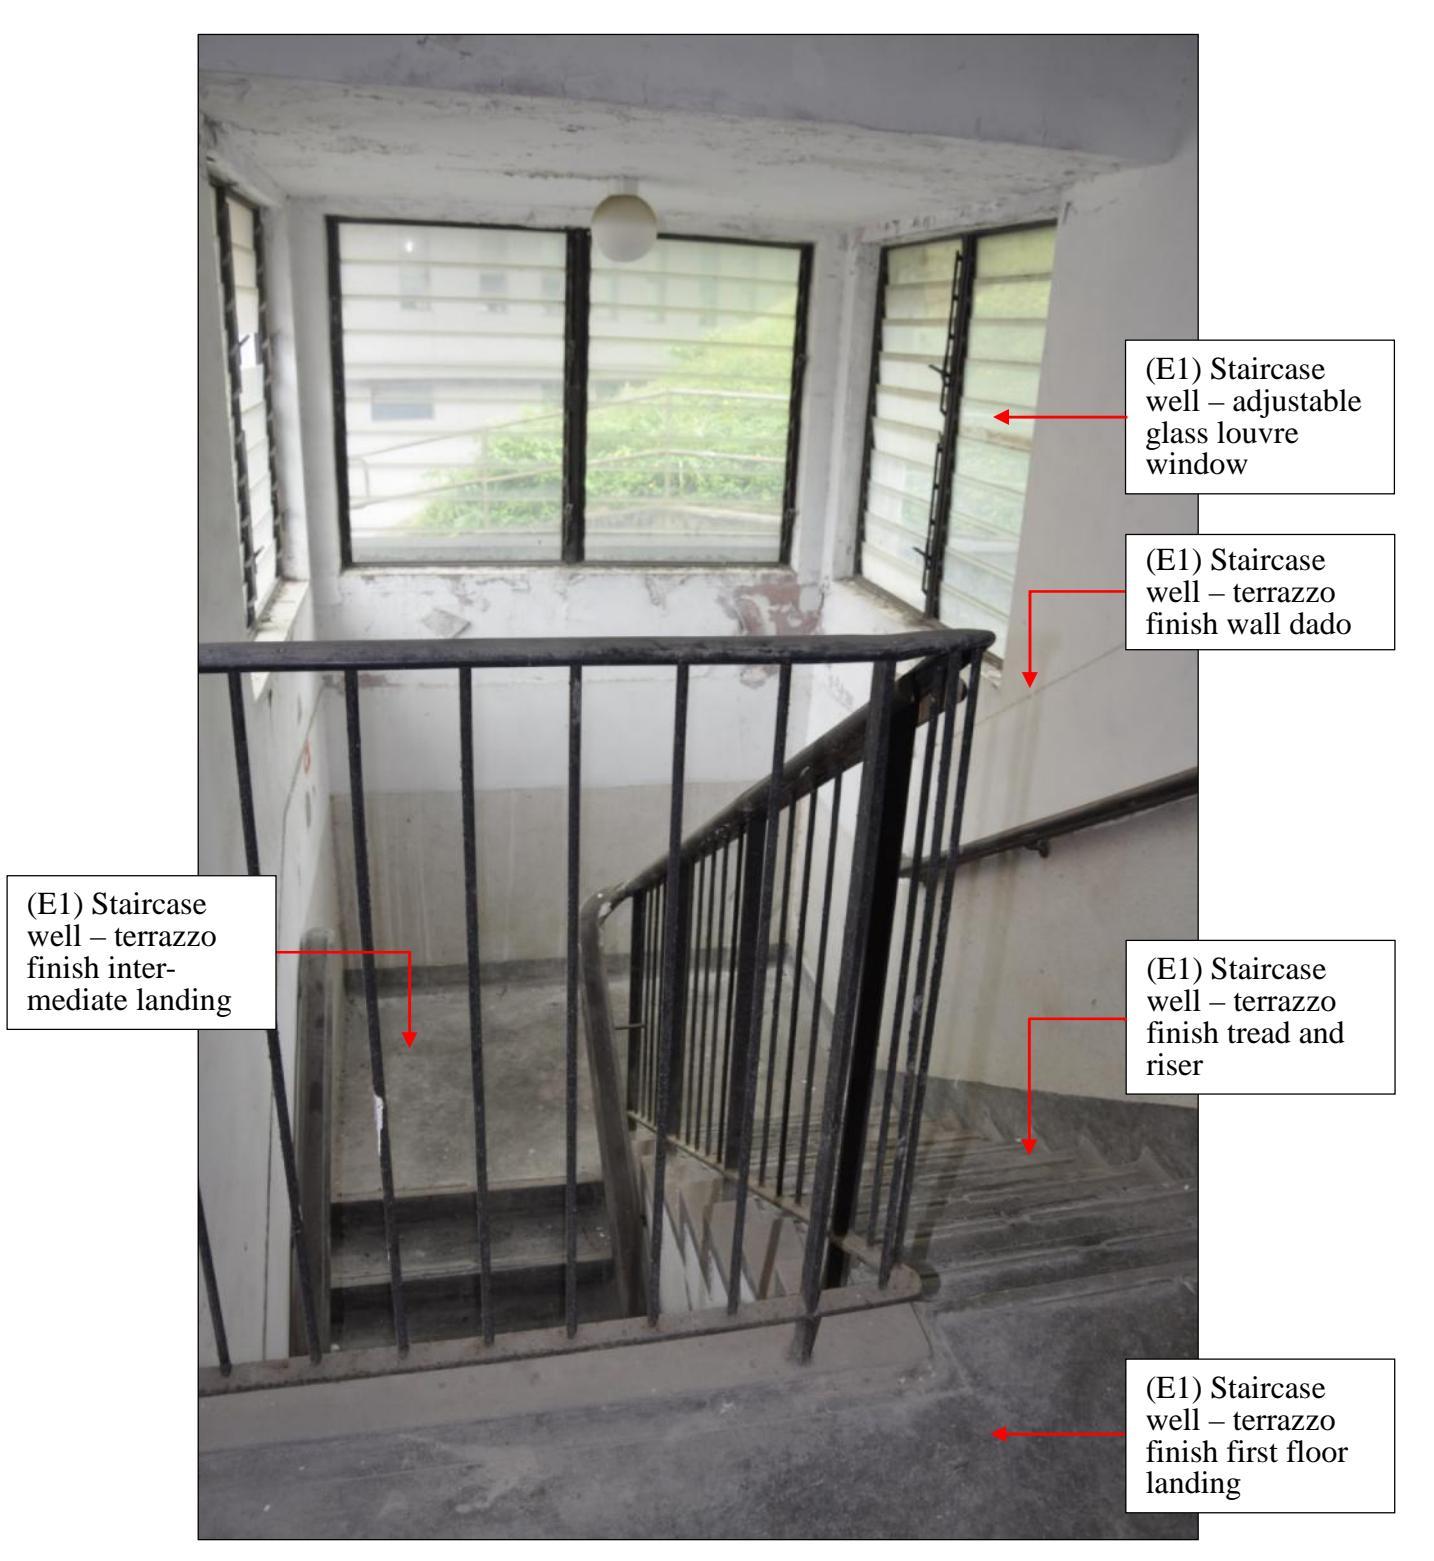
<u>Photo 2-55 – (E1) Staircase and staircase well, (looking downwards from</u> <u>first floor landing towards intermediate landing), (13<sup>th</sup> June, 2020)</u>
# Part 2 – Cultural Significance

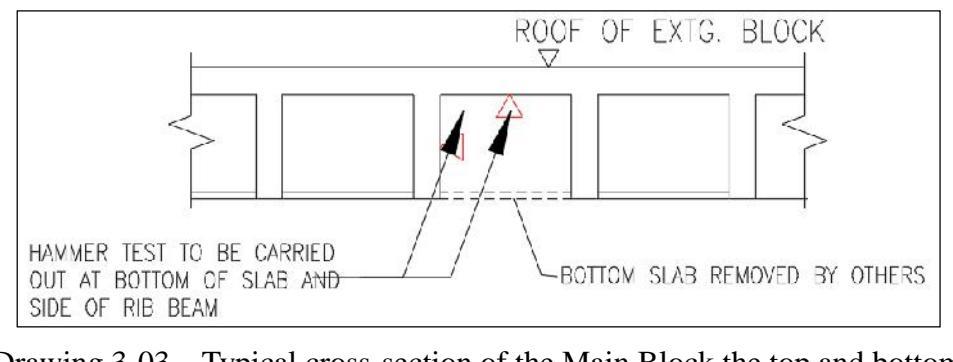
Drawing 3-03 – Typical cross-section of the Main Block the top and bottom double slab-rib beam roof, (not to scale)

The Main Block roof structure is in form of double slab-rib beam-slab with a layer of reinforced concrete ceiling slab at the bottom of rib beams, which form a void with the top slab for thermal insulation. This type of roof structure is quite common at the time of the building being constructed.

- (d) Spalling was identified on some existing members of the double slab-rib beam roof structure, and will be repaired in accordance with be requirements for repair of spalling concrete.
- (e) The existing slabs, beams, columns, walls and footings are structurally capable to resist the increase in loading according to the current Code of Practice.

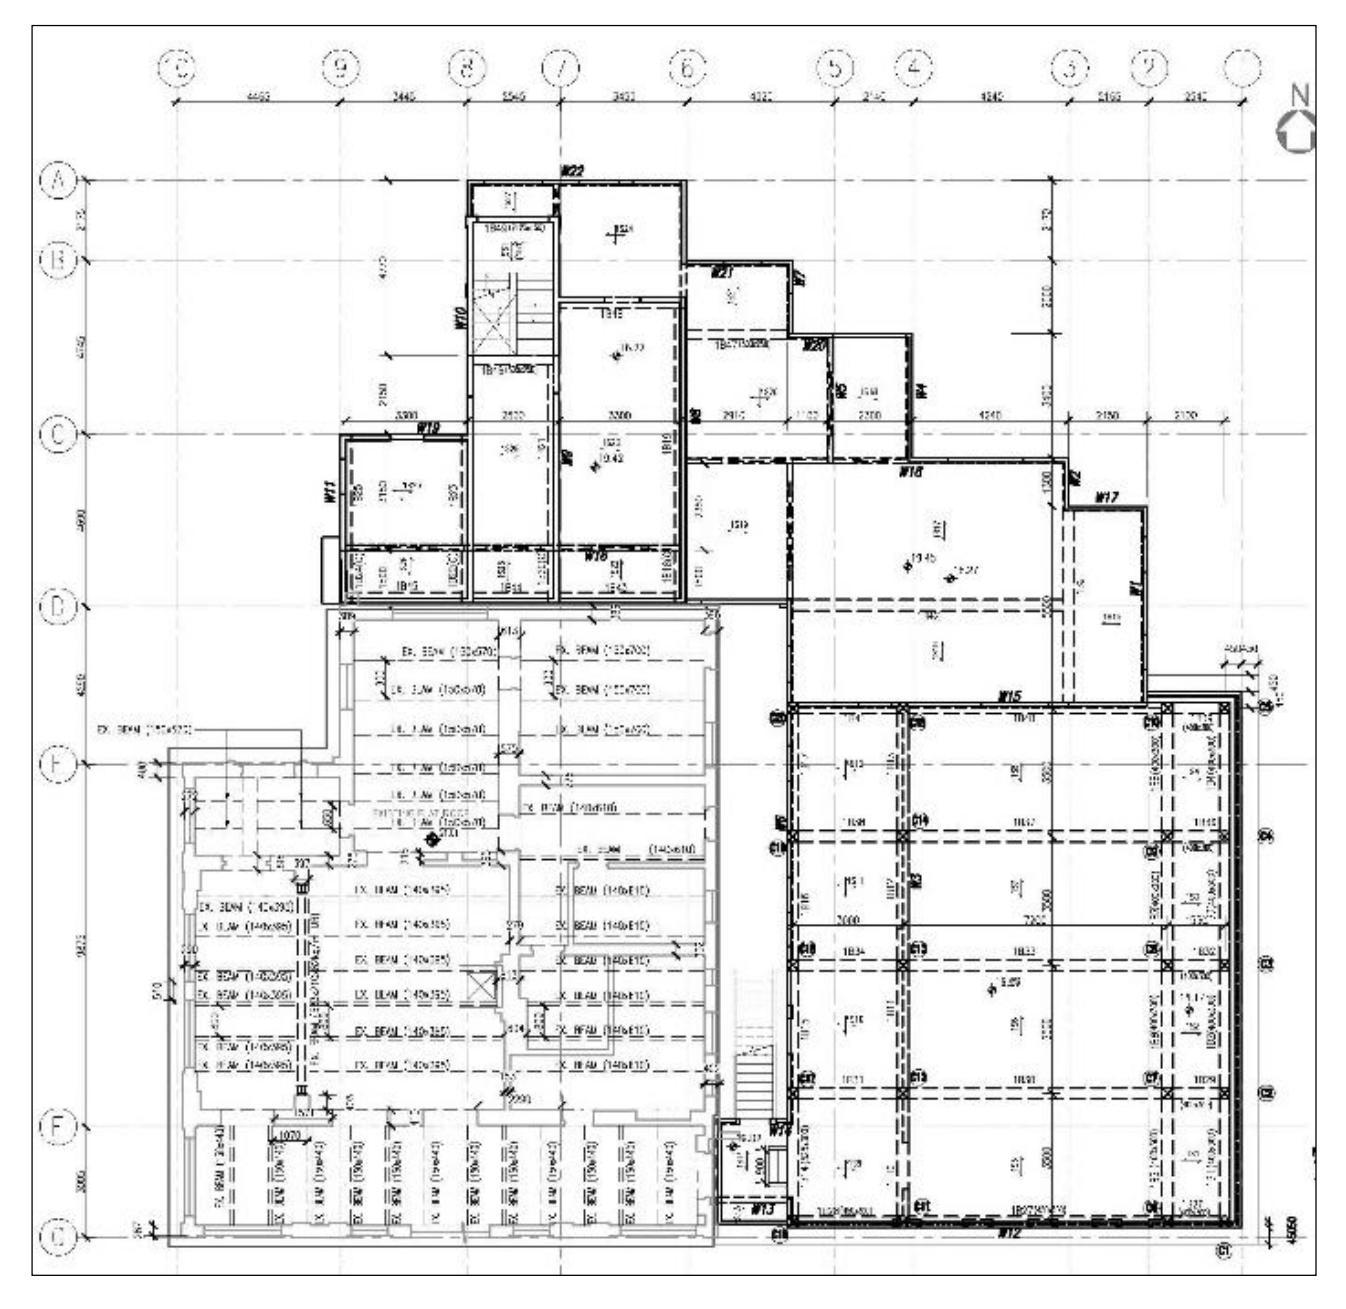
Drawing 3-04 - Main Block and Extension, existing first floor framing plan

For the Extension, according to the record plans retrieved from Architectural Services Department, it was designed and constructed in 1984. The building is a 2-storey reinforced concrete beam and column frame structure. The structural framing record plan as shown on drawing 3-04. From observations during site inspections, the structural condition of the extension block is satisfactory in general.

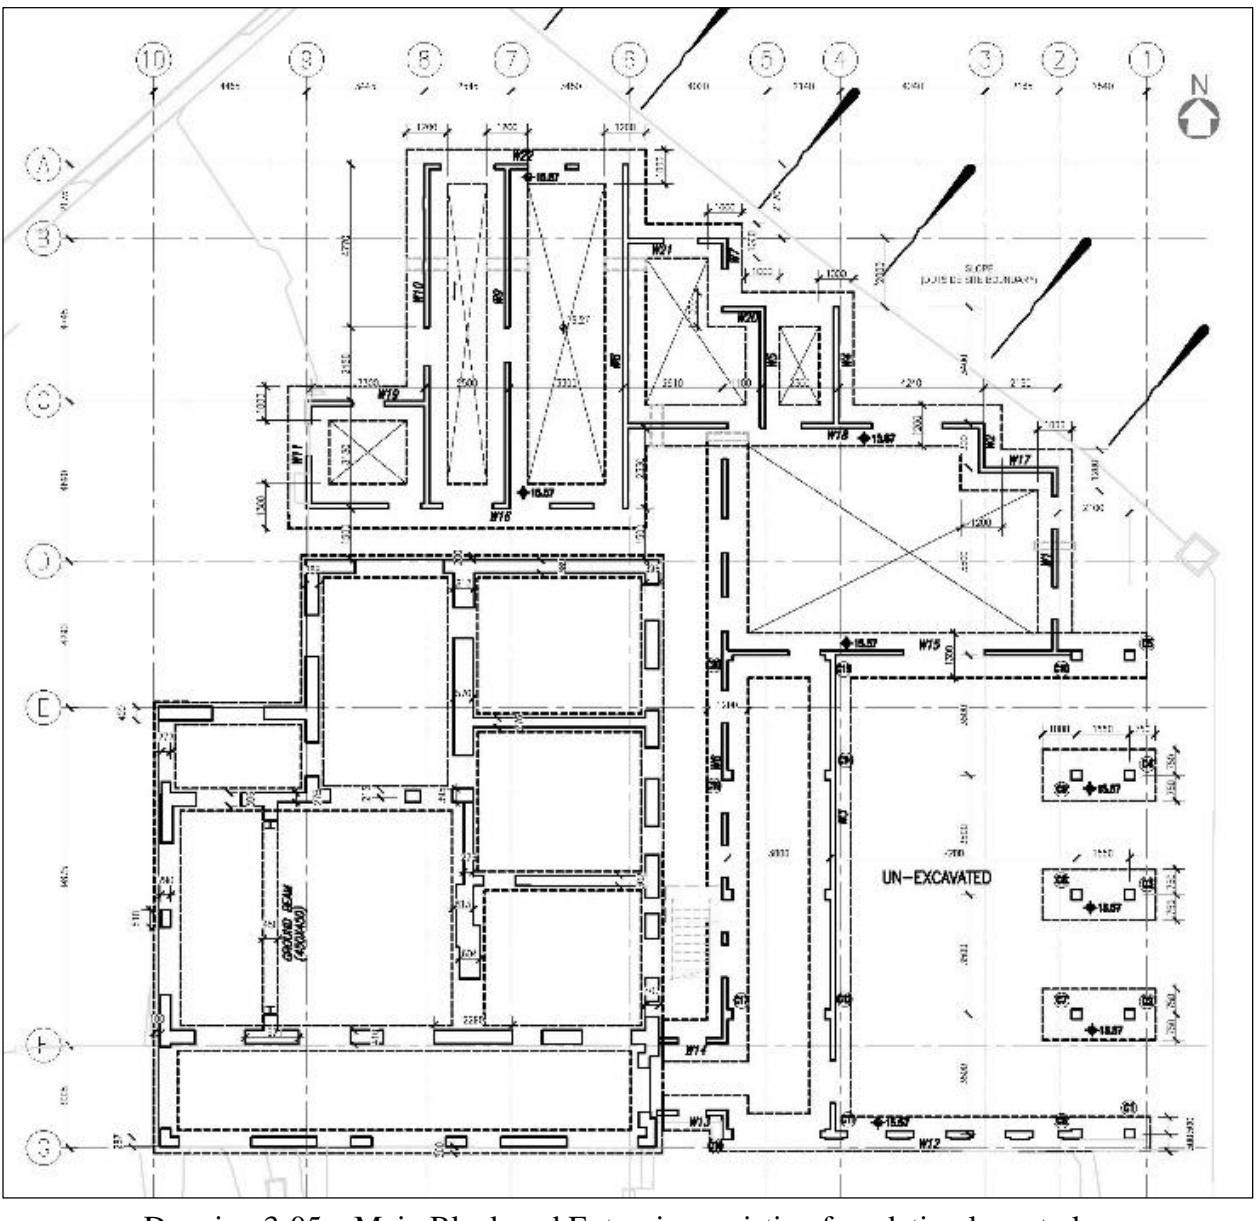
Drawing 3-05 - Main Block and Extension, existing foundation layout plan

•	Re-bound hammer test	the equivalent in-situ concrete strength -
		varies from 33 MPa to 60 MPa.
٠	Half-cell potential test	millivolt equivalents of copper / copper
		sulphate electrode - varies from -521 to -11,
		which is relatively high and can be evaluated
		together with carbonation depth measure to
		represent the representative the potential
		vulnerability of element surface to corrosion
		is high.
•	Radar Scanning	Thickness of roof slab was found as 100 $\sim$
		125mm thick, thickness of roof floor
		finishing was found as ~100mm thick,
		reinforcement bar of roof slab was found as
		R9 with 150 ~ 30 0mm spacing.
(b)	Foundation –	
•	Main Block	strip footing, size 200 to 300 mm thick, and
		average 700 mm deep, as shown on drawing
		3-05 (on peyt page)
		5 05 (on next page).

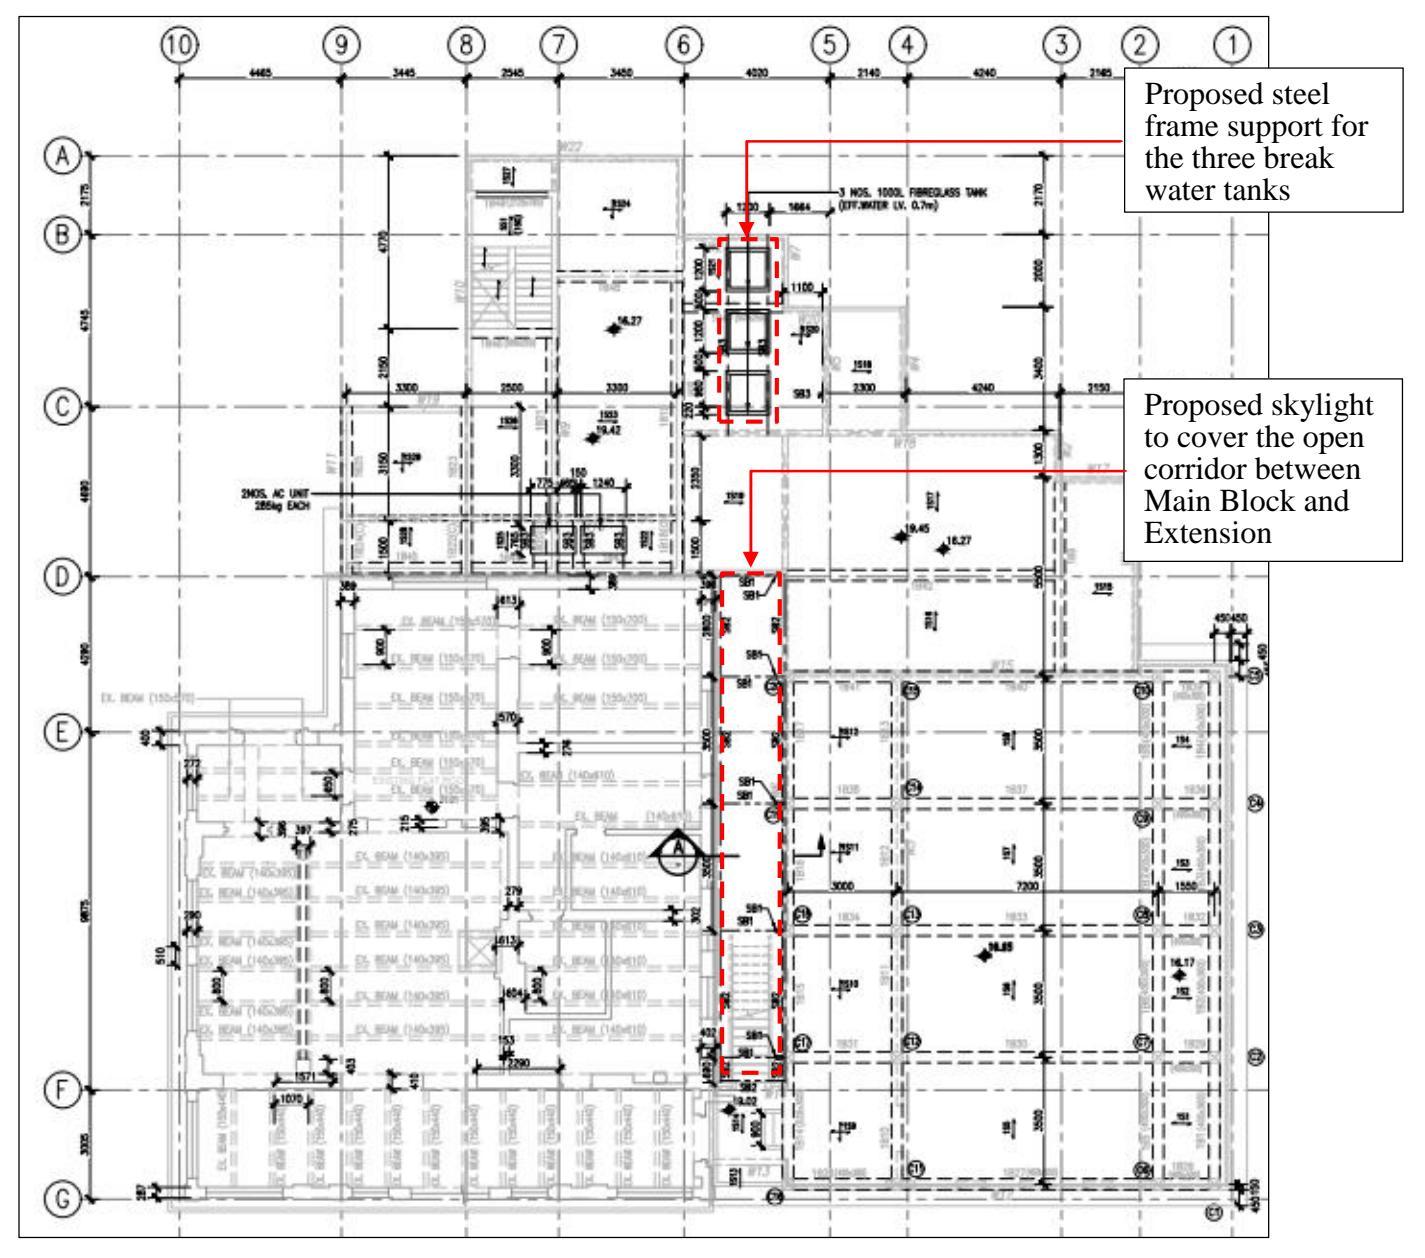
Drawing 3-06 – Proposed skylight to cover the open corridor between Main Block and Extension, and steel frame support for three break water tanks

- The skylight would not be fixed to the Main Block, it would only be fixed to the existing column of Extension, as shown on drawing 3-07.

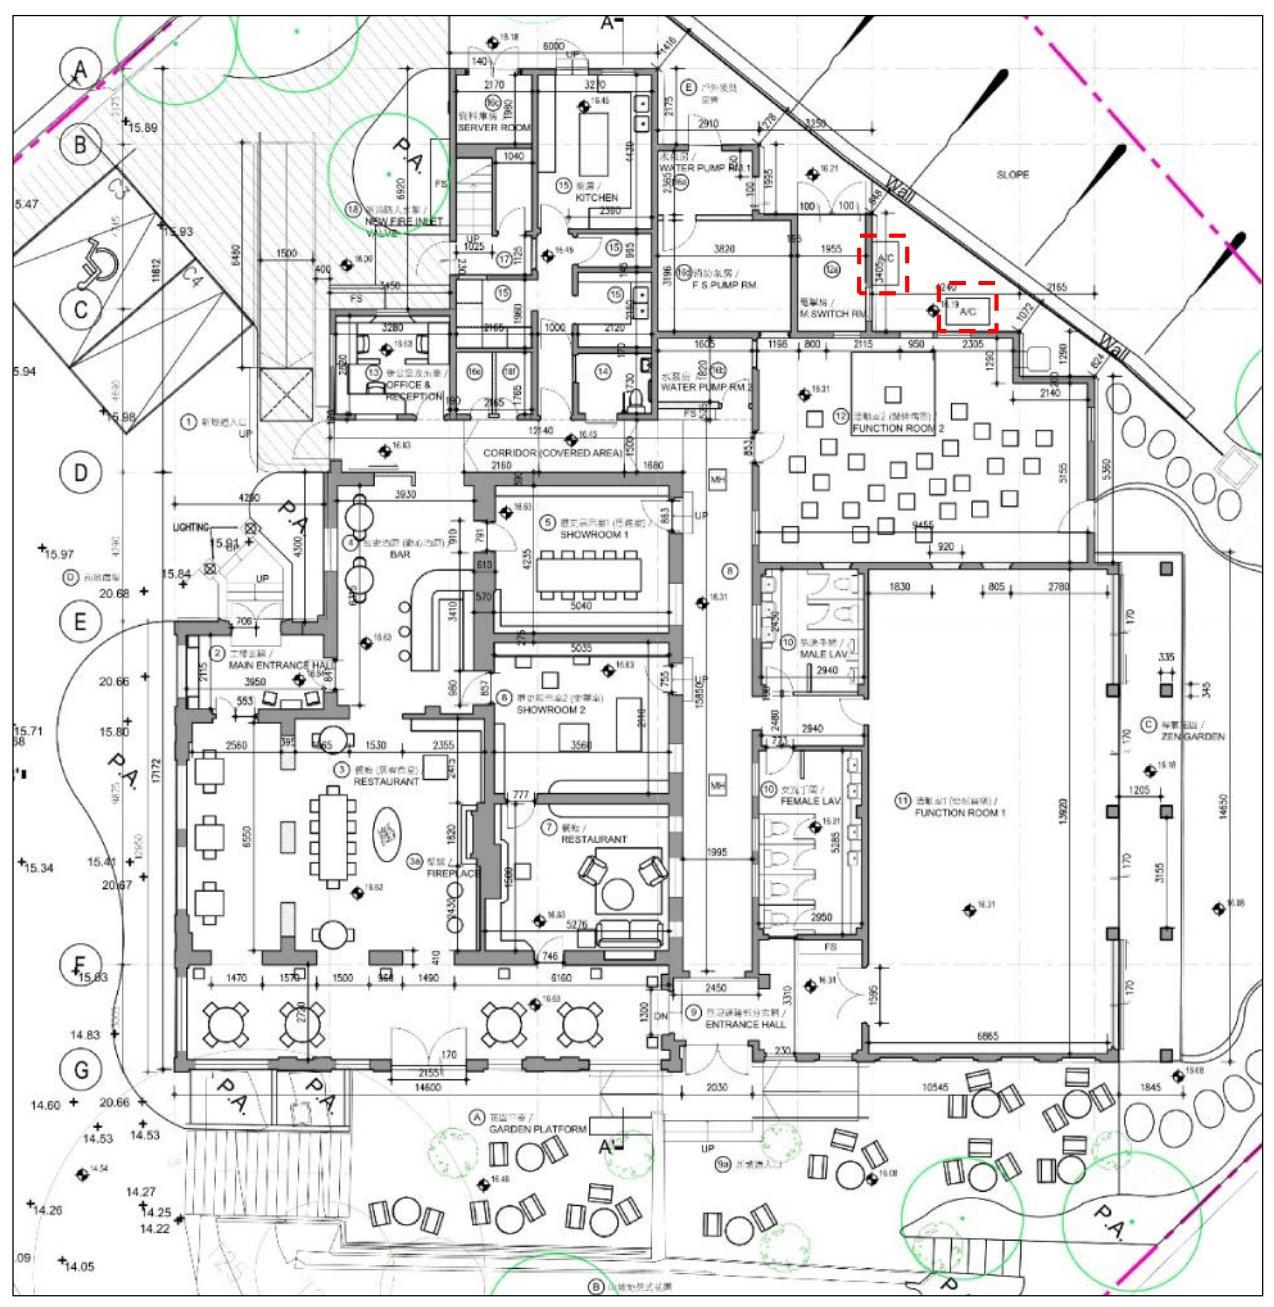
Drawing 3-08 – Location of the 2 nos. of air-conditioning out-door units located at ground level outside north (rear) elevation

- 3.7.1 <u>Air-conditioning installation and mechanical ventilation system</u>
- (a) The existing air-conditioning provision is by window type air-conditioning.
- (b) The new air-conditioning system will be a Variable Refrigerant System (VRV) (cooling only) consisting of in-door units.
- (c) Two out-door units will be placed at ground level external outside the north– east elevation, and two on the roof of Main Block.
