Revitalising Historic Buildings Through Partnership Scheme Batch V Project

# Watervale House, Former Gordon Hard Camp into Tuen Mun Soul Oasis

Heritage Impact Assessment Report

**The Tuen Mun Soul Oasis Foundation** P.K. Ng & Associates (H.K.) Limited and The Team Consultant

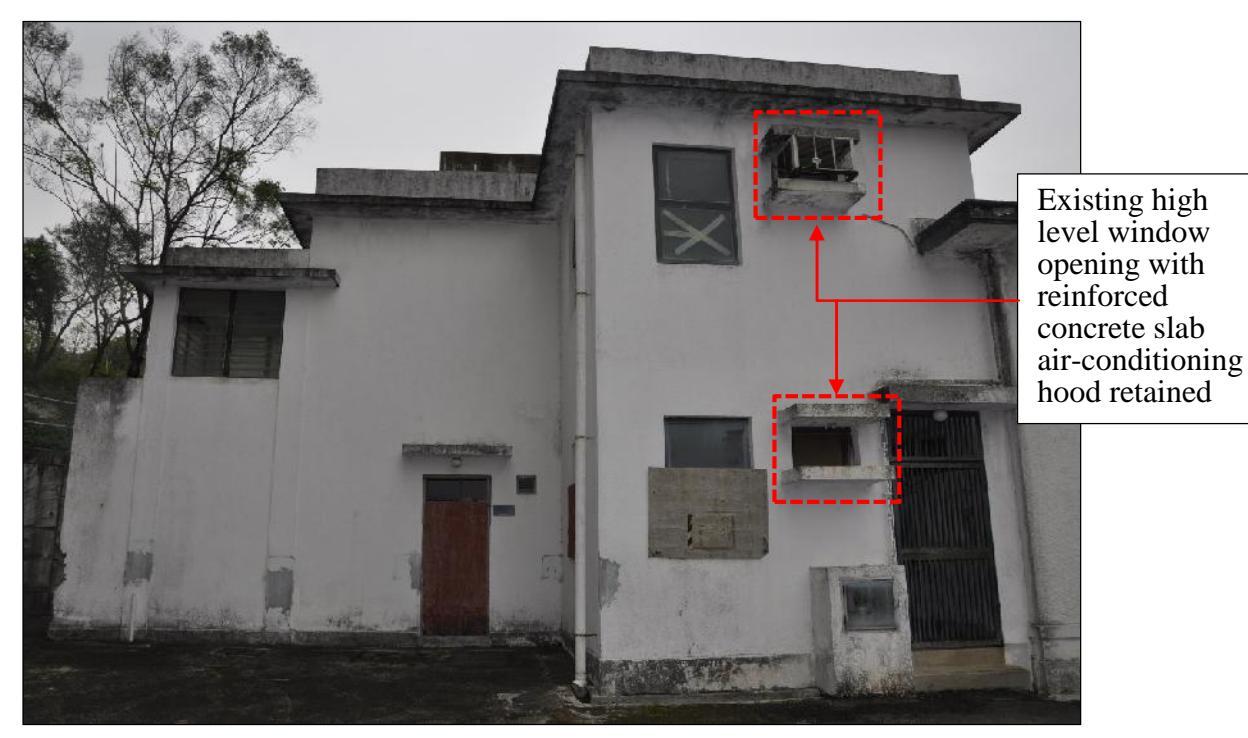
<u>Photo 3-01 – West elevation, the existing high level window opening with</u> <u>reinforced concrete slab air-conditioning hood at ground floor and</u> <u>first floor of Extension, (7<sup>th</sup> April, 2020)</u>

- (d) Window type air-conditioning unit with Energy Label Grade 1 of the Energy Efficiency Office (EEO) of Electrical and Mechanical Services Department will be provided to the Extension ground Office and Reception, and first floor rooms, and installed in the existing original high level window opening with reinforced concrete slab air-conditioning hood.
- (e) Spilt-type air-conditioning system will be provided for the Kitchen and Server Rooms.
- (f) Mechanical exhaust system will be provided for all rooms for general ventilation and the removal of contaminant / odour / moist air, thus some of the glass panes of the steel window in Main Block will need to be modified to incorporate the exhaust fan, and several wall openings for the ductworks of exhaust air fans need to be provided, (character defining element nos. B5 and C2).

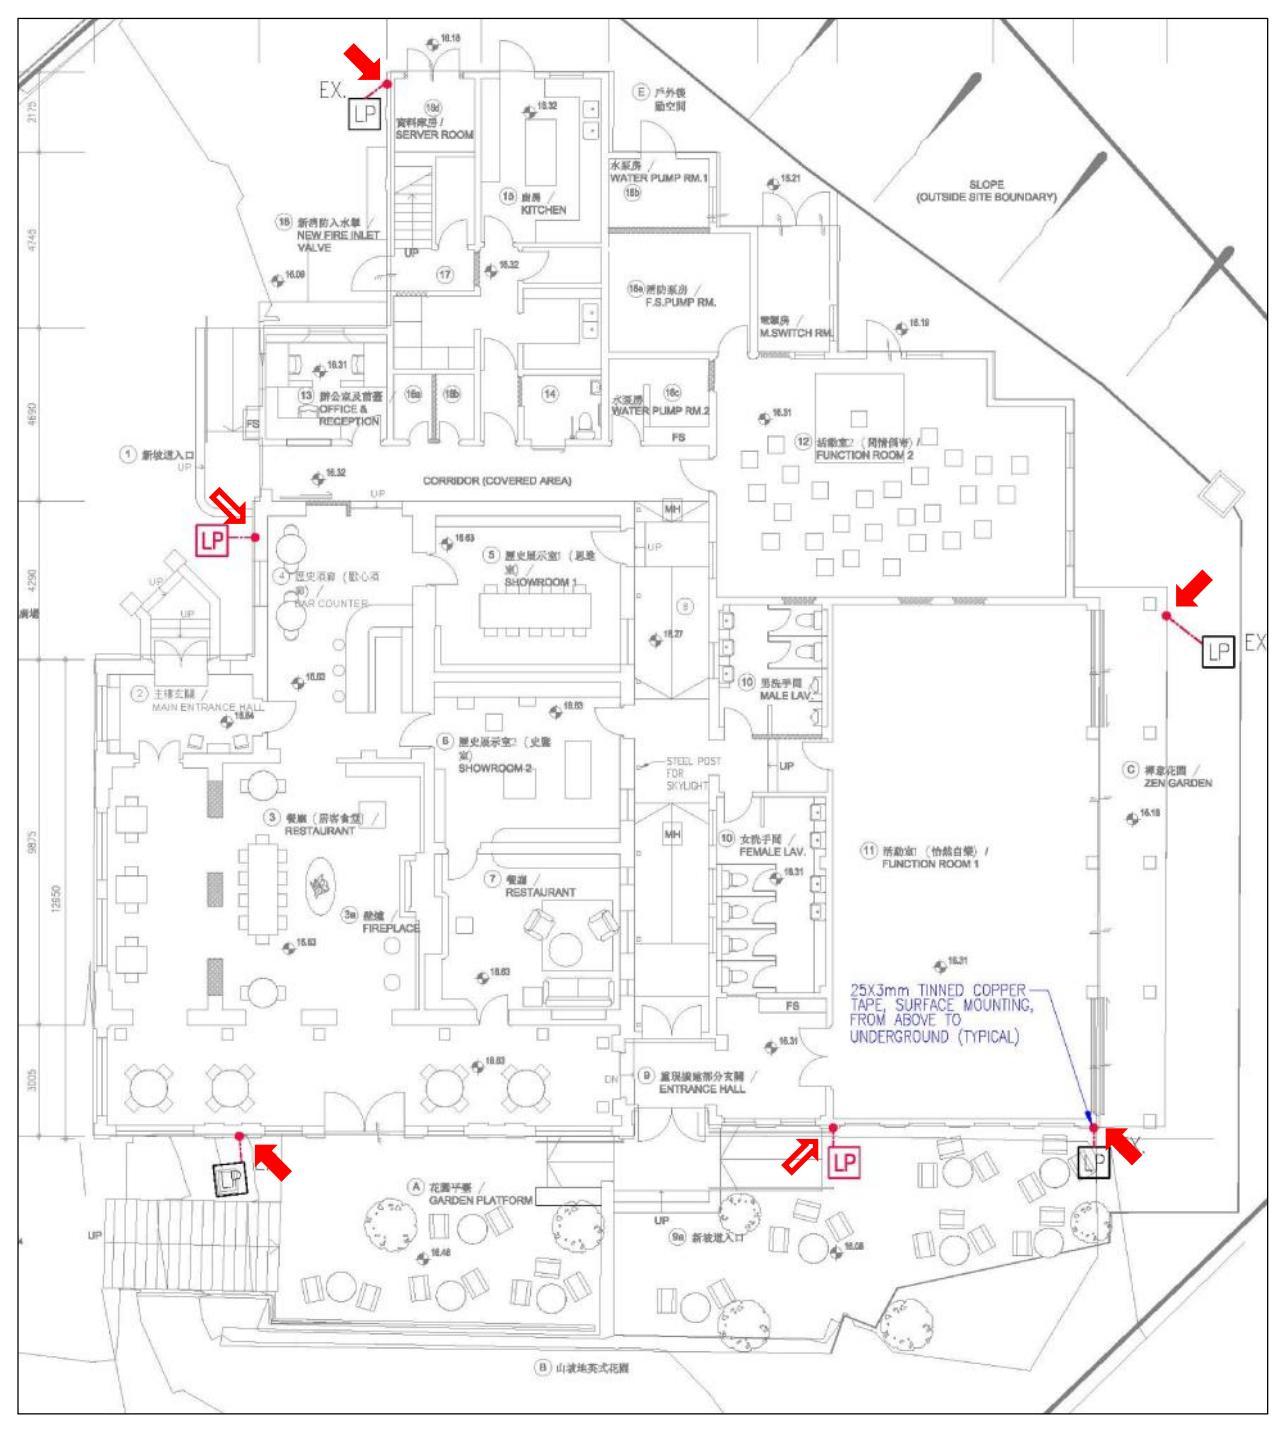
Drawing 3-10 – Location of the lightning conductor taps fixed on external wall

- (b) The whole electrical installation will be effectively earthed.
- (c) All extraneous conductive parts such as metallic gas pipes, water pipes, window frame, etc. shall be provided with equipotential bonding to ensure safety.

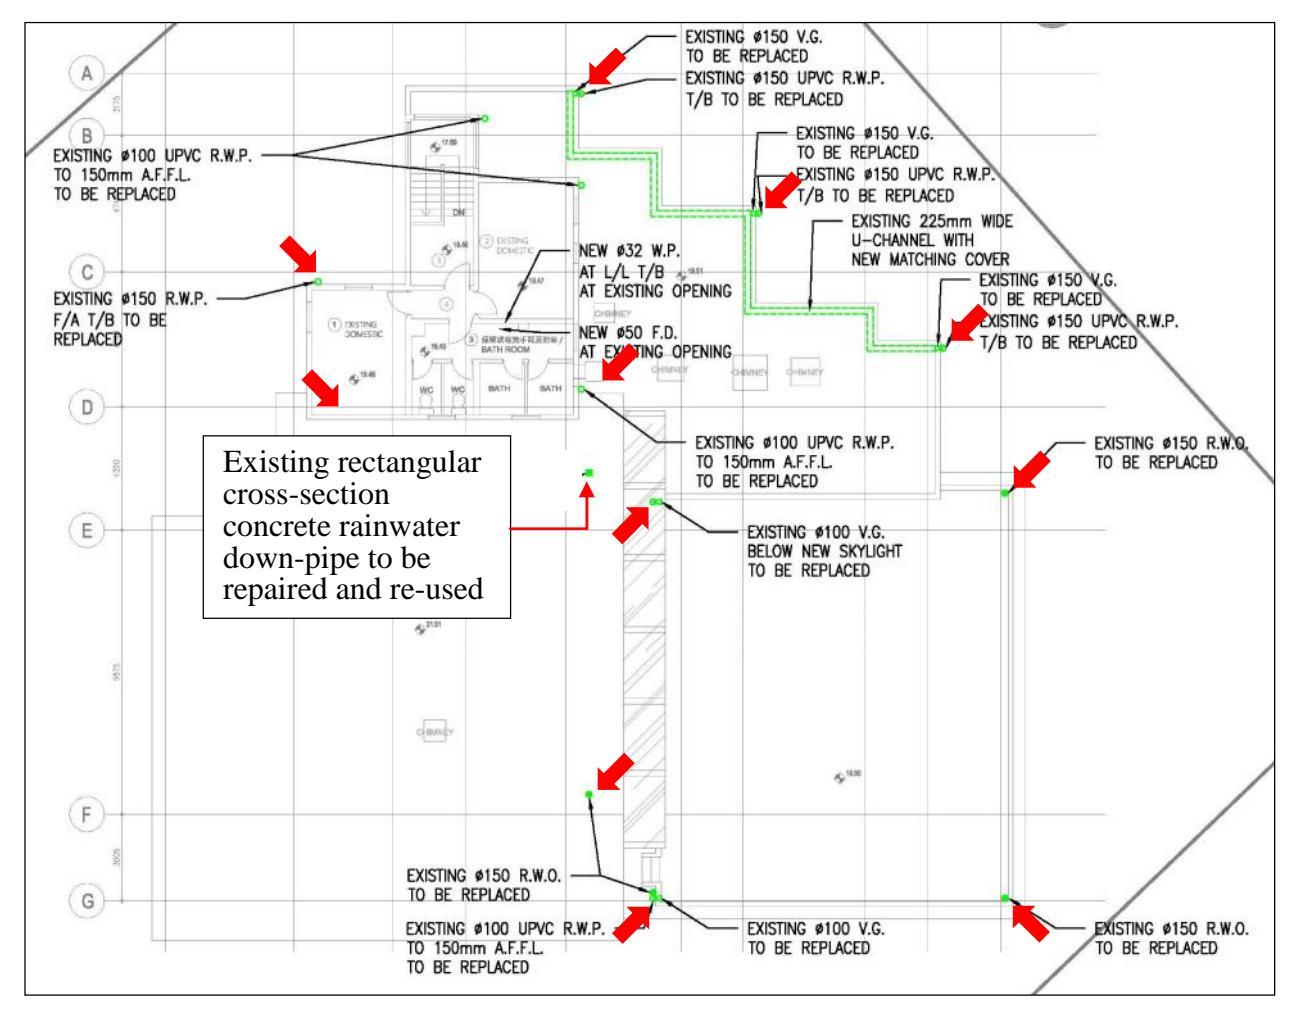
Drawing 3-12 – Location of the rainwater downpipe fixed at external wall of ground floor

- 3.7.9 <u>Rainwater disposal</u>
- (a) The rainwater collected from the main roof and upper roof will be discharged via vertical stack by gravity to the building surround U-channels, then to the underground storm water drainage system.
- (b) The two concrete rectangular cross-section rainwater downpipes with hopper will be preserved in-situ and repaired as necessary to retain the appearance. Some of them will be blocked or restored its function if feasible to suit the new rainwater disposal system, (character defining element no. B11).
- (c) New cast iron rainwater downpipes will be added, (character defining element nos. B1 and D1).

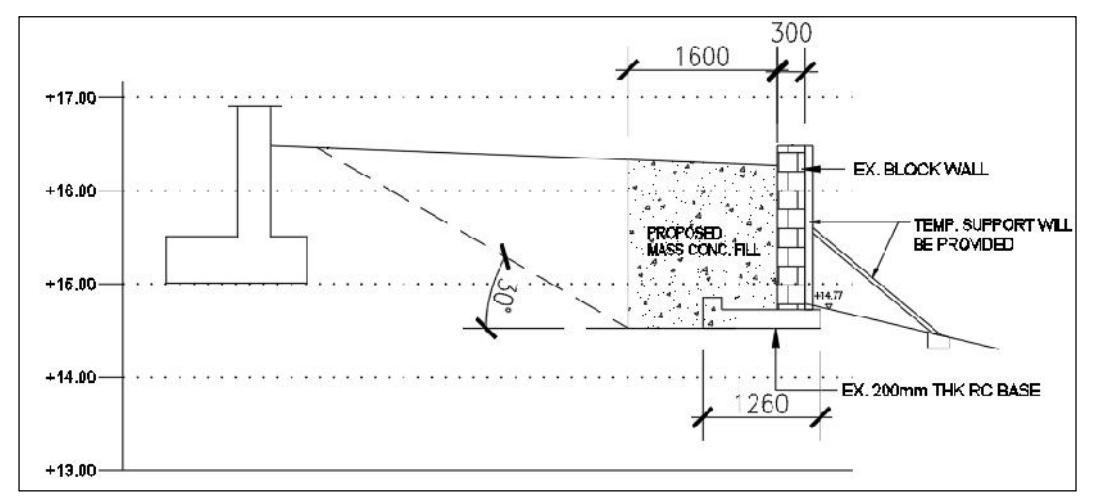
<u>Drawing 3-15 – Section of the mass concrete strengthening wall at</u> <u>underside of Terrace outside south part of Main Block and</u> <u>behind the existing granite block retaining wall</u>

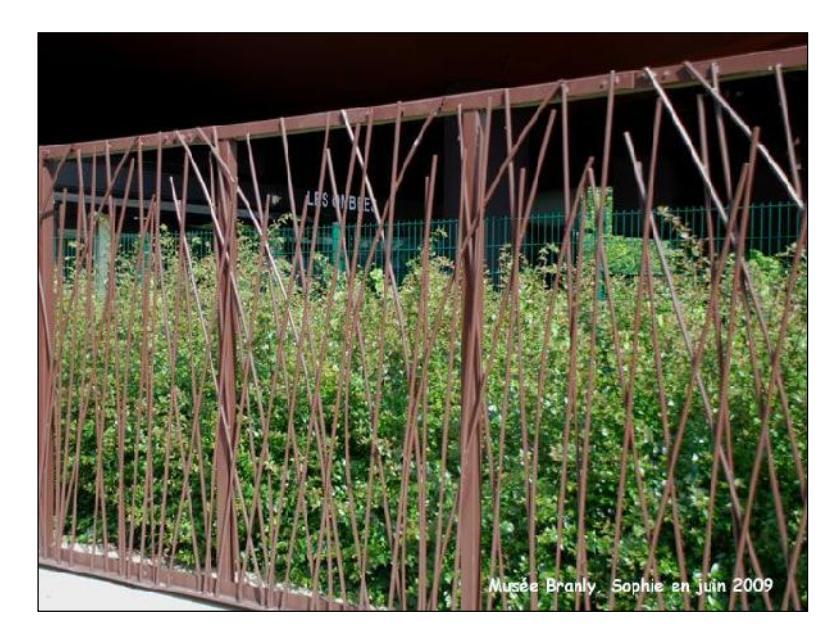
Drawing 3-19 - Proposed site boundary fence and entrance gate design

- (k) Replace the entrance gate.
- (1) Add "Tuen Mun Soul Oasis" signage at entrance.
