**Proposed Recovery Work for Block 4 at
The Central Police Station Compound**

PURPOSE

This Paper briefs Members of the Antiquities Advisory Board (AAB) on the proposed plan for the recovery of the Married Inspectors' Quarters ("Block 4") at the Central Police Station (CPS) Compound, which partially collapsed on 29 May 2016. This Paper follows a submission on eight initial options for the recovery of Block 4 to the AAB on 8 September 2016 (Board Paper AAB/33/2015-16) and a subsequent submission on three shortlisted options for the recovery of Block 4 to the AAB on 7 September 2017 (Board Paper AAB/15/2017-18).

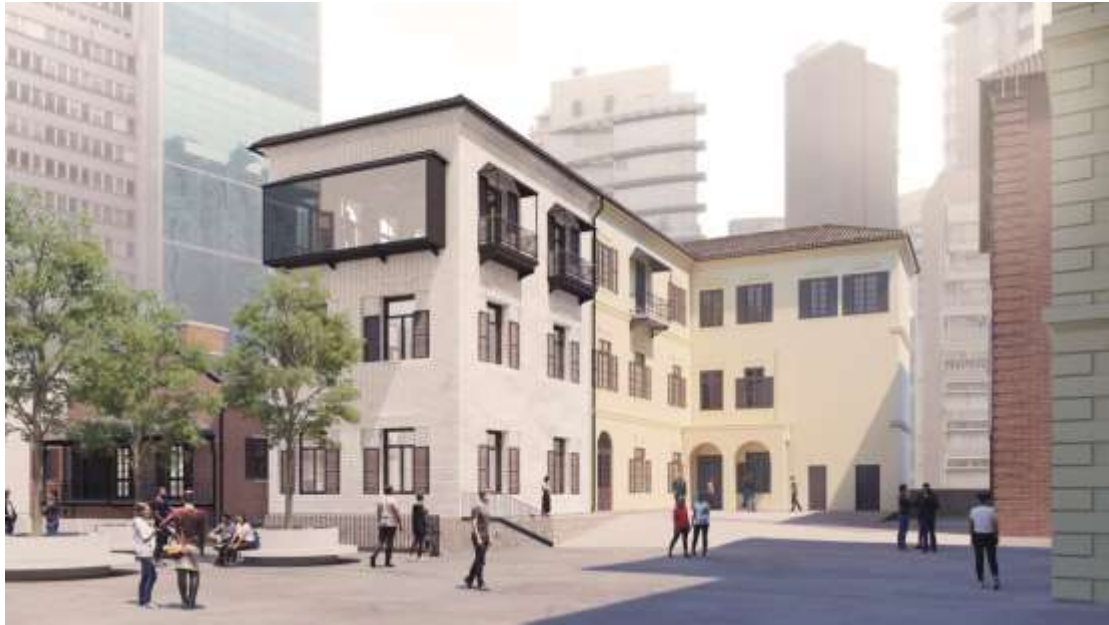
Image one: Architect's rendering of the recovered Block 4

In the proposed design, in order to maintain a high degree of compatibility between the new annex and the extant portion, the platform on which the building stands will be unaltered. The Chinese-style tiled roof will be extended from the extant portion to cover the new annex so that the old and new structures are clearly shown as one building. The windows and doors of the new annex will be opened along the same grid lines of the openings of the extant portion. The new annex will also have a brick facade as does the extant portion so that the two structures share very similar building materials. Two decorative metal balconies, a key feature of Block 4, which were removed for storage after the partial collapse, will be reinstalled although strengthening will be required to ensure safety.

At the same time, visible yet modest design adjustments will be executed to differentiate the new annex from the extant portion. The facade of the new annex will be built with bricks made of materials of a lighter colour than the bricks of the extant portion, and the bricks will be oriented at an angle so that it is clear that the two structures were built at different times. The second-floor balcony facing the Parade Ground, which had been damaged many years ago, will be rebuilt with new materials to increase the transparency of the building, creating more possibilities for future activities. These adjustments will assist in differentiating the old and the new structures but emphasizing the linkages between the two.

The facade of the new annex will make strong references to the extant portion, including Character Defining Elements such as the layered rhythmic arches, balustrades, windows, shutters and balconies. These features have been carefully studied and interpreted in the new facade with functional considerations and contemporary expression.

— An architect's rendering of the recovery design is attached in the **Appendix** as Image 1 and a rendering of the recovered Block 4 sitting in the heritage compound is attached as Image 2.

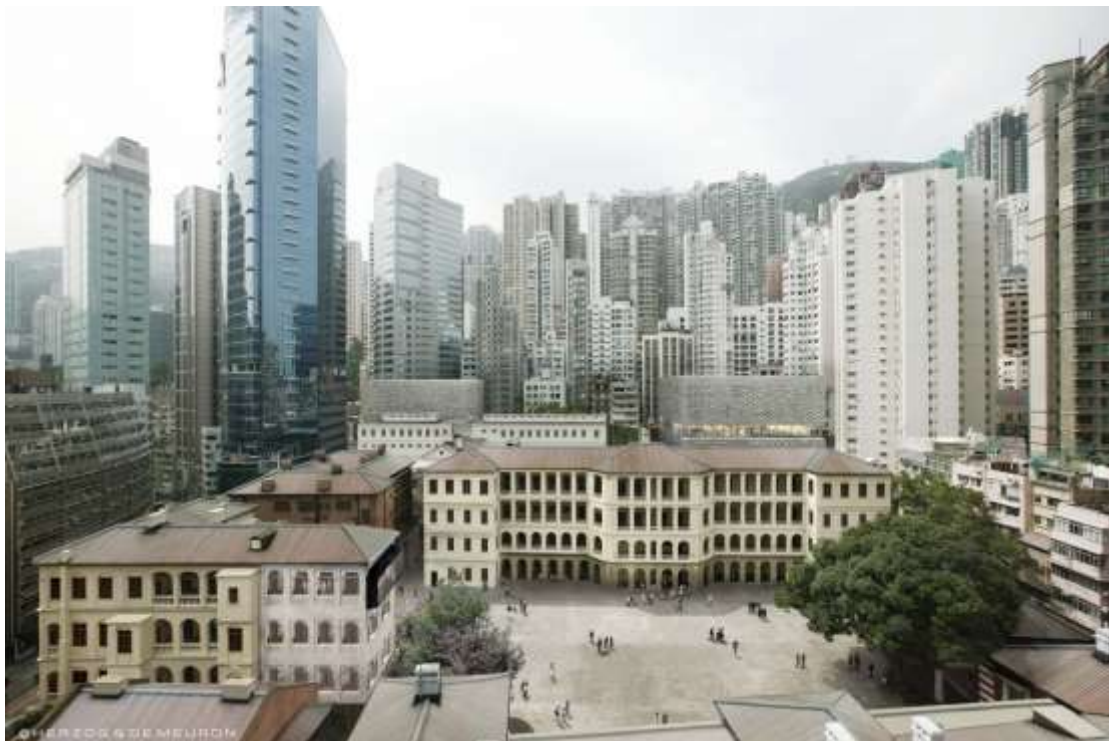
Image 2: Architect's rendering of the recovered Block 4 sitting in the Central Police Station compound
