# Concept Design for Interpretation of the Former Mountain Lodge and Improvement to its Surrounding Areas

February 2014

# The Improvement, Intervention and Interpretation

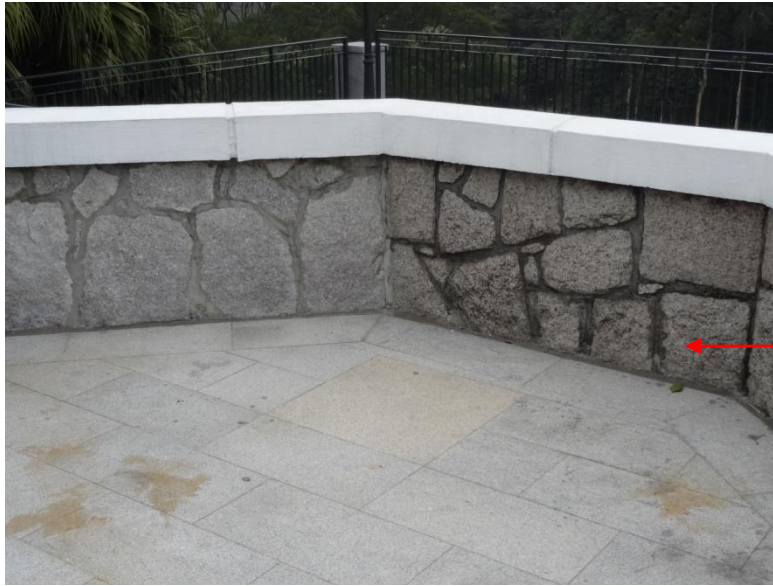
Stone parapet to be demolished and replaced with metal railing

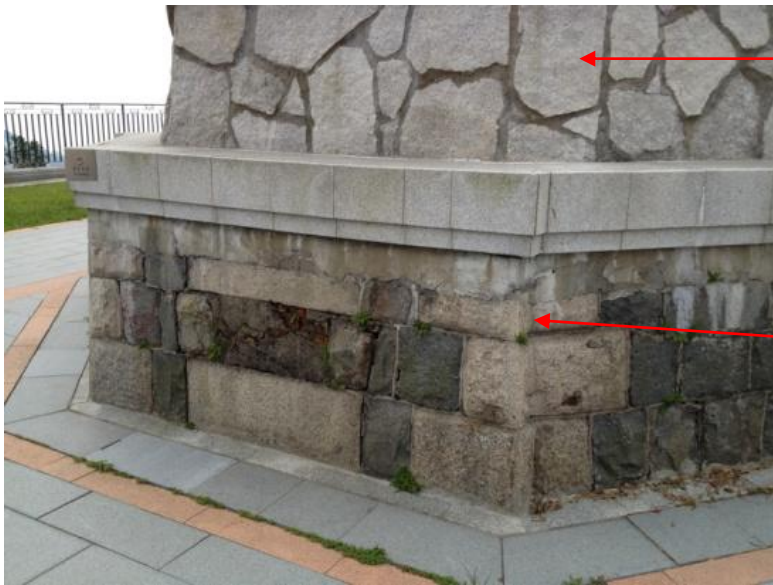
Foundation of FML to be retained

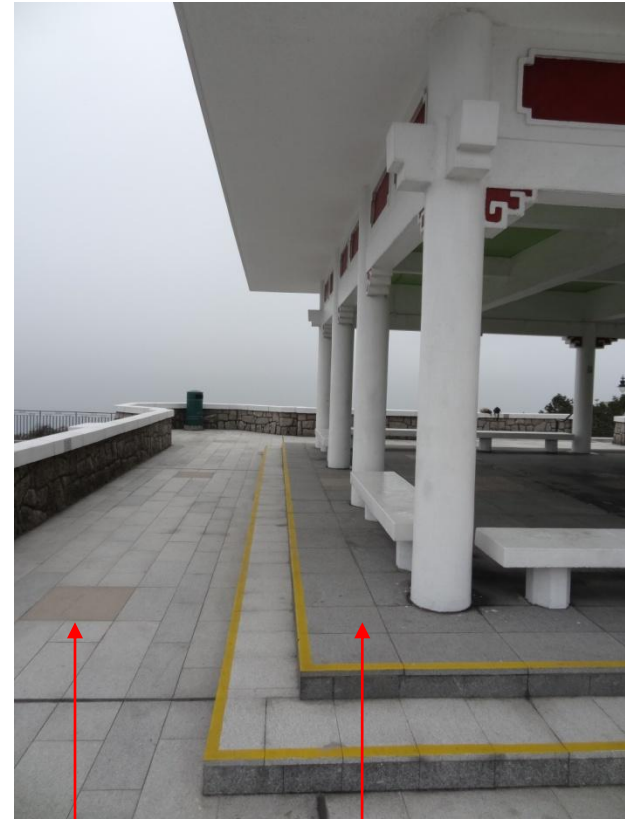
New decking over existing floor tiles to level the pavilion floor level with the whole site

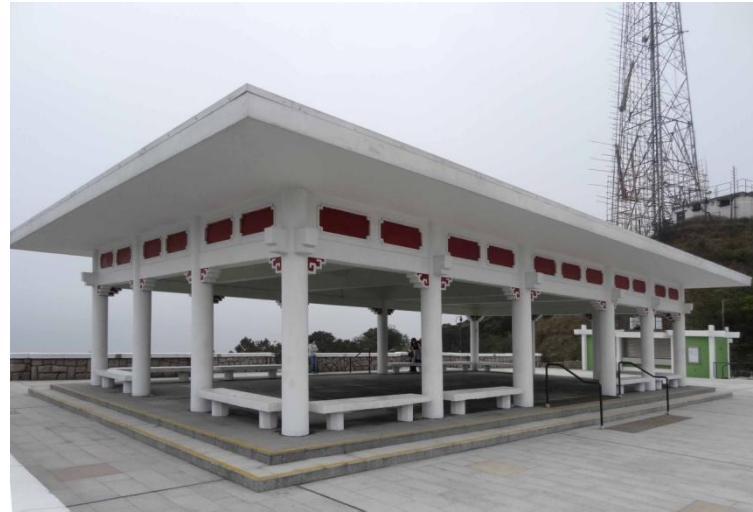
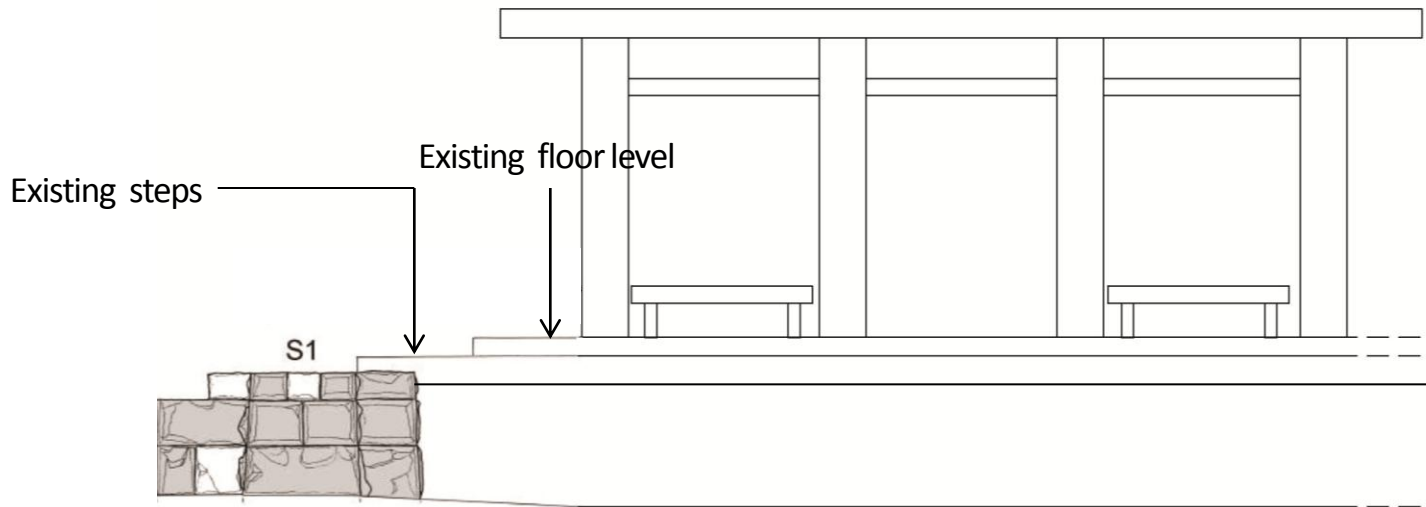
Section - Existing Pavilion

## Timber Decking

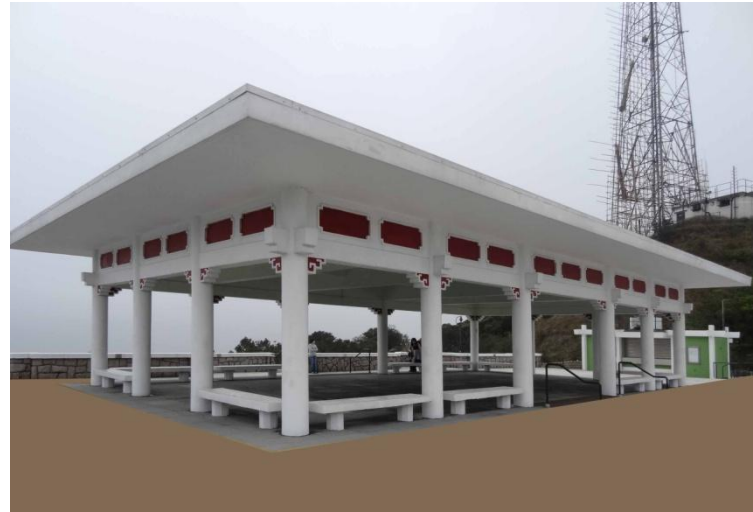
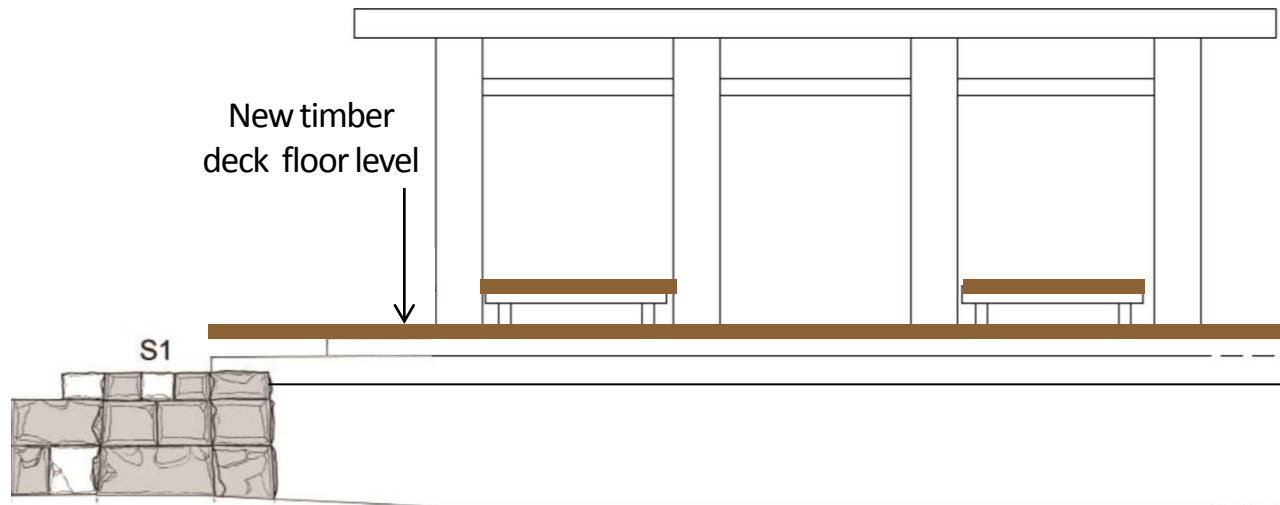
Section - Existing Pavilion

# Intervention (I-2) – New raised timber decking

## Timber Decking

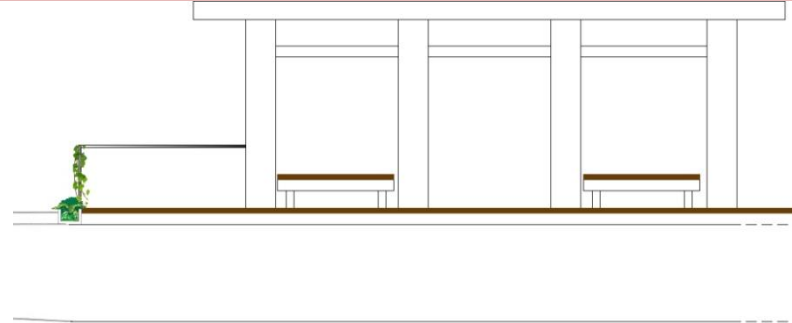
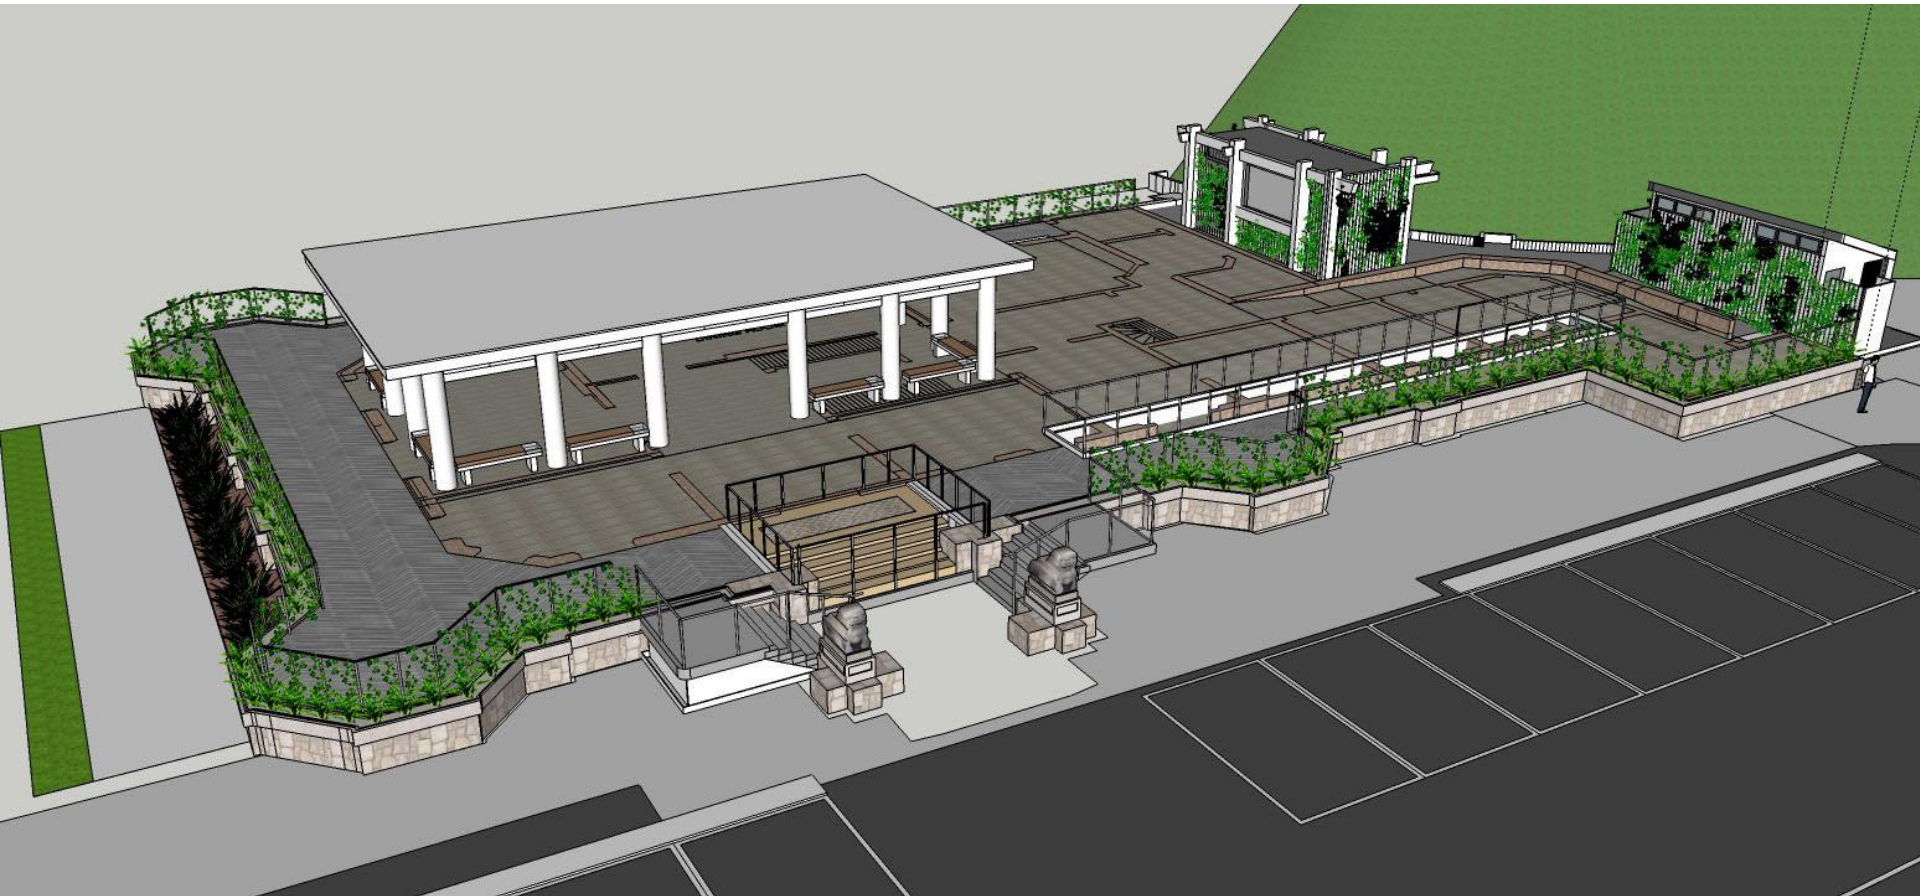
Option of vertical greening on metal railings

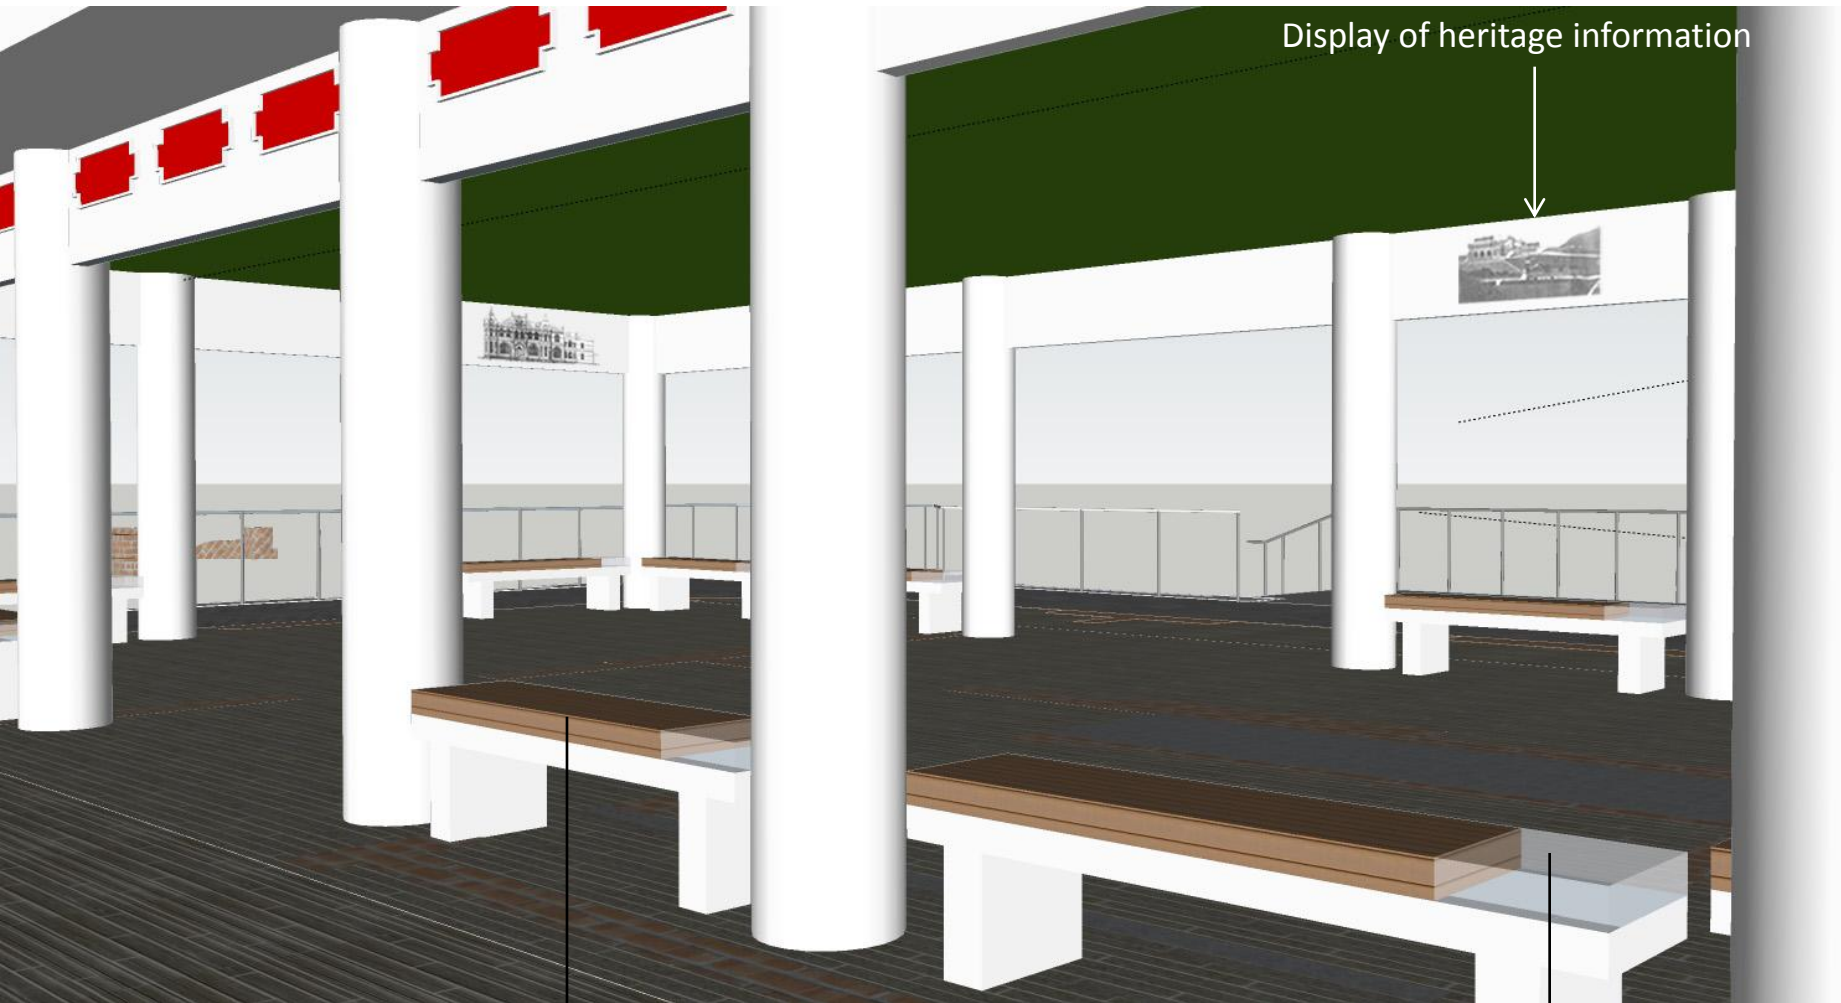
Allow visitors to “sit side by side with the history of FML”

Display of heritage information

New timber finishing

Information display

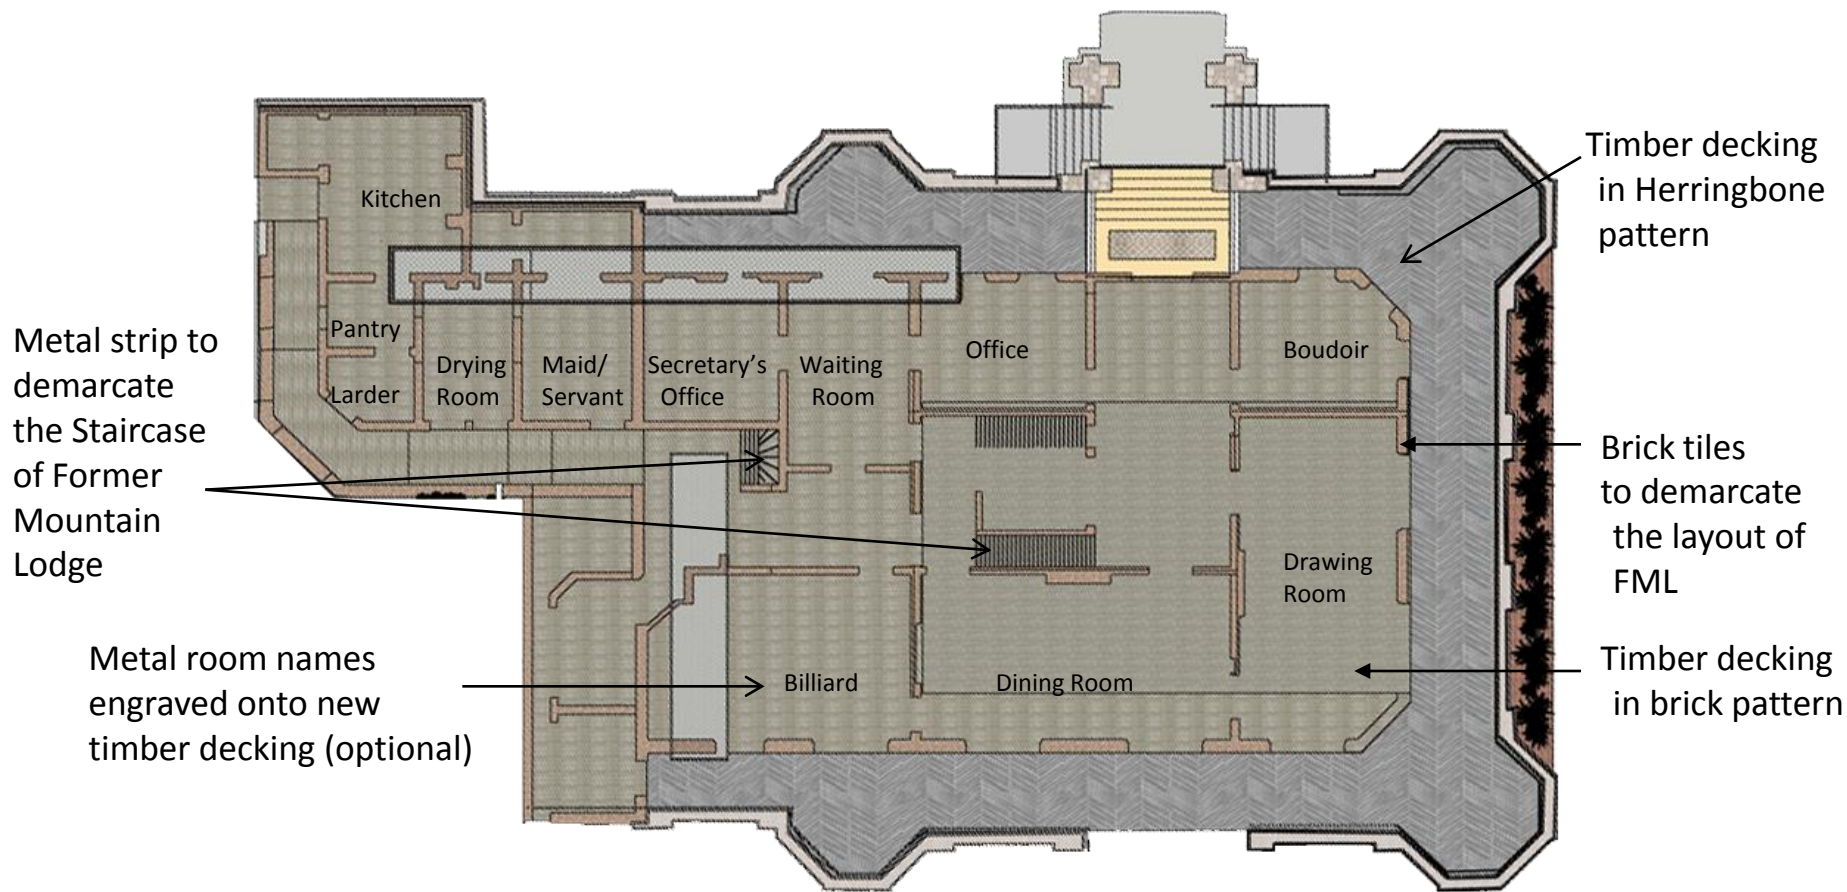
## Plan of Former Mountain Lodge incorporated onto pavilion

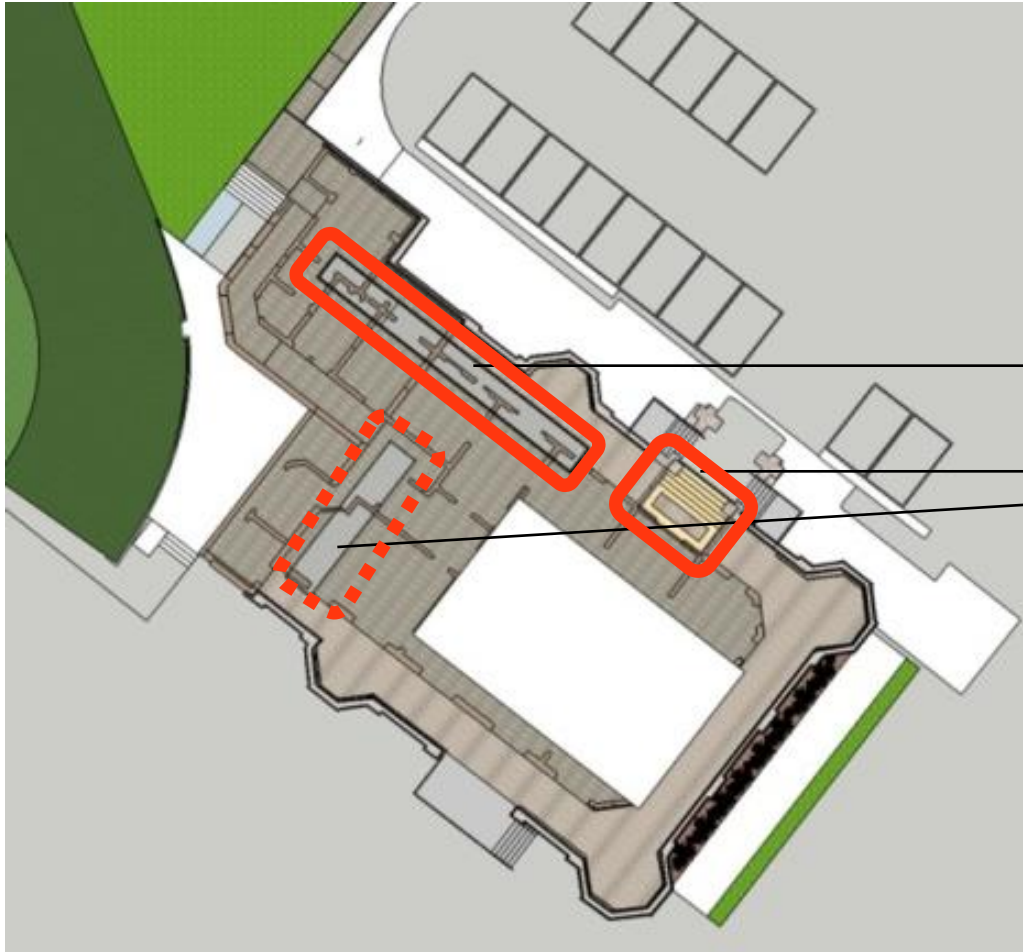
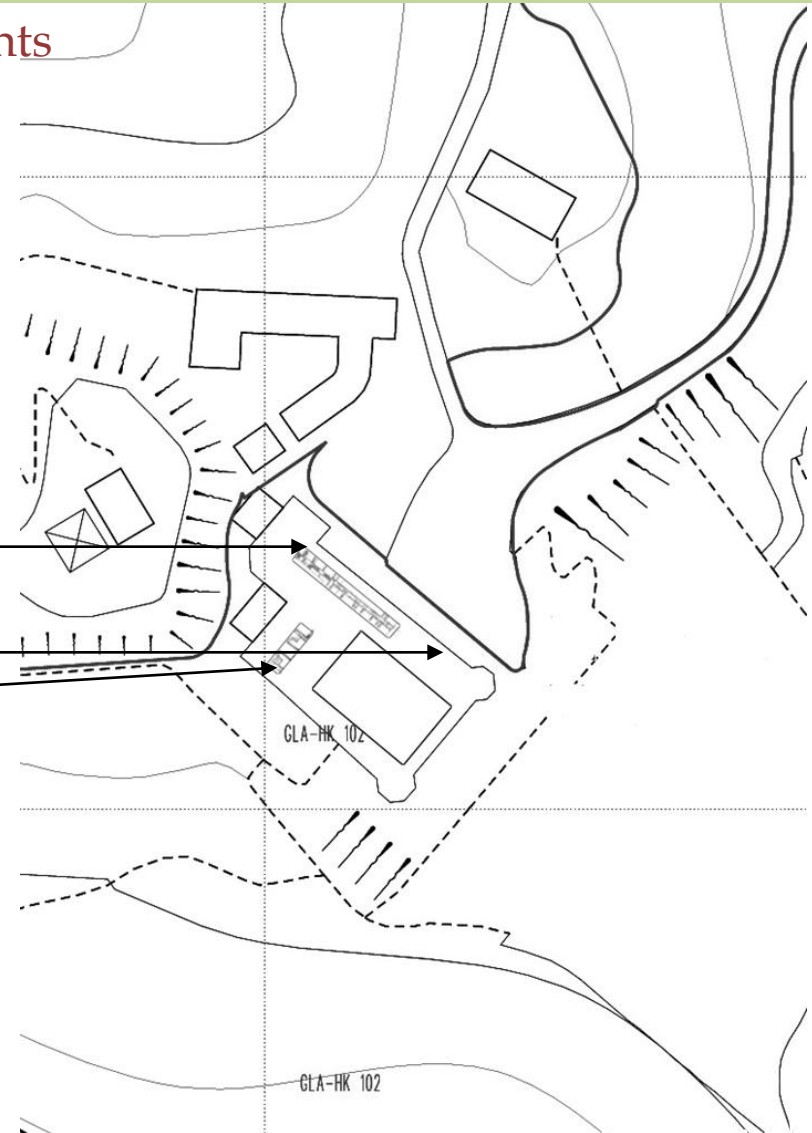
Option of exposing one more portion of remnants

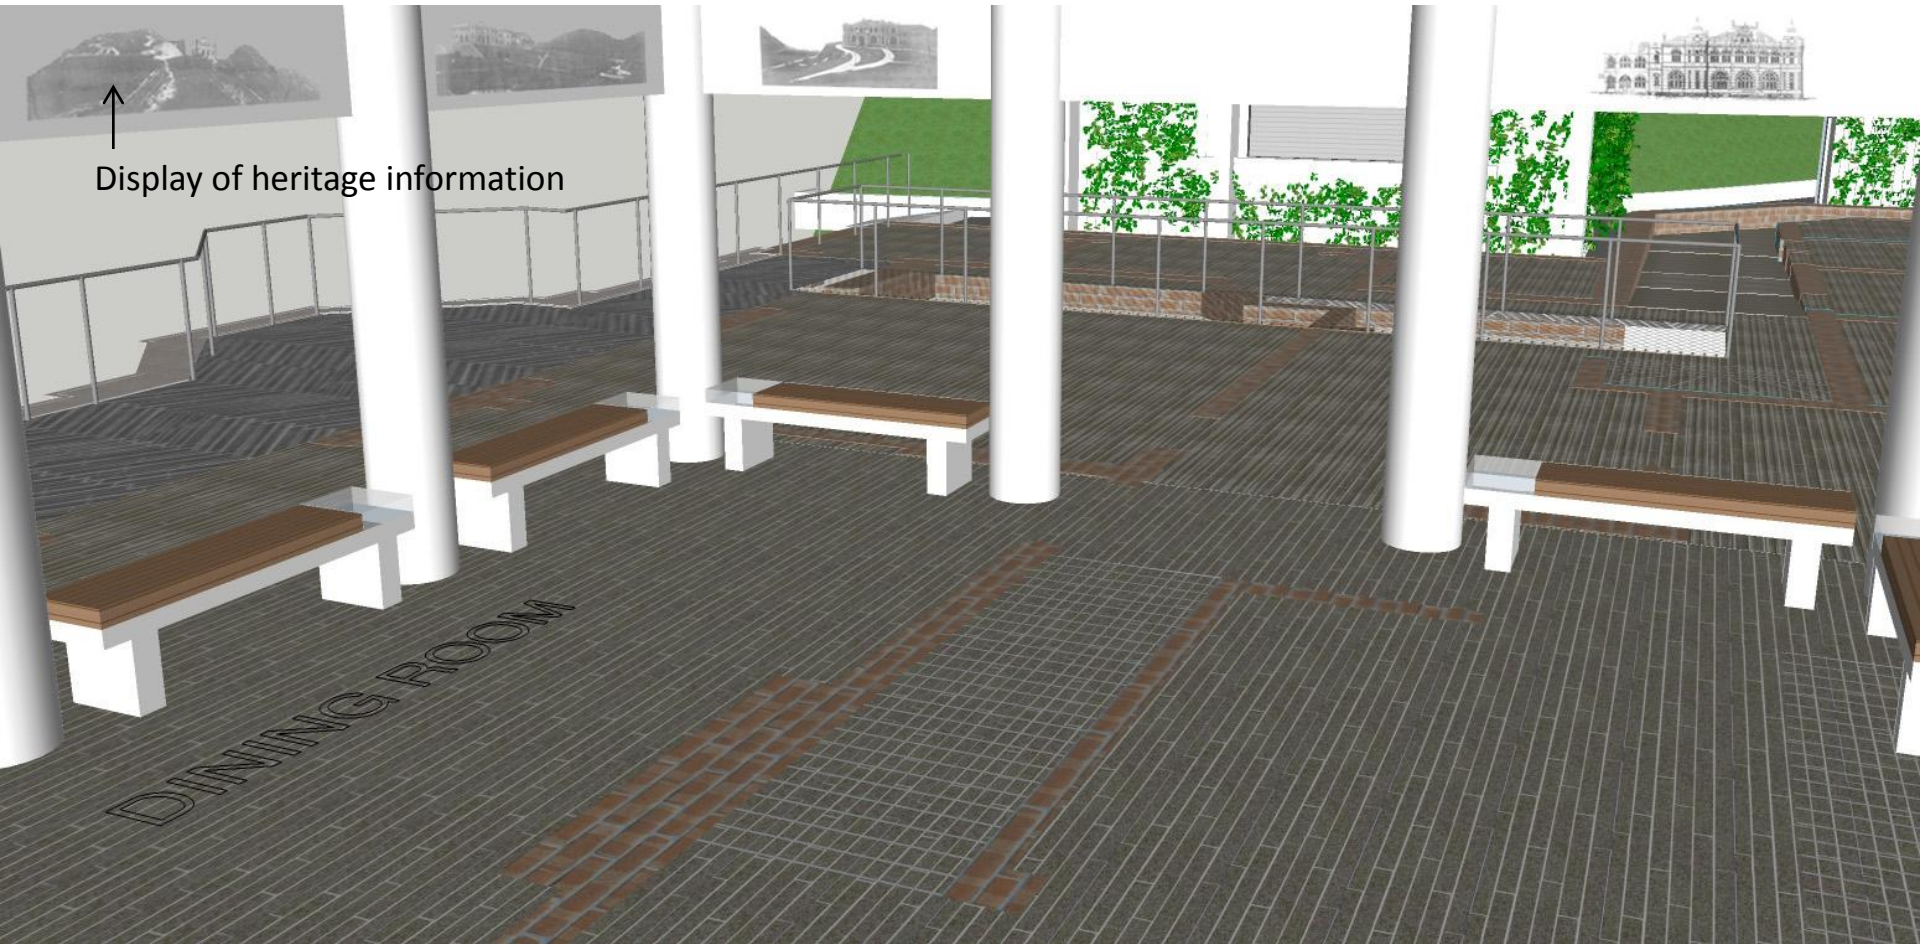
- G/F Plan of the Former Mountain Lodge demarcated on new decking
- Display of heritage information on the internal spandrel of pavilion
