Photos of Block 7, Old Lei Yue Mun Barracks, Lei Yue Mun, Chai Wan

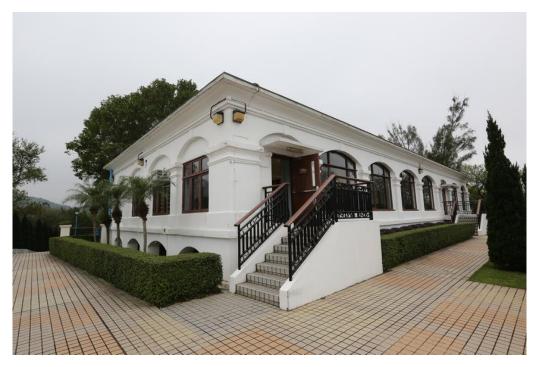
The north and east facades, originally surrounded by wide verandahs set on low segmental arches.

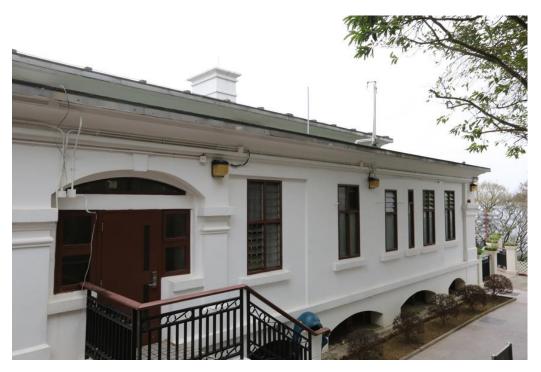
The two-step flat roof converted from the original pitched "Jack-Roof".

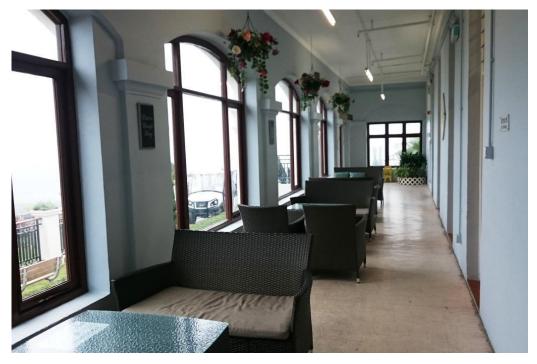
The front verandah with windows installed.

Originally the open verandah would have been a common sitting-out area for the tenants.

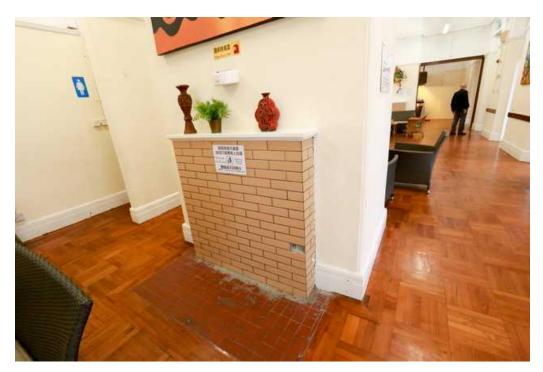
Brick chimney breast with fireplace is now bricked up.

A portion of old ceramic red quarry tile flooring still remains.

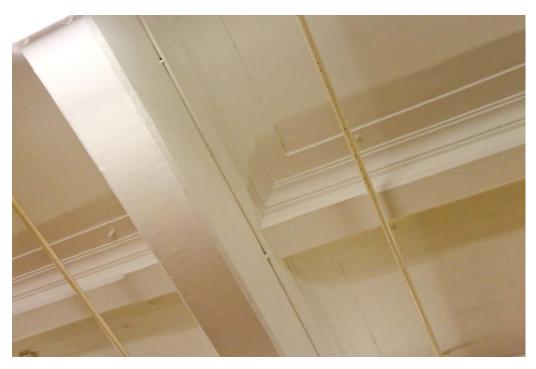
Classical plaster mouldings to the ceiling cornices.

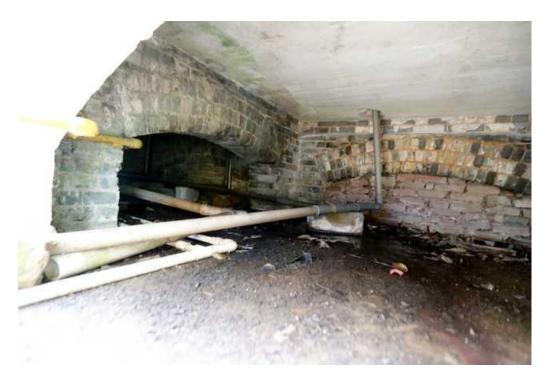
Typical view of the ventilated sub-floor, showing grey brickwork and arched supports to the main ground floor structure above.
