## Heritage Impact Assessment

in respect of the Revitalisation of  
Former North Kowloon Magistracy into  
NK Future

Heritage Impact Assessment in respect of the Revitalisation of Former North Kowloon Magistracy  
into NK Future under Revitalising Historic Buildings through Partnership Scheme Batch VI

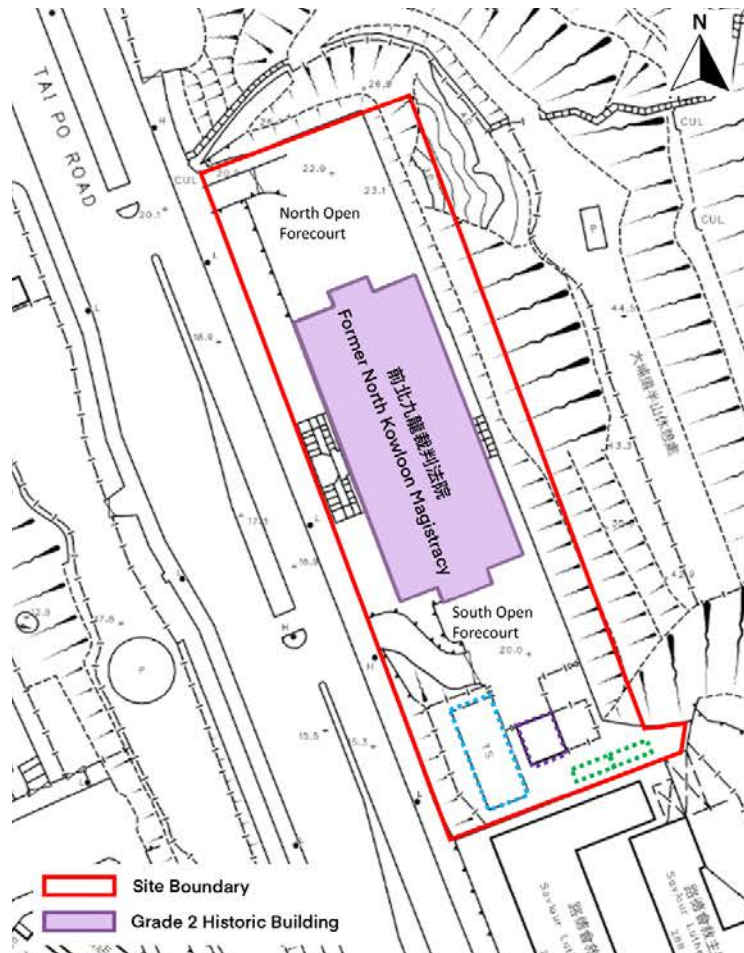
*Figure 1* Site boundary plan and graded historic building.

The Former North Kowloon Magistracy is located at 292 Tai Po Road, at the foot of a hill, near the junction of Sham Shui Po and Shek Kip Mei. The Former North Kowloon Magistracy was accorded as a Grade 2 Historic Building by the Antiquities Advisory Board in December 2009.

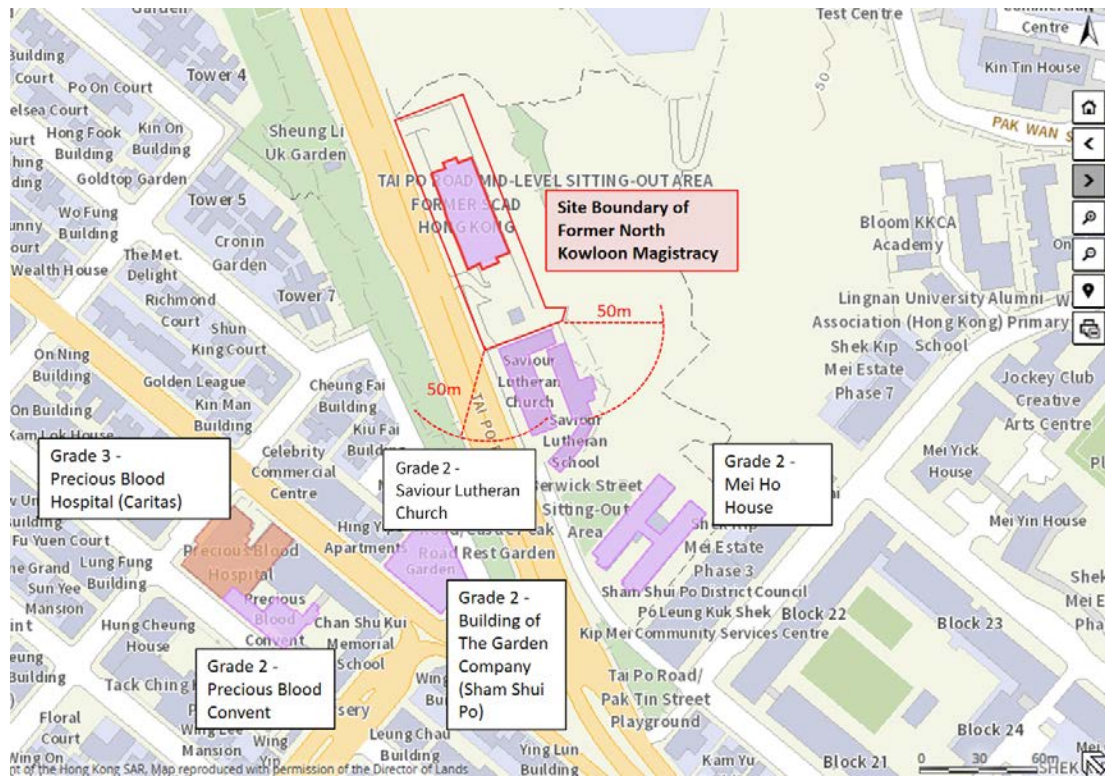
Figure 2 50m boundary of the site boundary.

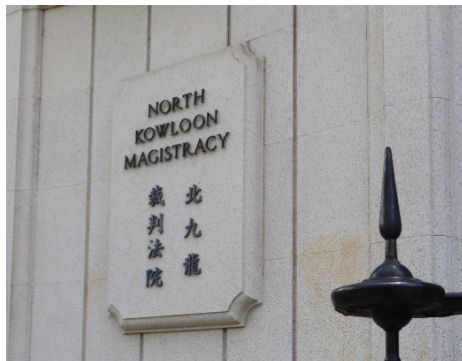
**Figure 22** Existing stone tablet showing the Chinese name of “北九龍裁判法院.”

Two sets of bronze letters are present on the main elevations of the Former North Kowloon Magistracy. One set is mounted on the projecting bay on the 4th floor, while another set is fixed to the stone tablet at the main entrance, positioned at the centre of the grand staircase. Both sets display the name in English and Chinese. The English characters, "NORTH KOWLOON MAGISTRACY," are original to the building's construction in 1960. However, the Chinese name, later with the magistracy's renaming, the original bronze Chinese characters “北九龍區裁判司署” were replaced by “北九龍裁判法院”.<sup>212</sup>

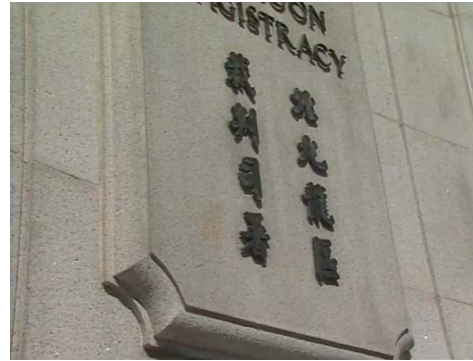
**Figure 23** Stone tablet in 1990s with the original Chinese name of “北九龍區裁判司署”.<sup>110</sup>

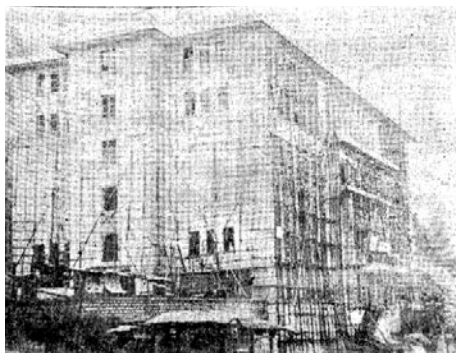
**Figure 28** North Kowloon Magistracy under construction.<sup>131</sup>

Beginning construction on 1958 June.<sup>128</sup>, Completed after approximately two years of construction at a total construction cost of HK\$4.3 million.<sup>129</sup>, the North Kowloon Magistracy officially commenced operations on November 7, 1960.<sup>130</sup>

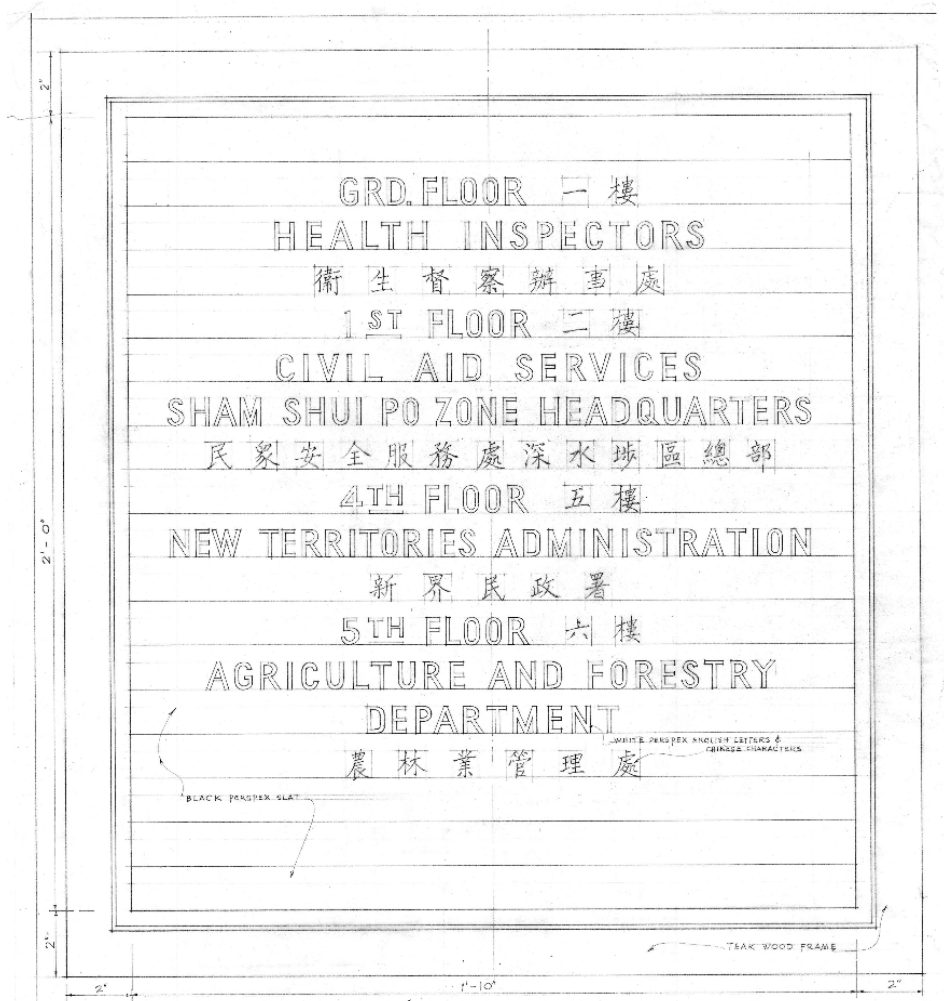
Figure 30 Drawing of Directory Boards.<sup>138</sup>

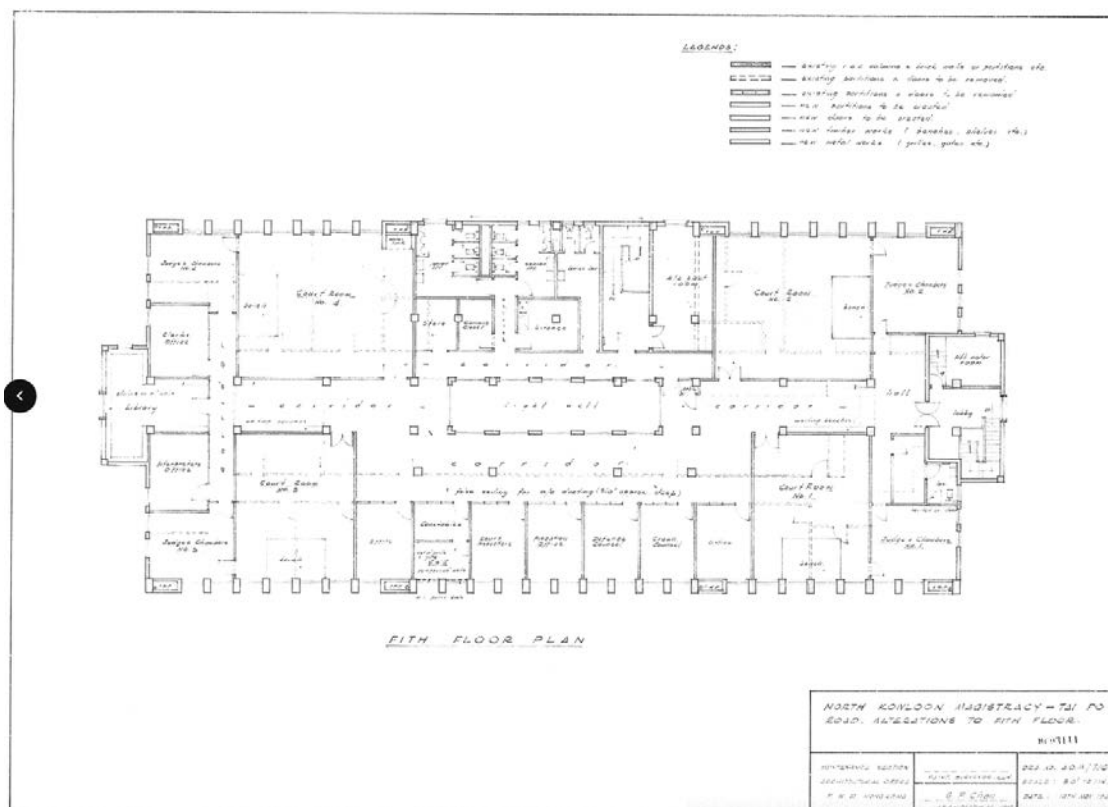
Figure 32 1964 recorded drawings of the alteration work on 5/F.

Despite these measures, the court still faced a backlog of 363 cases after the Easter holiday in 1965, with the first working day heavily congested.<sup>141</sup> After only five years of operation, this new building was scheduled for alteration to accommodate four additional court rooms.<sup>142</sup> Following the Agriculture and Fisheries Department office on the fifth floor relocated to the Cambridge Court on Waterloo Road in September 1965, the vacant floor to be converted for judicial use.<sup>143</sup> The first two new courtrooms (Nos. 6 and 7) were completed in January 1966, and later that year, two more courtrooms (Nos. 8 and 9) were introduced, bringing the total to nine, including one juvenile court, with a more clear distribution of duties among courts was introduced (Table 4).<sup>144 145</sup>

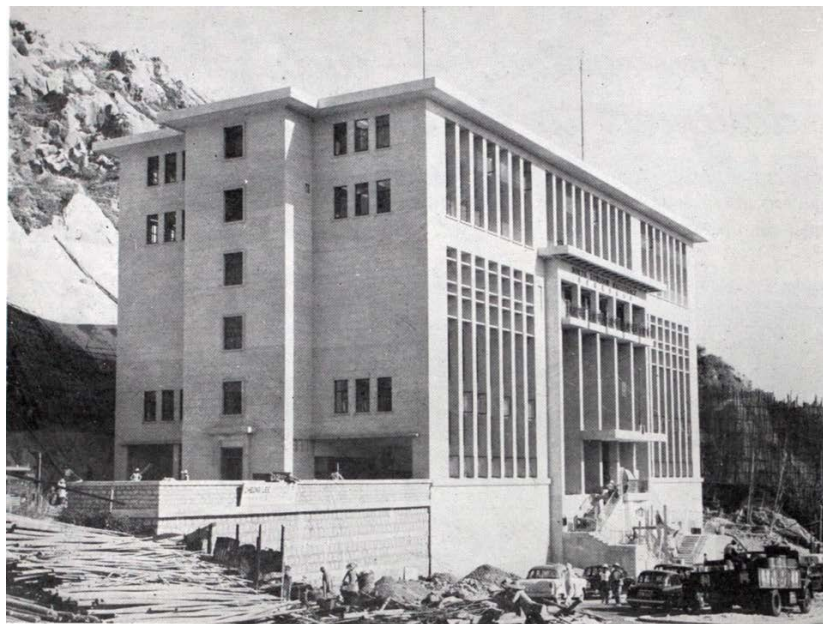
*Figure 51* North Kowloon Magistracy in 1961.<sup>189</sup>

The Former North Kowloon Magistracy is a fine example, likely the largest surviving civic architecture from the post-war period that embodies the Stripped Classicism style. The facade is characterised by a strong emphasis on verticality through a massive use of simplified “giant order” columns and the repetition of tall narrow windows. These design elements underscore Stripped Classicism’s focus on structural clarity – to avoid excessive ornamentation but convey a sense of dignity and authority which in line with the building’s civic purpose.<sup>188</sup>

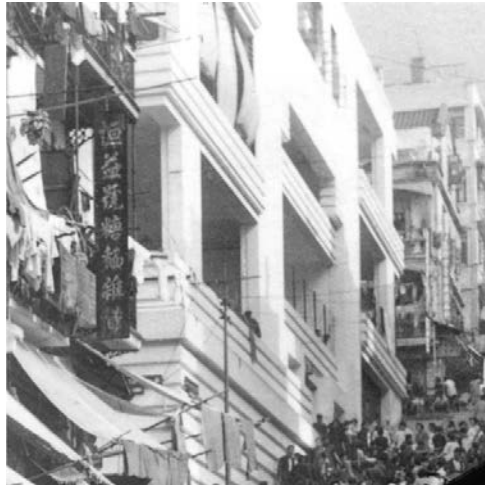
**Figure 54** Sai Ying Pun Market in 1950s.<sup>197</sup>

A key example of this shift was the Sai Ying Pun Market, which marked the Public Works Department's early adoption of Stripped Classicism in Hong Kong.<sup>196</sup> The market was constructed between 1930 and 1932 featured a modern, unadorned aesthetic, devoid of classical ornamentation such as pillars, arches or mouldings which was long been use in market building before the First World War. Instead, it presented a symmetrical, monolithic form, constructed entirely from reinforced concrete, with a clearly articulated central portion.

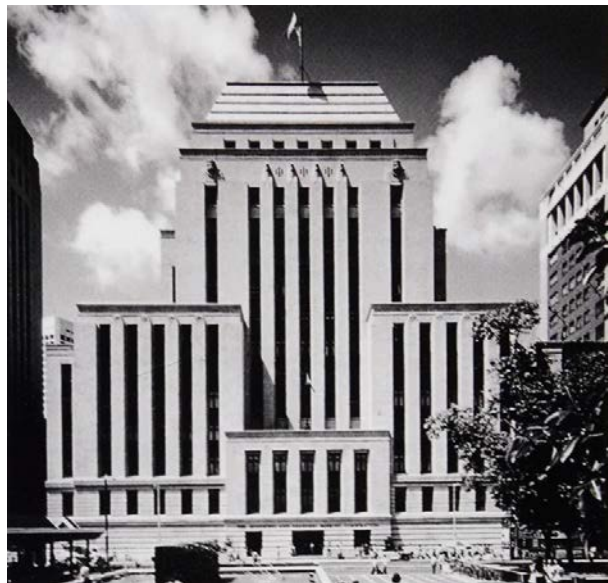
*Figure 56* Hong Kong & Shanghai Banking Corporation.<sup>203</sup>

A defining example of Palmer & Turner's evolution is the Hong Kong & Shanghai Banking Corporation (HSBC) Headquarters, completed in 1935. Designed in a Stripped Classical style with Art Deco influences, the building featured a monumental and modern composition, with clean stone-clad vertical lines rising from its base and receding in stages towards the top of each tower. At the time of its completion, it was the tallest structure on Hong Kong Island, reflecting both Palmer & Turner's architectural innovation and the city's rapid urban development.<sup>202</sup>

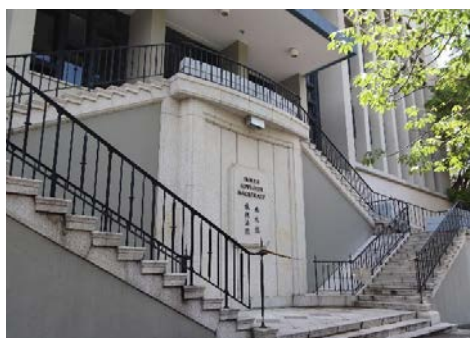
**Figure 61** Main Entrance of North Kowloon Magistracy.

The main entrance stands as the focal point of the building. The grand double staircase is designed as a symmetrical half-turn structure, ascends to the entrance platform. It forms a hexagonal shape as it rises, providing a formal and ceremonial approach to the building. At the top of the staircase, the entrance is distinguished by a pair of bronze panel cladding doors, with studded detailing, which reflect the quality and craftsmanship typical of civic buildings from the era. The staircase is flanked by ornamental ironwork on its balustrades that enhance its classical aesthetic and provide a graceful transition from the street level to the main entrance.

The main entrance structured is constructed with granite ashlar blocks, giving the building a solid and dignified appearance. The use of granite, sourced from the Diamond Hill quarry, located approximately 5-6 km from the site, making it relatively close and accessible for transporting quarried materials to the sites.<sup>210</sup> Between the staircase spandrels, a moulded granite name tablet is set into the central bay of the main entrance.

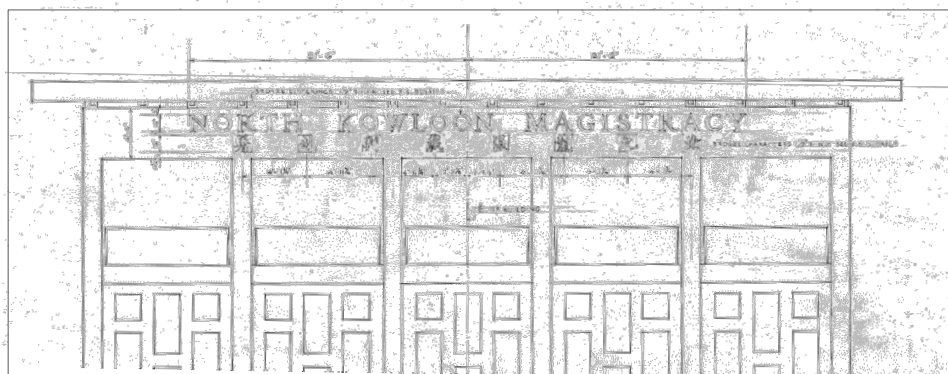
**Figure 63** 1957-1960 construction drawing showing “北九龍區裁判司署” on the main façade.<sup>213</sup>

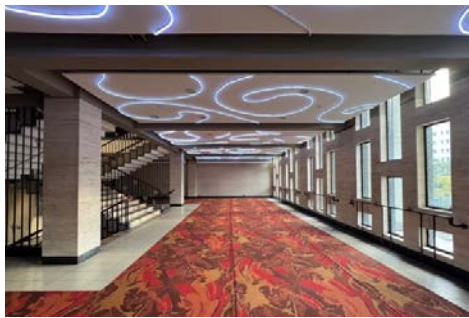
**Figure 65** 1<sup>st</sup> Floor Hall in 2025.

The Public Hall is a three-storey volume extending from the Ground Floor to the Second Floor and organized around the central staircase. It was designed to accommodate circulation and congregation for the four magistrates' courts, each seating approximately 200 persons. People assemble within the hall prior to court proceedings, with separate male and female public toilets provided on the same floor. The space is naturally lit by a Central Lightwell above the Second Floor, supplemented by tall vertical glazed openings that admit ample daylight and offer expansive views towards Sham Shui Po.

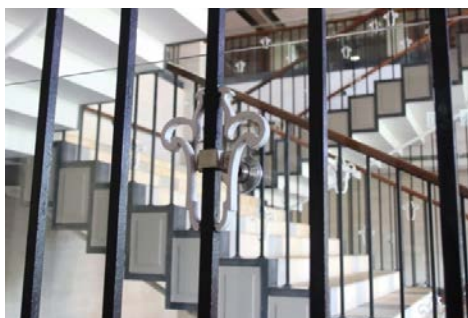
*Figure 67* Fleur-de-lis motifs.

The Entrance Hall at Ground Floor is finished to a notably higher standard than other interior spaces, reflecting its importance. Floor and wall surfaces across all three levels are clad in stone, with patterned stone flooring to the ground level, travertine wall finishes and plaster cornices enriching the ceiling edges. The main staircase features stone treads and risers, teak handrails and wrought-iron balustrades enriched with fleur-de-lis motifs, reinforcing the symbolic authority of the judicial institution.

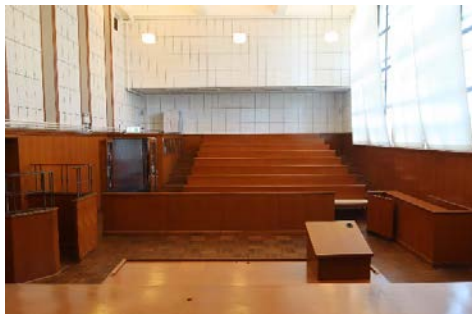
*Figure 69* Public seating in Court No.1.

Within the courtroom proper, the interiors are heavily clad in teak panelling, extending to the walls, floors and furnishings. Public seating is arranged in a stepped configuration at the rear of the room, accommodating up to approximately 200 spectators, to allow a clear sightlines to the raised magistrate's bench..<sup>215</sup>

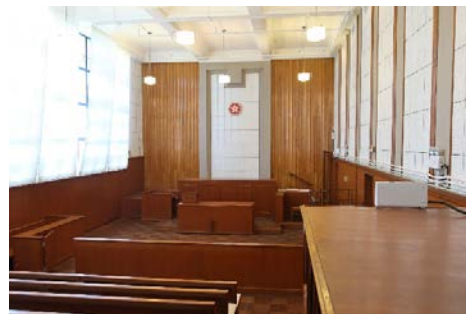
*Figure 70* Magistrate's bench.

Behind the magistrate's bench, a full-height backdrop wall framed with a moulded border, housed the Bauhinia plaque at the centre (which previously a bronze letter of "EIIR", the initials of the Royal Cypher of Queen Elizabeth II). The defendant's dock is centrally located, facing both the magistrate and the public. The courts feature a double-storey ceiling height, designed to reinforces the sense of authority and distinction between the magistrate and the public..<sup>216</sup> The court includes seven bays of tall windows that allow ample natural light, and on the opposite wall, acoustic panels mirror the window pattern, providing both aesthetic balance and sound insulation.

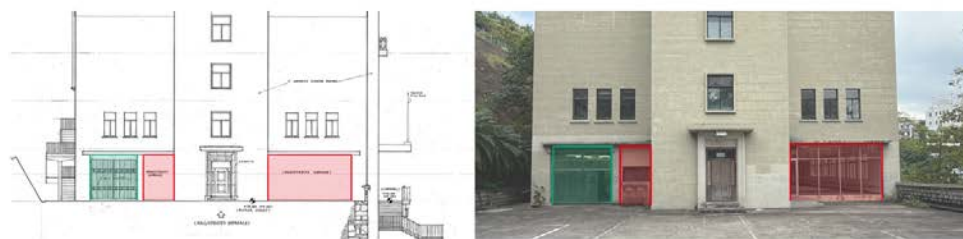
**Figure 71** Existing condition of the old Magistrates' Garages (green: police garage; red: magistrates' garages).

Two magistrates' garages were originally provided on the north side of the building as recorded in the 1958 design drawings. The smaller garage was designed to accommodate a single parking space, while the larger garage was intended for up to three vehicles. During the operational period of the North Kowloon Magistracy (1960–2005), the smaller garage was converted into office use, with its original vehicular entrance infilled and a new window opening introduced for ventilation. The larger garage was later adapted during SCAD revitalization, when the original garage entrance was replaced with glazing and the garage space was combined with adjacent offices to form a new library.

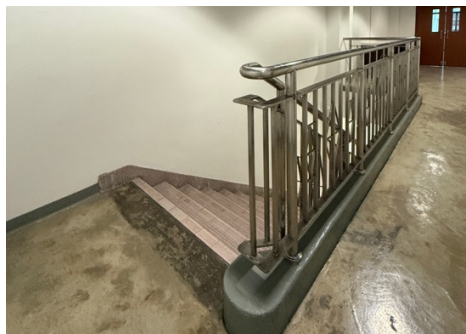
*Figure 72 Conserved Magistrates' staircase in 2025.*

Originally, the magistrates' staircases were finished with wrought-iron balustrades and plastic handrails, with mosaic tile finishes to floor and skirtings. These finishes were comparable in specification to staircases used by other government staff within the building, such as Staircase No. 3 at the south entrance. During SCAD revitalization, Staircase No. 8 was demolished following the modification of Court rooms No. 3 and No. 4 into classrooms. Staircase No. 2 was also altered, with the section between the Ground Floor and First Floor removed. The original wrought-iron balustrades is believed to be replaced with modern stainless steel balustrades during the period of magistracy operation (1960–2005), leaving the mosaic tile flooring finishes as the only surviving original materials.

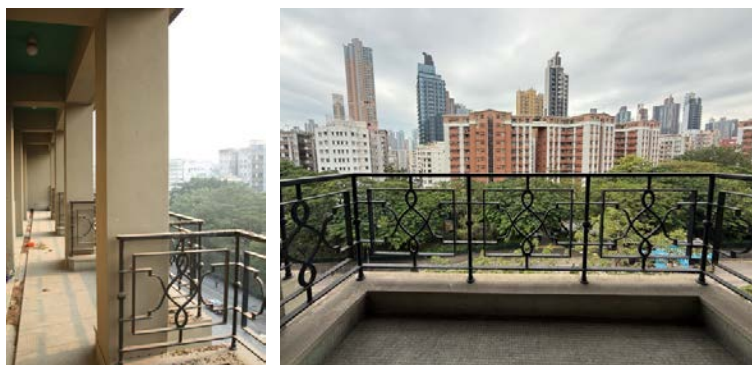
*Figure 74 Balcony at the Magistrates' offices.*

The magistrates' offices were located on the Third Floor along the main elevation. Originally, four offices of identical size were provided, all enjoying open views and connected to a shared magistrates' terrace overlooking Sham Shui Po, with distant views towards Nam Cheong. The terrace floor was finished with mosaic tiles matching those used in the magistrates' staircases, while the wrought-iron balustrades featured more refined and elaborate patterns. The viewing and finishes of these offices clearly expressed the magistrates' central authority and institutional status within the building.

These spaces remained largely unaltered until SCAD revitalization, when the four original offices were internally subdivided and reconfigured, while most of the external architectural elements, including the steel French doors and balustrades, were retained.

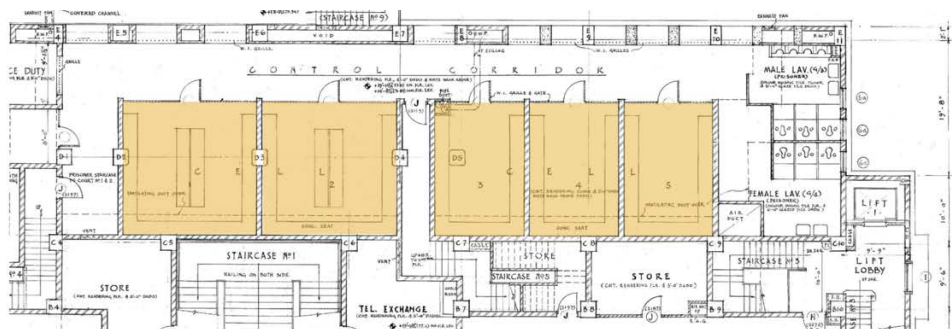
*Figure 75 The configuration of detention cells in 1960.*

The original design drawings in 1960 indicate that five detention cells were provided: two larger cells of approximately 30 square metres and three smaller cells of approximately 22 square metres. Separate male and female toilets were located at the end of the detention corridor. Each cell was basically plaster and finished with painted dado, was secured by iron gates and fitted with concrete benches to allow defendants/ prisoners to rest while awaiting court appearances.

During the operational period of the North Kowloon Magistracy between 1960 and 2005, significant alterations were made. The original toilets were removed and replaced by squat toilets within each cell, separated by low partition walls, with washbasins mounted outside the cells. The former toilet area was subdivided into two smaller cells of approximately 15 square metres each. One of the original large cells was converted into a registration counter. By the time the court ceased operation in 2005, a total of six detention cells were in use. According to an interview with retired Correctional Services officer Mr. Yeung Tak-shun, detainees were segregated by category, with adult males

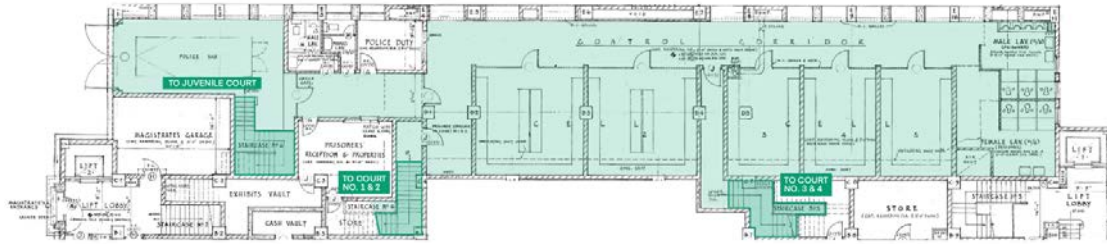
*Figure 79 Prisoner staircases (staircase no. 4-6) in 1960 design.*

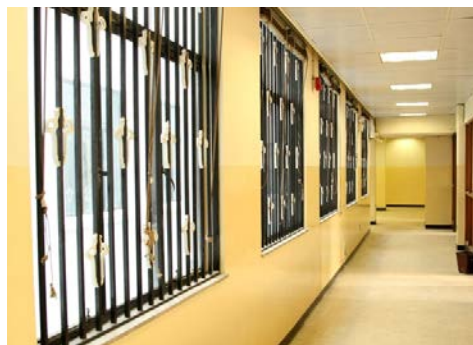
**Figure 80** Additional iron grilles at 4/F.

As both the Fourth and Fifth Floors transitioned from office use to magistrates' courts, defendants'/prisoners' movement extended to the upper floors. Iron grilles were added around the Central Lightwell openings along the corridors to enhance security.

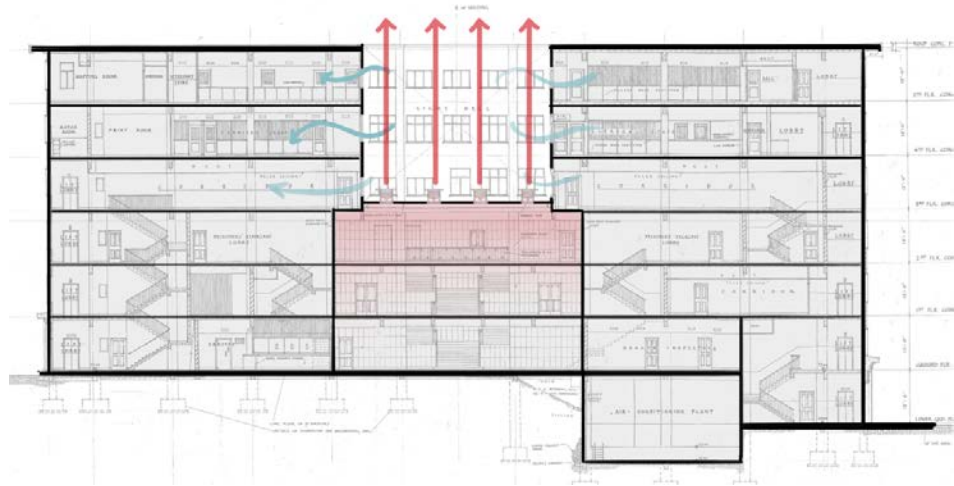
*Figure 82 Ventilation diagram of the Central Lightwell.*

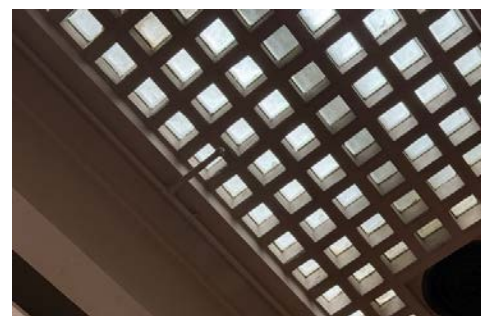
**Figure 84** Central Lightwell in 2025.

Beyond its environmental function, the Lightwell plays a significant role in the building's spatial composition. Positioned directly above the main stairwell, it allows natural daylight to penetrate deep into the Public Hall, creating a spatial climax as the hall is dramatically illuminated from above.<sup>219</sup> As recorded in the 1958 design drawings, the Lightwell was installed with a Crete-O-Lux system imported from the United Kingdom, a proprietary roof light system developed by Hayward Brothers, comprising glass blocks set within a concrete frame. A comparable lightwell design was also adopted in the contemporaneous Causeway Bay Magistracy, designed by the same architect Palmer & Turner.

The Lightwell remained open to the sky until the closure of the Magistracy in 2005. During SCAD revitalization, it was enclosed with a glazed skylight for operational reasons, and the original exhaust fan units were modified and interconnected through additional ductwork.

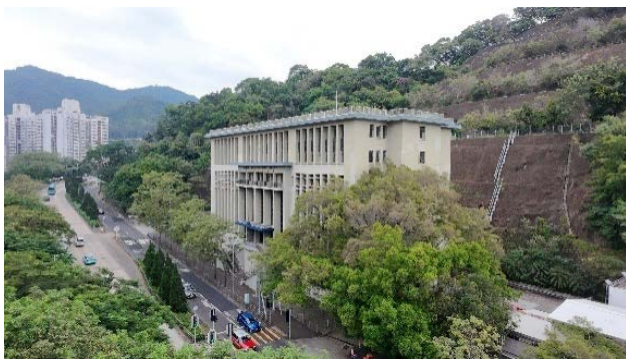
| A. Site Context | | | |
|---|---|---|---|
| Notes | Significant architectural design and topographical positioning which determine the form, façade and fenestration of the building. | | |

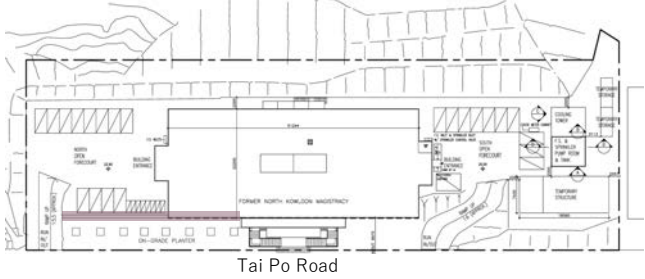
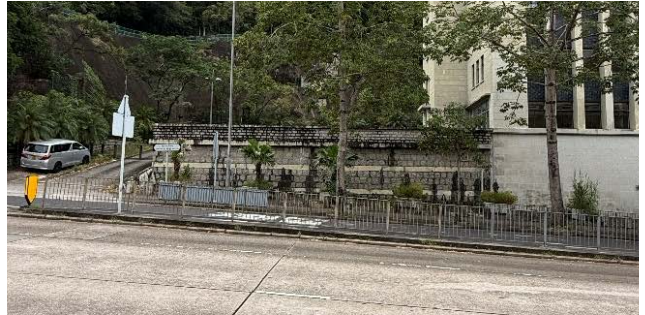
| Description | <p><u>Stone Parapet Wall and Retaining Wall at North Open Forecourt</u></p> <ul style="list-style-type: none"> <li>Original 1960 stone parapet wall and plain ashlar-faced retaining wall, supporting the building's elevated position and forming podium facing Tai Po Road.</li> </ul> | | |
| Notes | Contributes to the historical setting and spatial definition of the forecourt. | | |

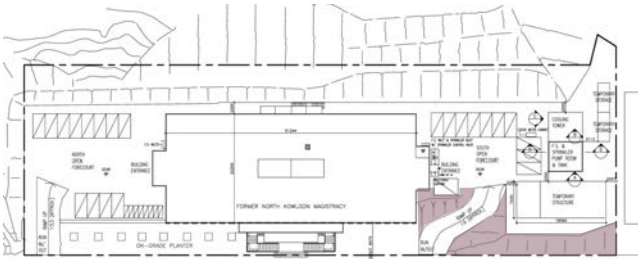
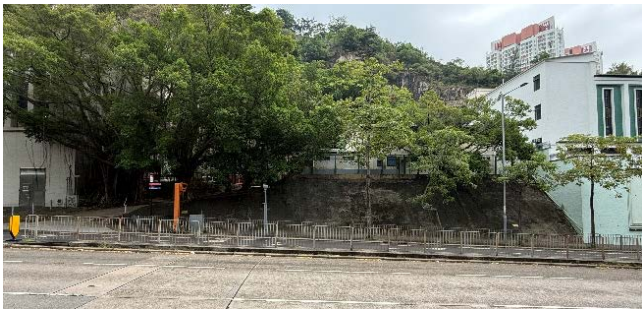
| Description of the Element | <p><u>Retaining structure at South Open Forecourt</u></p> <ul style="list-style-type: none"> <li>Stone retaining wall forming the podium, with mature trees and natural landscape elements near Tai Po Road.</li> </ul> | | |
| Notes/ Justifications | Enhances the topographic context of the site, contributing to the historical setting and spatial definition of the forecourt. | | |

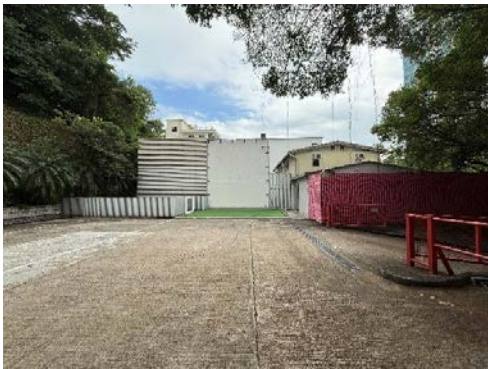
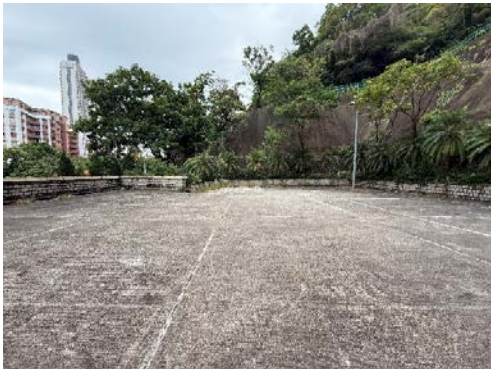
| Item no. | A5 | Level of Significance | Neutral |
|---|---|---|---|
| Description of the Element | <p><u>Later forecourt additions</u></p> <ul style="list-style-type: none"> <li>• South open forecourt: ancillary facilities (e.g. fire services pump room and tank, cooling tower for air-conditioning system, temporary storage and temporary structures. Bonded by metal fencing and vehicular access gate.</li> <li>• North open forecourt: bonded by vehicular access gate.</li> </ul> | | |
| Notes/Justifications | <p>The elements are later-added and not part of the historic fabric. Records indicate that the temporary structure predates the most recent revitalisation, establishing it as a part of the Magistracy's ongoing evolution. Furthermore, its visual presence is effectively mitigated by the dense tree line, which naturally screens the structure from view.</p> | | |

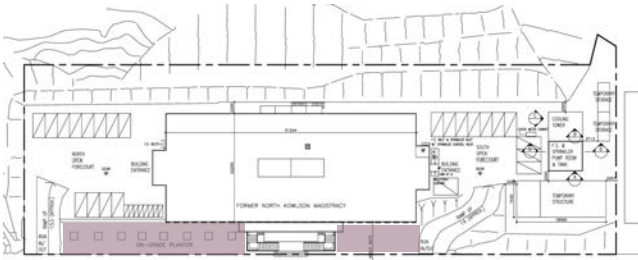
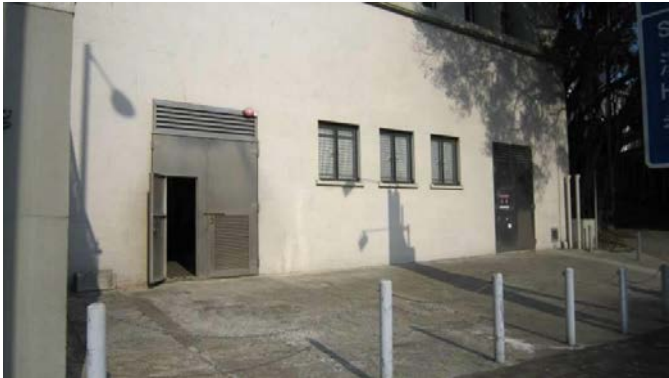
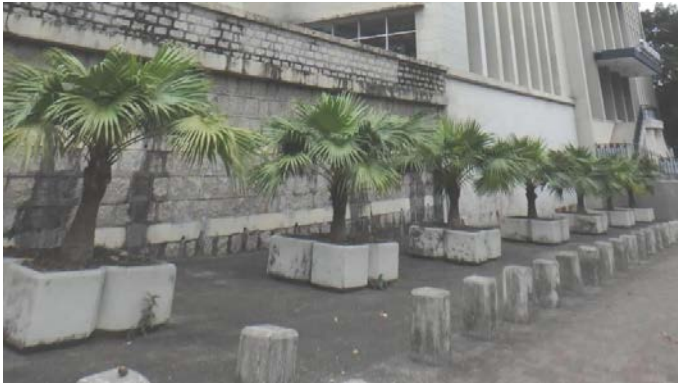
| Description of the Element | <p><u>Open Spaces at Pavement</u></p> <ul style="list-style-type: none"> <li>Open spaces between the vehicular run in/out and central grand double staircase at pavement level facing Tai Po Road.</li> </ul> | | |
| Notes/ Justifications | <p>Contributes to the historical setting and spatial definition of the magistracy by creating a breathing space that accommodates the converging flows of public visitors and media, reflecting the building's original function as a court building.</p> | | |

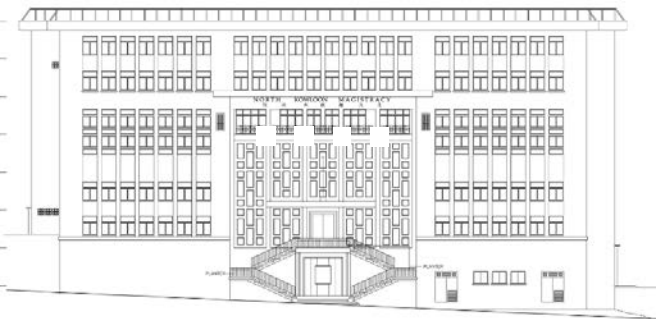
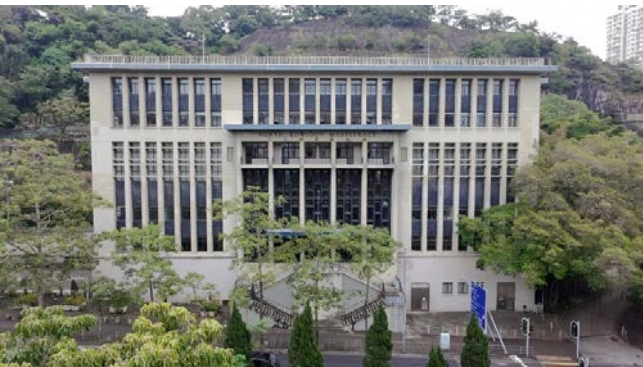
| B. Exterior | | | |
|---|---|---|---|
| Description of the Element | <u>Tai Po Road Elevation (Overall)</u> <ul style="list-style-type: none"> <li>The front elevation features a symmetrical design with three bays and distinct decorative elements, including a stone staircase, balcony, decorative balustrades, windows, and wall finishes, etc.</li> </ul> | | |
| Notes/<br>Justifications | <p>Key elements of the overall building design shape the exterior perception of the heritage building.</p> <p>All surviving original or early historic elements should be preserved and repaired. Any alterations or proposed changes to this elevation should be justified and assessed for visual impact.</p> | | |

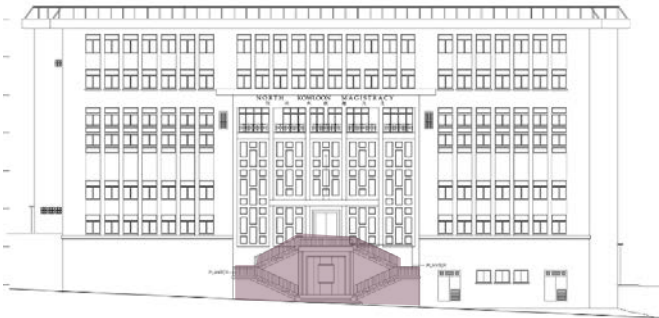
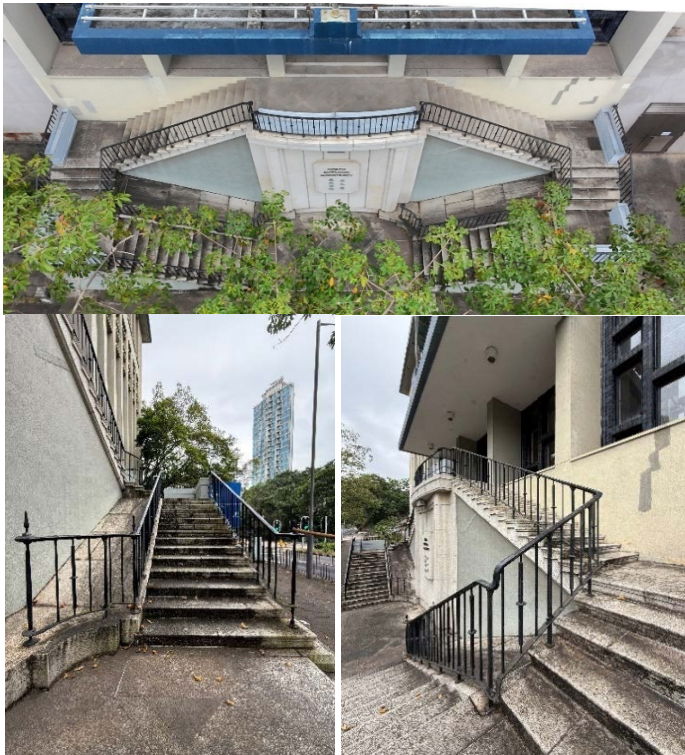
| Item no. | B2 | Level of Significance | High |
|---|---|---|---|
| Description of the Element | <p><u>Grand Double Staircase and Balustrade</u></p> <ul style="list-style-type: none"> <li>A stone staircase leading from street level to the main entrance, featuring symmetrical design and projecting buttresses between the spandrels.</li> <li>Decorative metal balustrades, granite loadings, string cornice decoration, spandrels, and ornamental ironwork balustrades.</li> </ul> | | |
| Notes/Justifications | This staircase defines the magistracy's formal entrance and reflects high craftsmanship, reinforcing the building's civic character. | | |

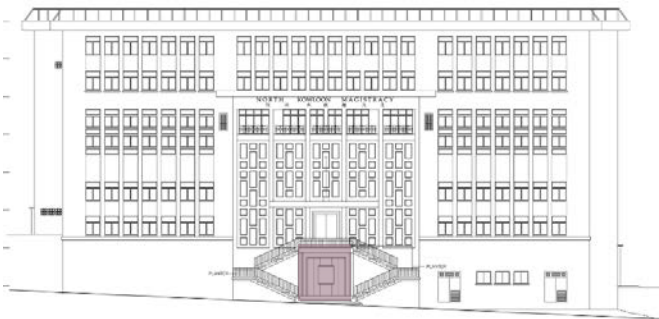
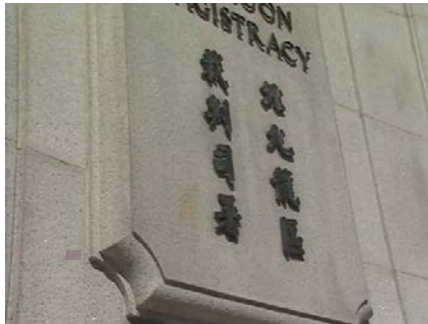
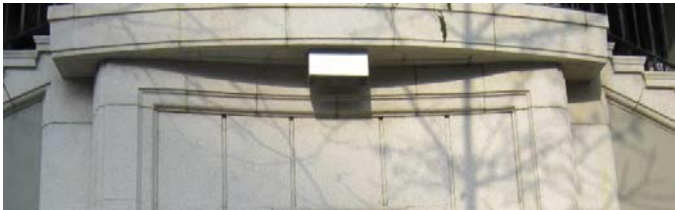
| Description of the Element | <p><u>Buttress and Stone Tablet</u></p> <p>Ashlar-faced projecting buttress between the staircase spandrels, and the granite tablet set in a recessed panel displaying the building's name in Chinese ("北九龍裁判法院") and English ("NORTH KOWLOON MAGISTRACY") in bronze lettering.</p> | | |
| Notes/Justifications | <p>Retain and preserved the projecting buttress, stone tablet and surviving bronze characters.</p> <p>The existing Chinese characters are replacements after 1992 the renaming in Chinese of magistracies, while the English characters are believed to be original from the building's early construction.</p> | | |

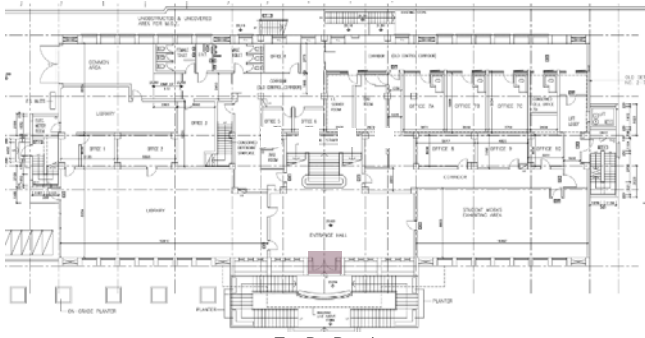
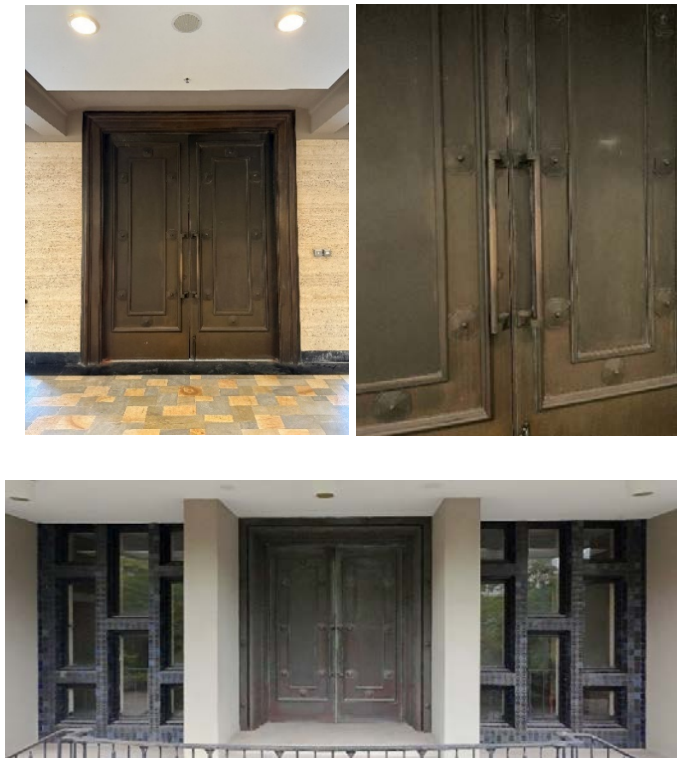
| Item no. | B4 | Level of Significance | High |
|---|---|---|---|
| Description of the Element | <u>Bronze Entrance Door</u> <ul style="list-style-type: none"> <li>Double bronze doors, marking the entrance and symbolizing durability and authority.</li> <li>Bronze studded panel cladding doors in a moulded bronze door case framed with moulded architraves, completes with handles, bolts, locks and hinges.</li> </ul> | | |
| Notes/Justifications | Key feature showcasing original design and materiality, reflecting civic architectural standards. | | |

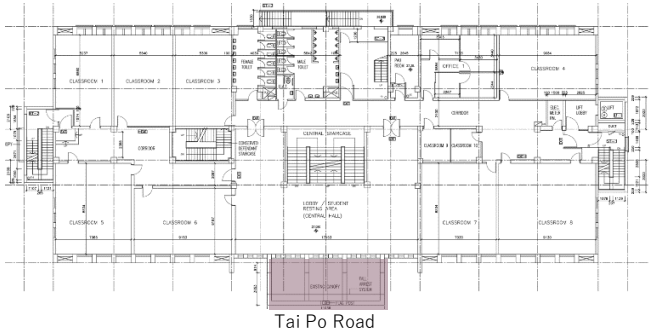
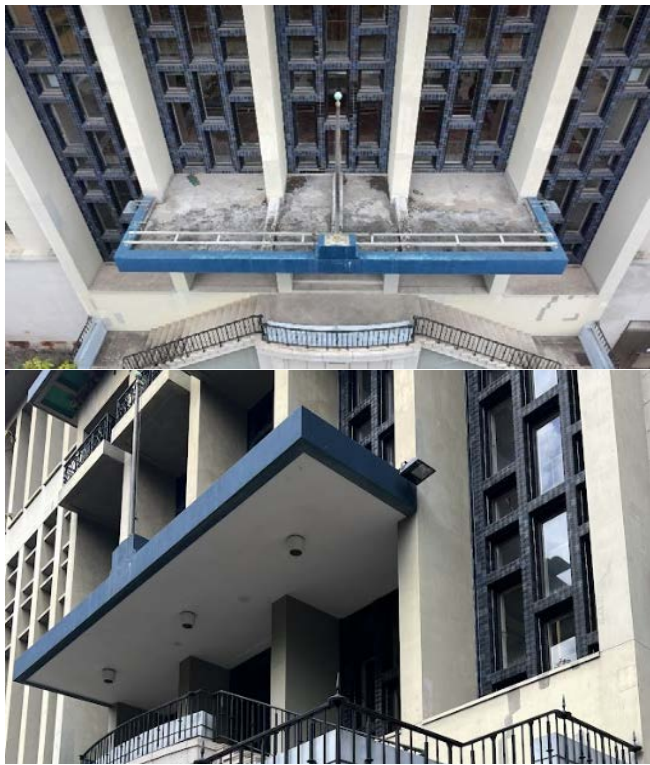
| Description of the Element | <p><u>Canopy above Main Entrance with Flagpole</u></p> <ul style="list-style-type: none"> <li>Deep projecting concrete canopy and the original metal flagpole fixed on concrete mass at the main entrance.</li> </ul> | | |
| Notes/Justifications | Reflects the judicial authority as a civic institution, contributing to the symbolic presence of the building. | | |

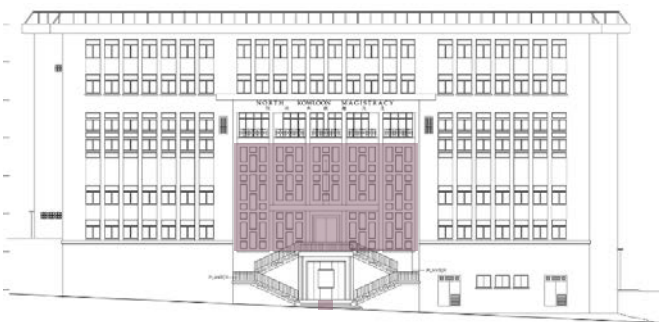
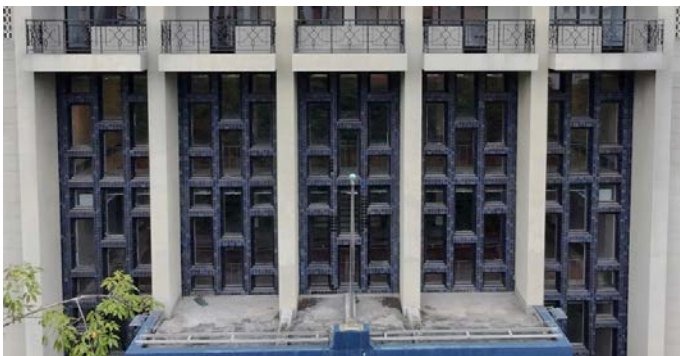
| Description of the Element | <p><u>Windows of the Central Projecting Bay</u></p> <ul style="list-style-type: none"> <li>Tall and narrow windows in the Central Projecting Bay enhance the vertical design language of the heritage building, allowing ample natural light to enter the lobby on each level of the former magistracy.</li> </ul> | | |
| Notes/ Justifications | <p>A distinctive feature shape the exterior perception of the heritage building. The configuration of the tall and narrow windows, including patterns and architraves, should be conserved and repaired on a like-for-like basis. Any later additions should be removed and replaced with replicas that respect the original design.</p> | | |

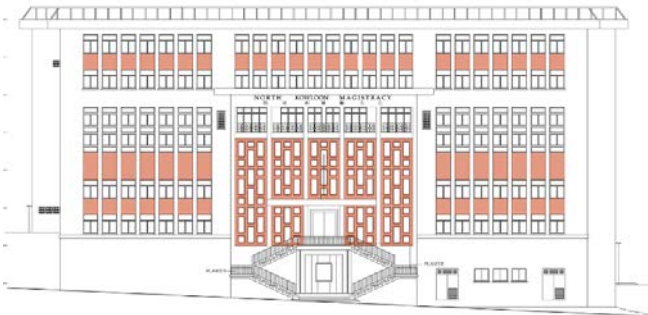
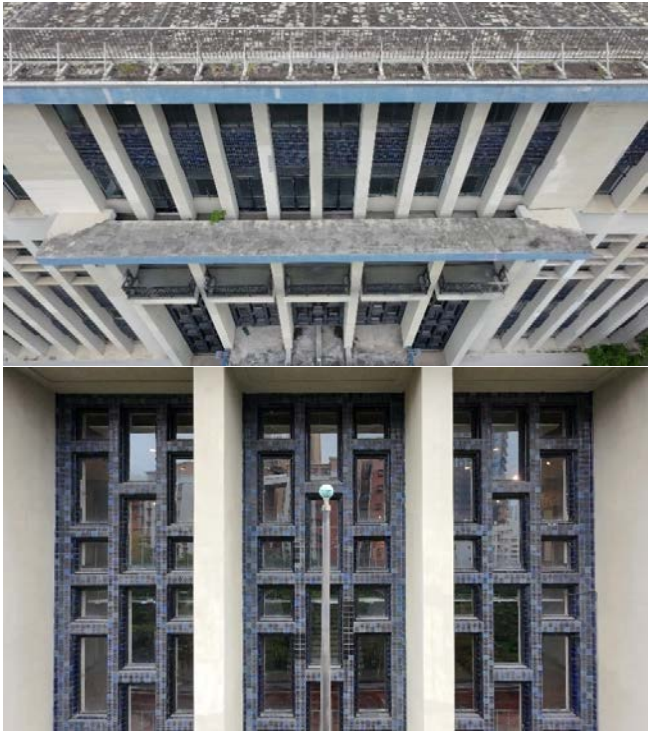
| Description of the Element | <u>Ceramic Façade Wall Tile</u> <ul style="list-style-type: none"> <li>Decorative glazed tiles surrounding window frames on the exterior façade.</li> </ul> | | |
| Notes/ Justifications | A distinctive feature shape the exterior perception of the heritage building. | | |

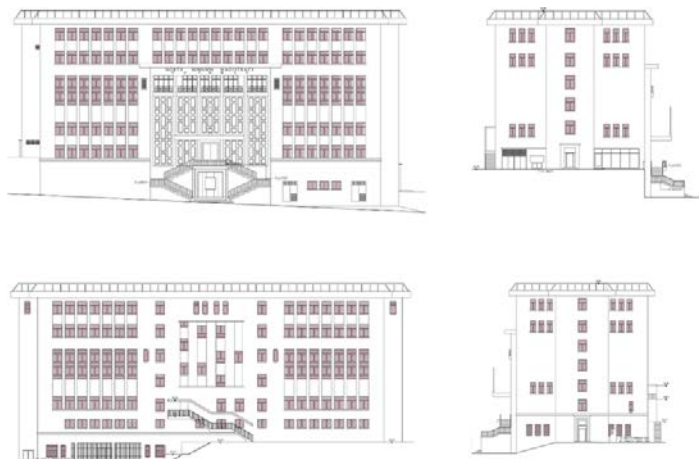
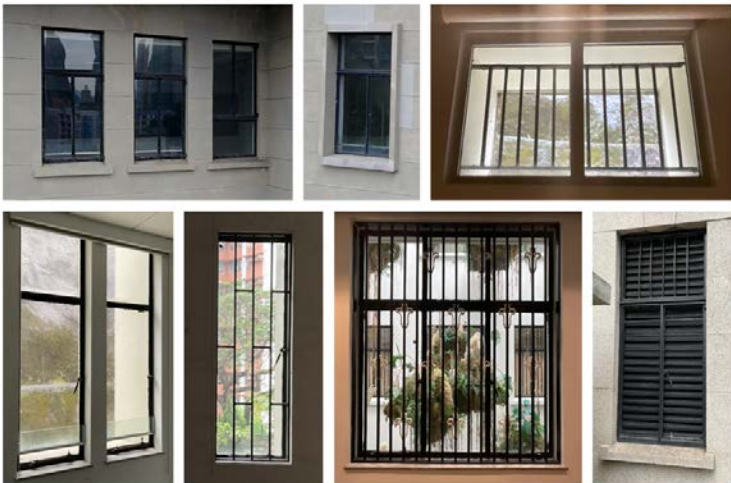
| Item no. | B8 | Level of Significance | High |
|---|---|---|---|
| Description of the Element | <p><u>Overall fenestration of metal windows and sills</u></p> <ul style="list-style-type: none"> <li>The regular window fenestration, metal casement windows, external stone windowsills, internal terrazzo window sills.</li> </ul> <p>(Windows of Central Lightwell included in item C11)</p> | | |
| Notes/Justifications | <p>The configuration of the metal casement windows, including windowsills, should be conserved on a like-for-like basis. Any later additions should be removed and replaced with replicas that respect the original design.</p> | | |

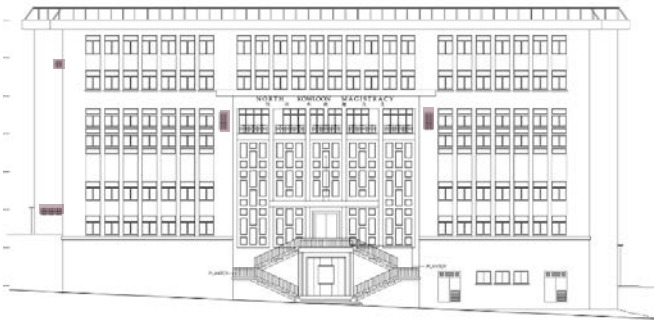
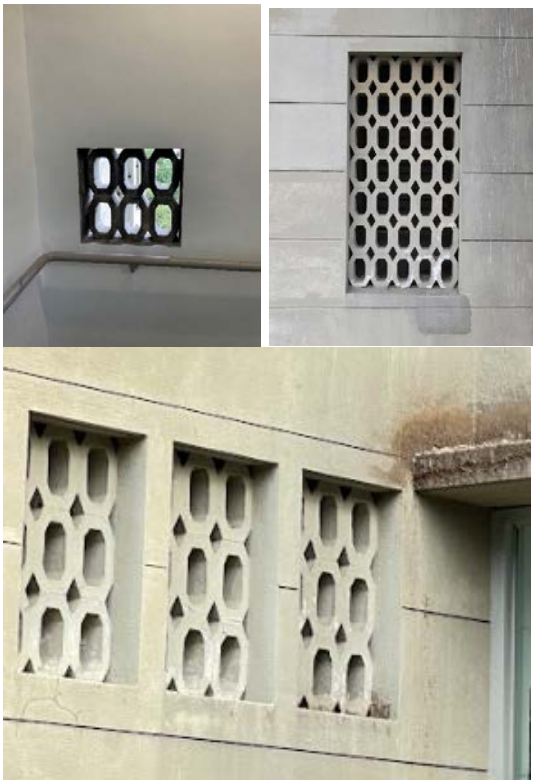
| Description of the Element | <u>Pre-cast Concrete Grilles Block</u> <ul style="list-style-type: none"> <li>Decorative grill blocks of pre-cast concrete allow airflow and ventilation at the back-of-house staircase, reflecting the materials and craftsmanship of the era.</li> </ul> | | |
| Notes/Justifications | A distinctive feature shape the exterior perception of the heritage building. | | |

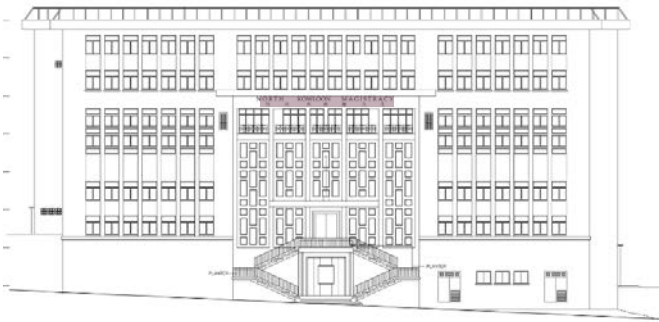
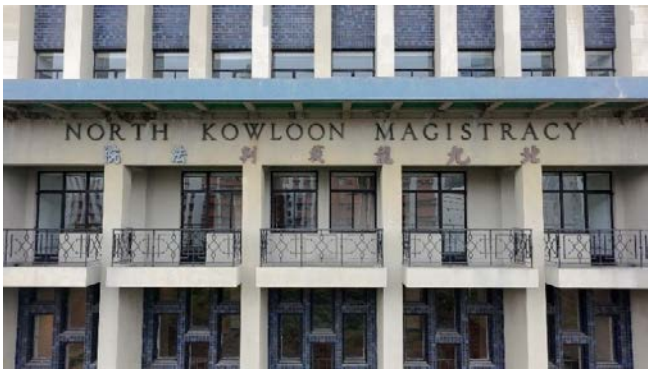
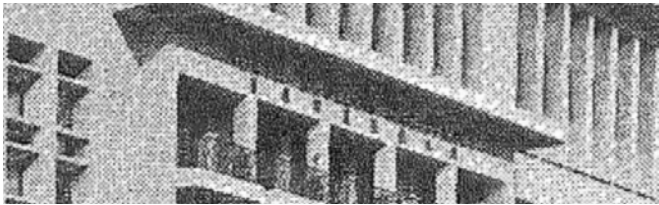
| Item no. | B10 | Level of Significance | High |
|---|---|---|---|
| Description of the Element | <p><u>Horizontal Bronze Characters</u></p> <ul style="list-style-type: none"> <li>The bronze characters fixed to central bay on West Elevation, displays the building's name in Chinese ("北九龍裁判法院") and English ("NORTH KOWLOON MAGISTRACY").</li> </ul> | | |
| Notes/ Justifications | <p>The existing Chinese characters are replacements after 1992 the renaming in Chinese of magistracies, while the English characters are believed to be original from the building's early construction.</p> <p>Retain and preserved the surviving bronze characters.</p> | | |
