## Heritage Impact Assessment

in respect of the Revitalisation of  
Former North Kowloon Magistracy into  
NK Future

Heritage Impact Assessment in respect of the Revitalisation of Former North Kowloon Magistracy  
into NK Future under Revitalising Historic Buildings through Partnership Scheme Batch VI

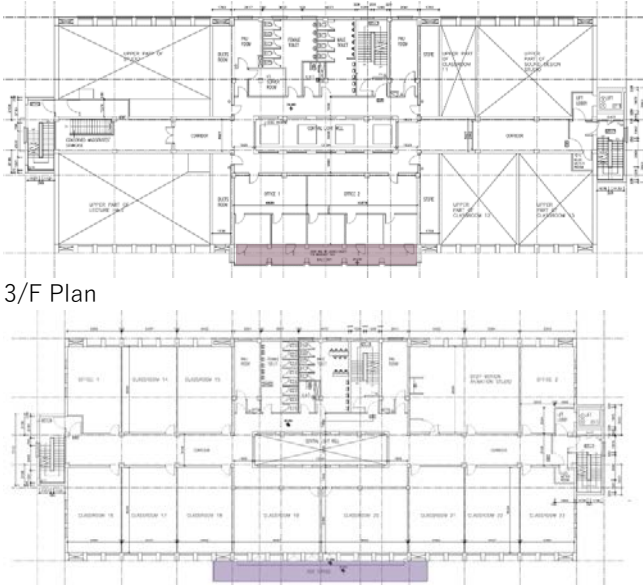
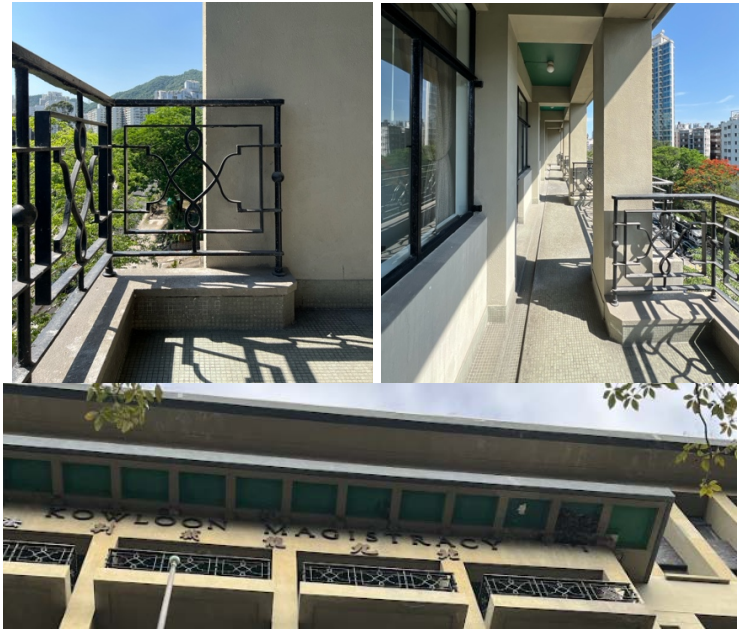
| Item no. | B11 | Level of Significance | High |
|---|---|---|---|
| Description of the Element | <u>Balcony and Roof Terrace</u> <ul style="list-style-type: none"> <li>The balcony on 3/F and roof terrace on 4/F are integrated into the design of the building, particularly between the projecting bays, including decorative metal balustrade, mosaic tiled floor finishes, surface channels and skirting of the balcony.</li> </ul> | | |
| Notes/Justifications | A distinctive feature shape the exterior perception of the heritage building. Preserved and all repairing works should be carried out on a like-for-like basis. | | |

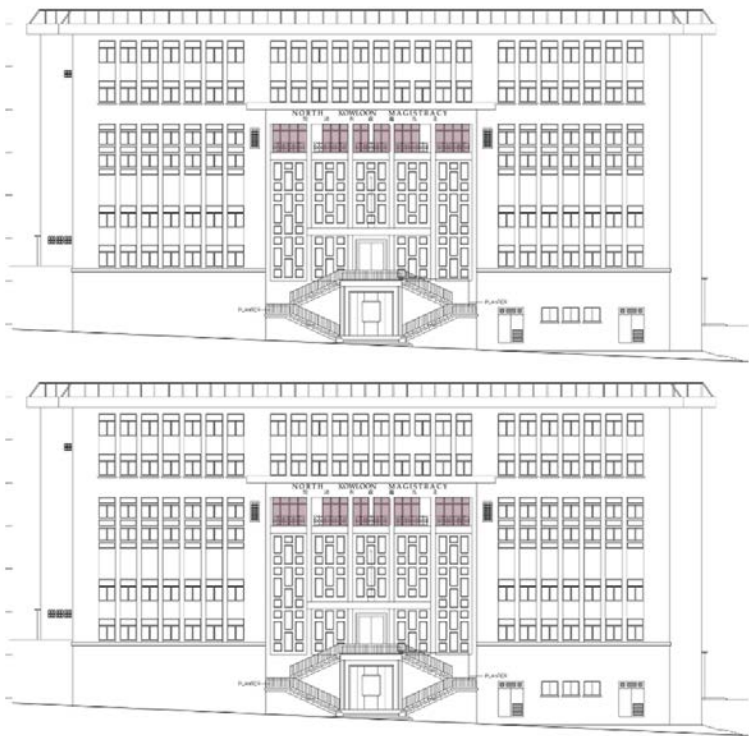
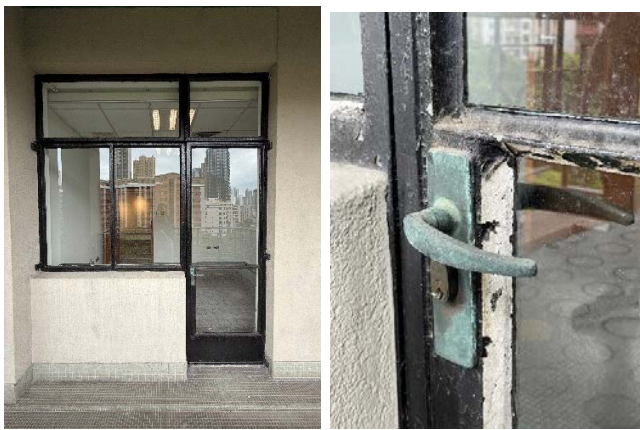
| Description of the Element | <u>Metal Windows and French Doors at Magistrates' Office</u> <ul style="list-style-type: none"> <li>The metal windows and French doors separate the outdoor balcony from the indoor office at the Magistrates' Office.</li> </ul> | | |
| Notes/ Justifications | Contribute to the exterior perception of the heritage building. The configuration of windows and French doors, including ironmongeries, should be conserved and repaired on a like-for-like basis. | | |

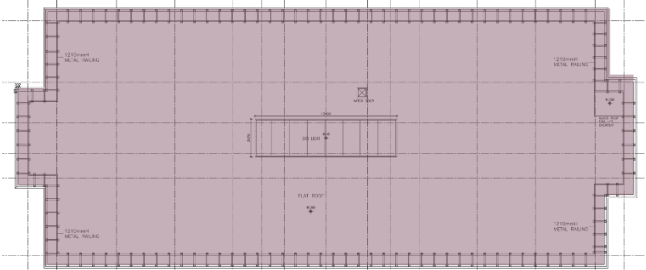
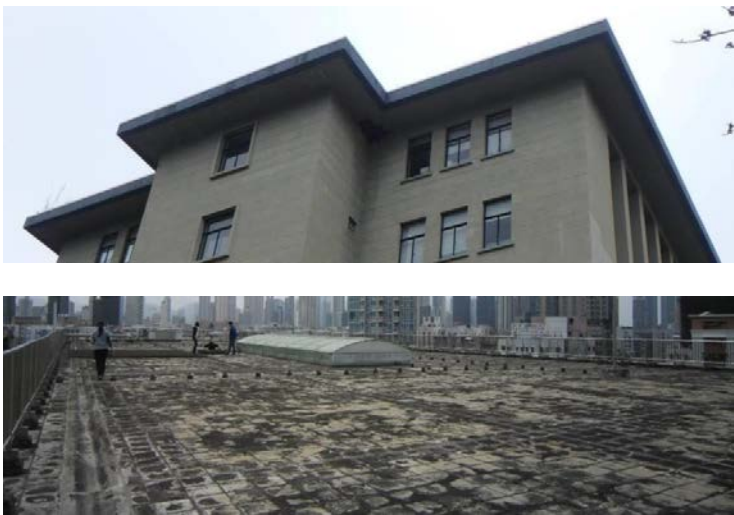
| Description of the Element | <u>Flat Roof and Projecting Roof Eaves</u> <ul style="list-style-type: none"> <li>Flat roof with its projecting eaves, roof tiles and surface channels.</li> </ul> | | |
| Notes/ Justifications | Contribute to the exterior perception of the heritage building.<br>Surviving original or early historic elements should be preserved and repaired. Any alterations or installation of building services equipment on the roof should be justified and assessed for visual impact. | | |

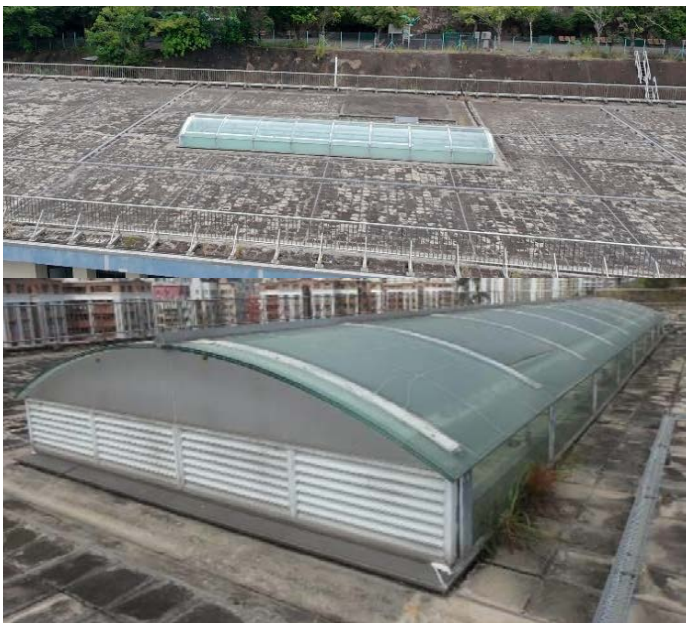
| Item no. | B14 | Level of Significance | Intrusive |
|---|---|---|---|
| Description of the Element | <p><u>Glazed Skylight</u></p> <p>The glazed skylight is a later addition that provides enclosure to the Lightwell spanning the third to fifth floors.</p> | | |
| Notes/ Justifications | <p>Retain the early historical fabric (i.e. the opening) where it is feasible to do so and subject to justification for any change.</p> <p>Subject to design proposal, removal of existing modern element is generally acceptable, provided that the natural daylight ambience is preserved.</p> | | |

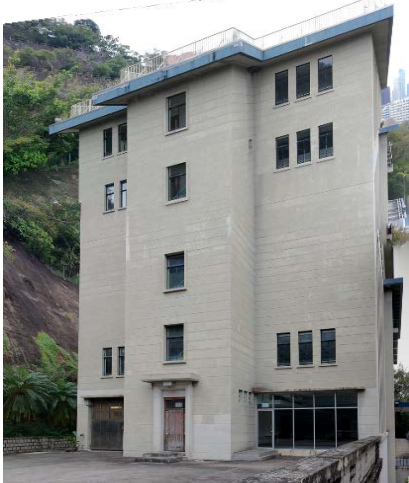
| Item no. | B15 | Level of Significance | Moderate |

| Description of the Element | <u>North Façade (Overall)</u> <ul style="list-style-type: none"> <li>Symmetrical façade with tall narrow windows aligned with the building's overall architectural language.</li> </ul> | | |
| Notes/ Justifications | While simpler than the main elevation, it reflects continuity in design and functionality. | | |

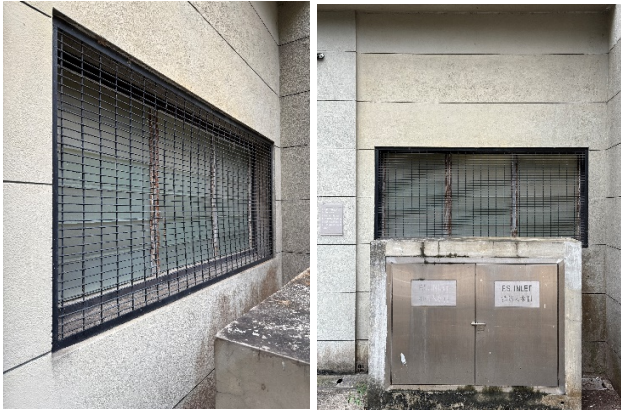
| Description of the Element | <u>Glazed Louvre Window and Mesh Grilles</u> <ul style="list-style-type: none"> <li>3 nos. of glazed louvered windows with mesh grilles on the exterior side.</li> </ul> | | |
| Notes/<br>Justifications | <p>This area originally served as the entrance to the magistrates' garage in the 1960 design. The existing room and the louvre window opening are likely later modifications made after 1960, when the space was adapted as office accommodation during the building's magistracy period.</p> <p>Retain if feasible, or otherwise, any proposed modifications are subject to justification.</p> | | |

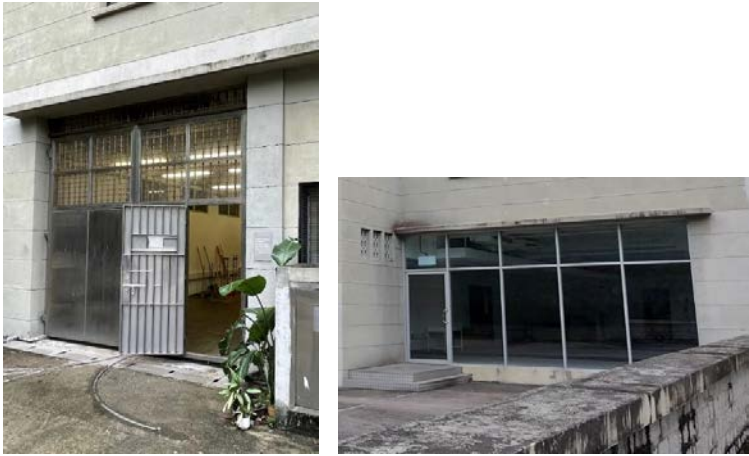
| Description of the Element | <u>Stainless Steel Gates of the old Police Van Garage</u> <ul style="list-style-type: none"> <li>The gates of the old Police Van Garage is a later addition.</li> </ul> | | |
| Notes/ Justifications | The stainless steel gates are modern replacements. Subject to the design proposal, to be retained as far as possible, or only replaced by gates of similar design that continues the controlled ambience. | | |

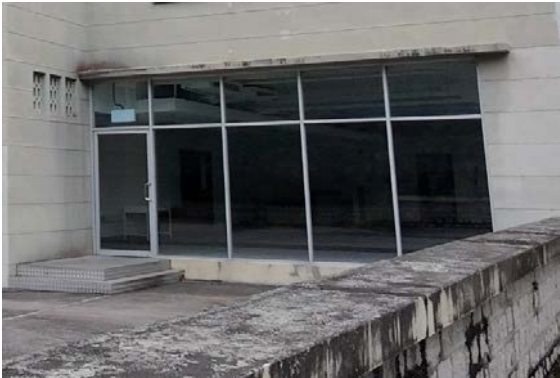
| Item no. | B19 | Level of Significance | Neutral |

| Description of the Element | <u>Glazed Partition of the old Magistrates' Garage</u> <ul style="list-style-type: none"> <li>The glazed partition of the old Magistrates' Garage is a later addition.</li> </ul> | | |
| Notes/Justifications | The glazed partition is a later modification introduced during SCAD revitalization. Subject to the design proposal, removal of these existing modern elements is generally acceptable. | | |

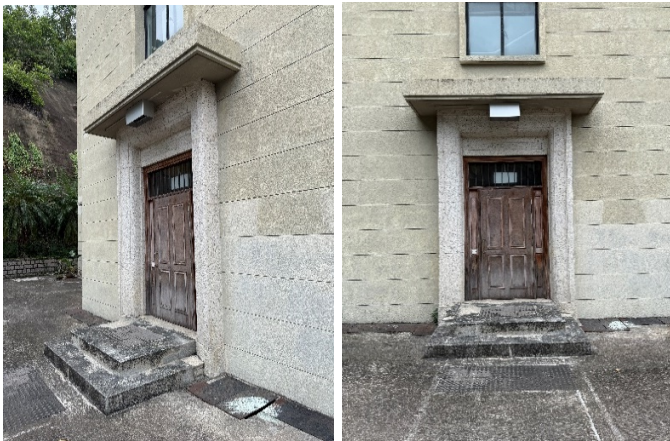
| Item no. | B20 | Level of Significance | Moderate |
|---|---|---|---|
| Description of the Element | <p><u>North Side Entrance Door</u></p> <ul style="list-style-type: none"> <li>• Wooden panelled entrance doors and fanlights with wooden frame, including decorative mouldings at the door faces, door jambs, door head and granite steps.</li> <li>• Entrance stone door cases with steps, carved stone door case, including the moulded architrave and ashlar-faced canopy above with granite and steps.</li> </ul> | | |
| Notes/Justifications | <p>Contribute to the overall side elevation design. The door leaves and frames are not original but with design mimic the old wooden doors. Retain the surviving original or early historical fabric and all repairing works should be conserved and repaired on a like-for-like basis.</p> | | |

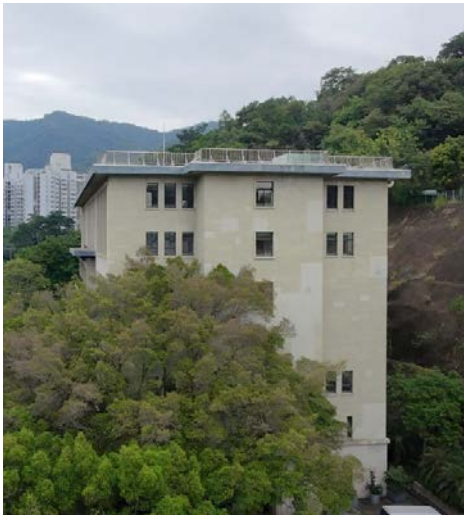
| Item no. | B21 | Level of Significance | Moderate |

| Description of the Element | <u>South Façade (Overall)</u> <ul style="list-style-type: none"> <li>Symmetrical façade with tall narrow windows aligned with the building's overall architectural language.</li> </ul> | | |
| Notes/Justifications | While simpler than the main elevation, it reflects continuity in design and functionality. | | |

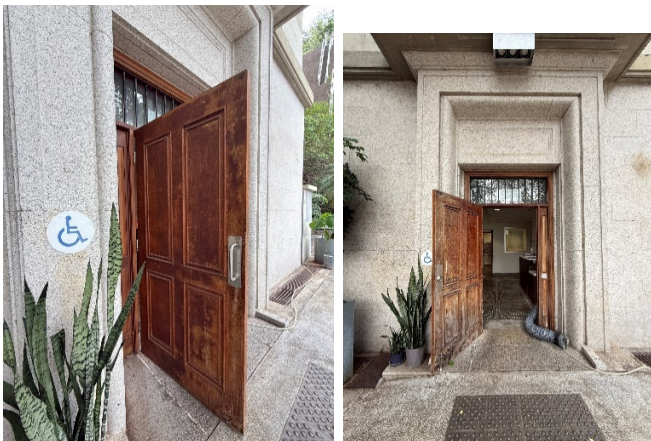
| Description of the Element | <p><u>South Side Entrance Door</u></p> <ul style="list-style-type: none"> <li>• Wooden panelled entrance doors and fanlights with wooden frame, including decorative mouldings at the door faces, door jambs, and door head and granite steps.</li> <li>• Entrance stone door cases with steps, carved stone door case, including the moulded architrave, cornice crown moulding with granite door threshold and steps.</li> </ul> | | |
| Notes/ Justifications | <p>Contribute to the overall side elevation design. The door leaves and frames are not original but with design mimic the old wooden doors. Retain the surviving original or early historical fabric and all repairing works should be conserved and repaired on a like-for-like basis.</p> | | |

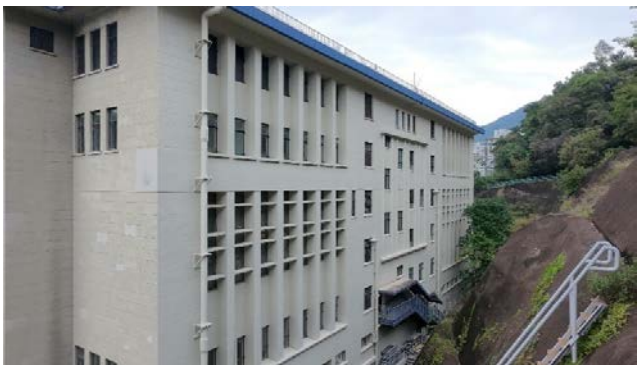
| Description of the Element | <u>East Elevation (Overall)</u> <ul style="list-style-type: none"> <li>Functional façade with metal windows that align with the building's overall architectural language, along with external stairs and utility fixtures to support its operation.</li> </ul> | | |
| Notes/ Justifications | This façade, while part of the original structure, possesses comparatively fewer heritage features and is in a less prominent position. Alterations may be considered acceptable if justified and not adversely impact elements of higher heritage significance. | | |

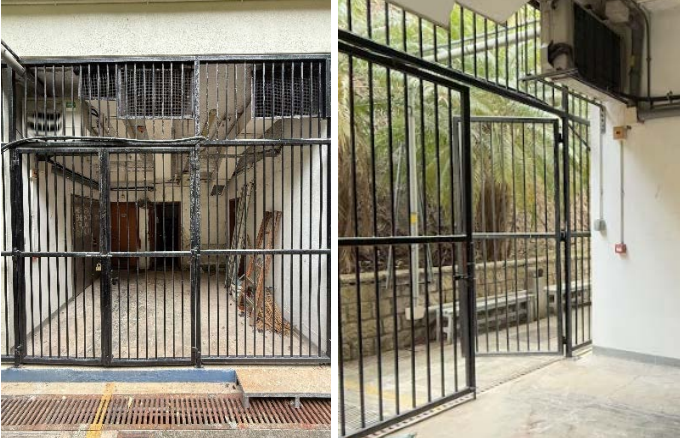
| Item no. | B24 | Level of Significance | Low |
|---|---|---|---|
| Description of the Element | <u>Original Verandah Openings</u> <ul style="list-style-type: none"> <li>The wall openings of the former verandah at the east elevation with metal gates at the LG/F east elevation.</li> </ul> | | |
| Notes/<br>Justifications | <p>Form an integral part of the building's façade composition. Retain if feasible, or otherwise, any proposed modifications are subject to justification.</p> <p>The existing metal gates are a later addition to the original 1960 verandah openings. Their design does not align with the reserved metal gates at other locations.</p> <p>Retain if feasible, or otherwise, any proposed modifications are subject to justification.</p> | | |

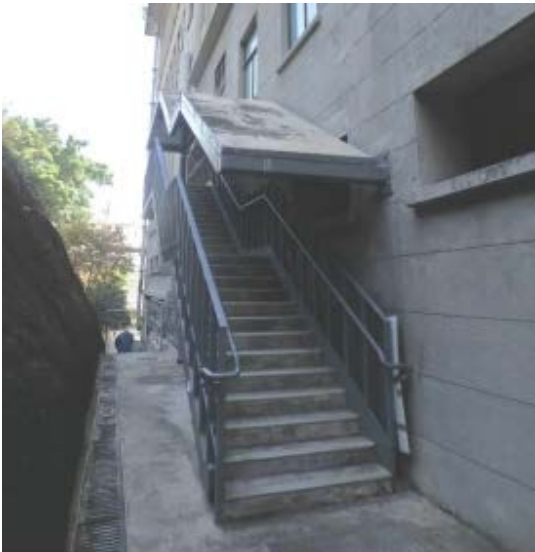
| Item no. | B25 | Level of Significance | Neutral |

| Description of the Element | <u>External Staircase</u> <ul style="list-style-type: none"> <li>The covered exit staircase from G/F to 1/F at East elevation including the exit door wall opening.</li> </ul> | | |
| Notes/ Justifications | The staircase has undergone alteration during the SCAD revitalisation. Retain if feasible, or otherwise, any proposed modifications are subject to justification. | | |

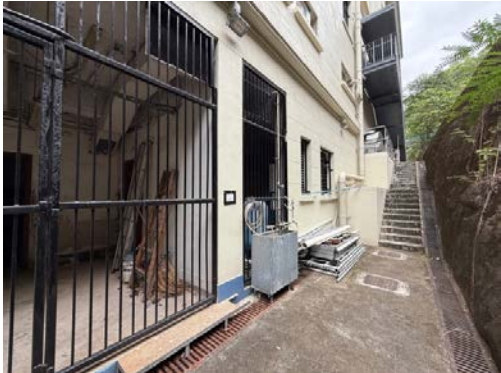
| Item no. | B26 | Level of Significance | Intrusive |

| Description of the Element | <u>Sink and faucet of the east courtyard</u> <ul style="list-style-type: none"> <li>The sinks and faucets including all routing/pipework are later-added provisions and not part of the original design.</li> </ul> | | |
| Notes/Justifications | Since the elements are later-added and not original, they are considered as intrusive elements that may cause confusion to the visitors. | | |

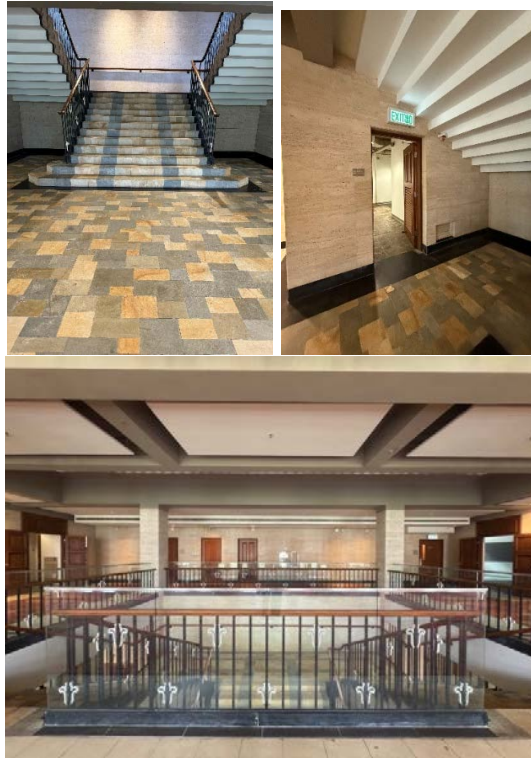
| Item no. | C3 | Level of Significance | High |
|---|---|---|---|
| Description of the Element | <p><u>Central Halls (G/F to 2/F)</u></p> <ul style="list-style-type: none"> <li>Central halls from G/F to 2/F including random pattern stone flooring on G/F, travertine wall cladding with black marble skirting on G/F to 2/F, the ornamental ironwork balustrades with wooden handrails and metal guard bars around the central hall staircase void featuring fleur-de-lis motifs, and ornamental metal handrails and guard bars to the vertical windows.</li> </ul> | | |
| Notes/Justifications | <p>The original symmetrical design of the entrance lobby was altered during the building's use as a magistracy.</p> <p>Consider restoring the original symmetrical layout to the G/F where feasible, following the 1960 configuration. All repair work should be distinguishable and reversible.</p> | | |

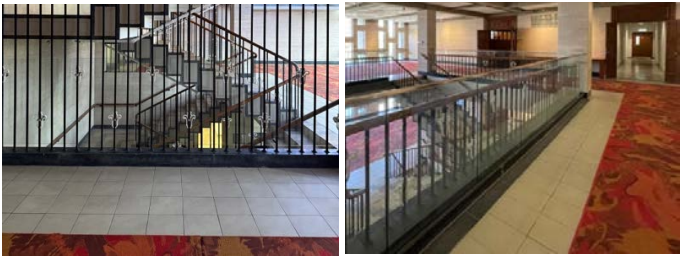
| Item no. | C4 | Level of Significance | Low |
|---|---|---|---|
| Description of the Element | <p><u>Floor finishes of Central Halls (1/F and 2/F)</u></p> <ul style="list-style-type: none"> <li>Modern tiled floor finishes at Central Halls on 1/F and 2/F.</li> </ul> | | |
| Notes/Justifications | <p>The original flooring at Central Halls on 1/F and 2/F was altered and replaced with the existing modern tiled floor finishes during 1961-2008 the building's use as a magistracy. Alteration or partial replacement of the floor finishes may be acceptable where required.</p> | | |

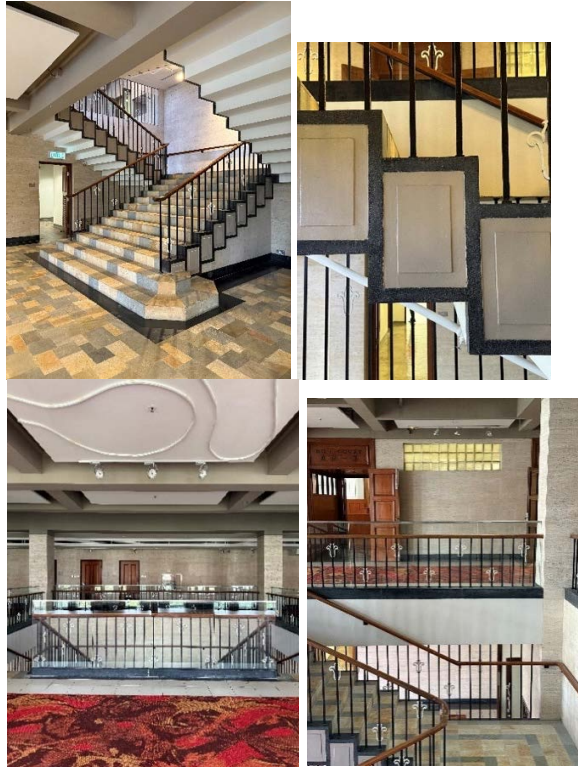
| Item no. | C5 | Level of Significance | High |
|---|---|---|---|
| Description of the Element | <p><u>Central Staircase</u></p> <ul style="list-style-type: none"> <li>The main interior staircase featuring ornamental ironwork balustrades with timber handrails and decorative motifs. The treads and risers are finished in stone likely quartzite, square mouldings at the sides, and a skylight above allows natural light to illuminate the space.</li> </ul> | | |
| Notes/Justifications | A key interior feature providing vertical circulation, with materials and craftsmanship reflecting the building's architectural integrity. | | |

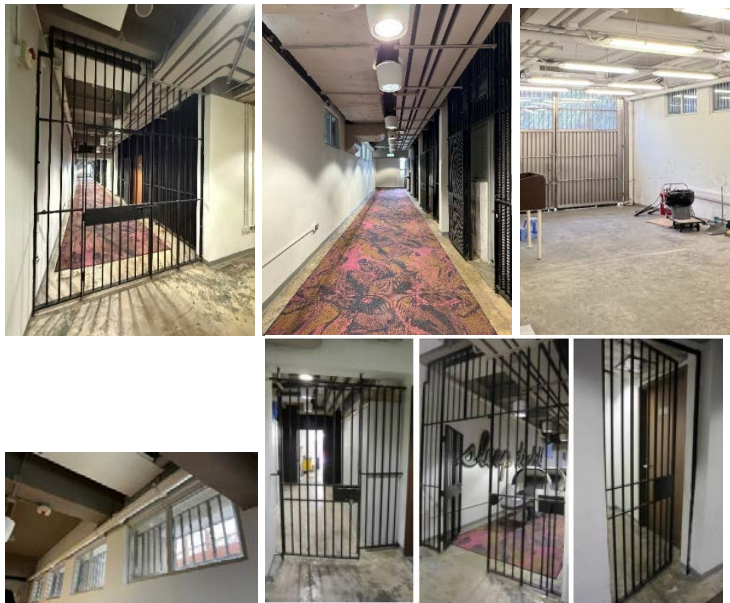
| Item no. | C6 | Level of Significance | High |
|---|---|---|---|
| Description of the Element | <p><u>Controlled Corridor</u></p> <ul style="list-style-type: none"> <li>Controlled space included the metal gates (framed in red), grilles, the areas of the former police van garage, the cells, metal guard bars at window openings, 4 nos. of metal gates (framed in blue), the corridors and defendants staircases to the courts.</li> </ul> | | |
| Notes/ Justifications | Incorporate into Interpretation in the original purpose to maintain operational security and circulation flow in the past. | | |

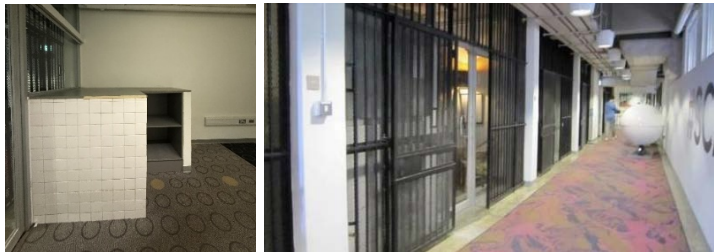
| Item no. | C8 | Level of Significance | Moderate |
|---|---|---|---|
| Description of the Element | <p><u>Other Detention Cells</u></p> <ul style="list-style-type: none"> <li>The configuration of cells with half-height partitioned squat toilet with white tiled wall finishes and mosaic tiles floor finishes, including floor and wall tiles on partition, metal guard bars and grilles, metal gate with mortice lock were unaltered and readapted in new use in SCAD revitalization.</li> </ul> | | |
| Notes/<br>Justifications | <p>The fabric and layout of the detention cells have undergone alterations over different periods, such as removal of the benches, the addition of glass panels on near the grills, the covering up of the squat toilets etc. during the SCAD revitalization.</p> <p>Retain any surviving early structures where feasible, with any proposed changes requiring justification.</p> | | |

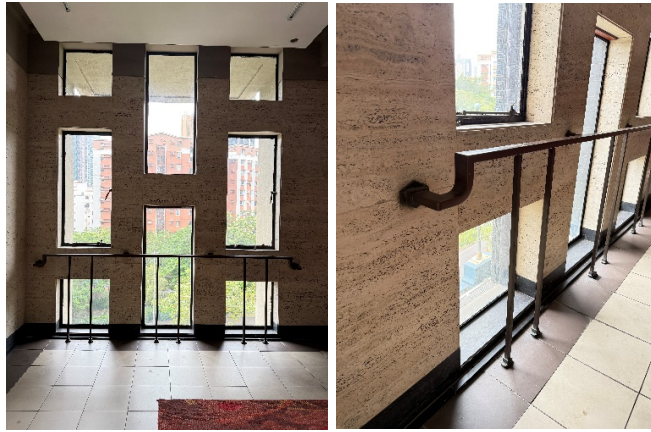
| Central Hall | | | |
|---|---|---|---|
| Description of the Element | <u>Ornamental Handrails and Guard Bars</u> <ul style="list-style-type: none"> <li>Metal handrails are original from 1960 and guard bars installed along the tall windows in the central hall.</li> </ul> | | |
| Notes/Justifications | Contribute to the overall building design. | | |

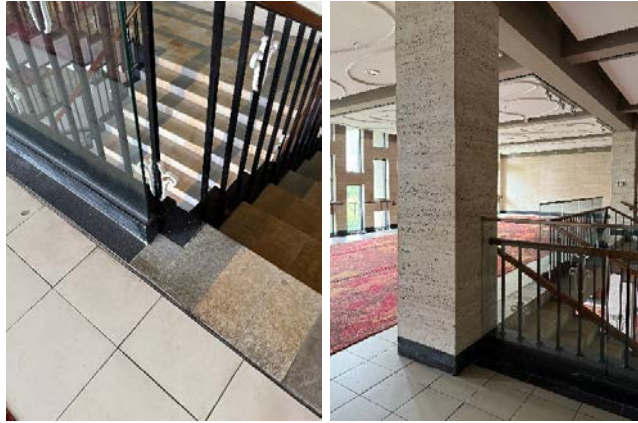
| Item no. | C10 | Level of Significance | High |
|---|---|---|---|
| Description of the Element | <u>Travertine Wall Finishes</u> <ul style="list-style-type: none"> <li>The original travertine wall cladding with black marble skirting on G/F to 2/F.</li> </ul> | | |
| Notes/Justifications | Contribute to the overall building design. | | |

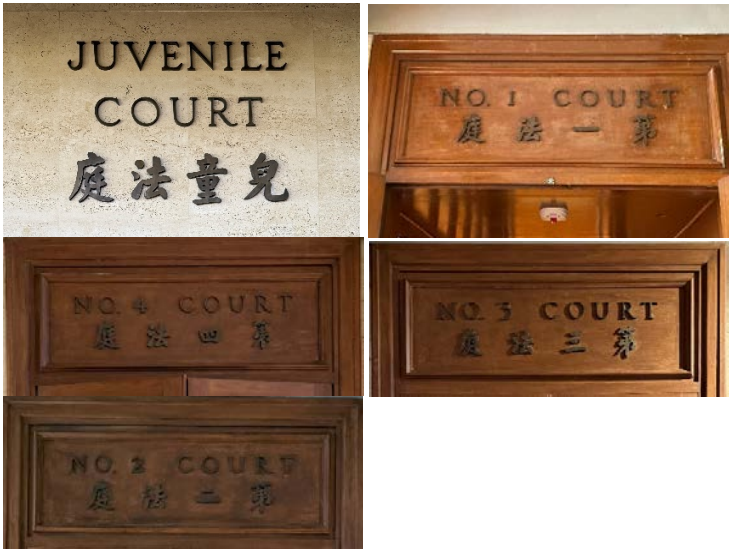
| Description of the Element | <p><u>Nameplates</u></p> <ul style="list-style-type: none"> <li>The original nameplates of bronze character to indicating the function of the space and courtroom numbers.</li> </ul> | | |
| Notes/Justifications | Key elements of the overall magistracy design. Retain and preserve the surviving original or early historical fabric. | | |

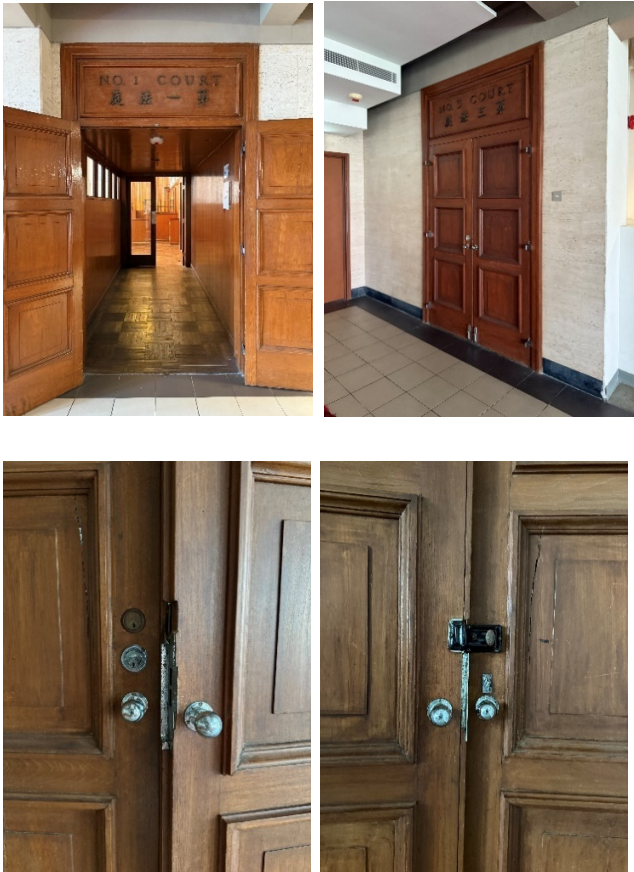
| Description of the Element | <u>Courtrooms Entrance Doors</u> <ul style="list-style-type: none"> <li>The original solid wooden panel doors, wooden door head panels with moulding, all old ironmongeries and frame to Courtrooms</li> </ul> | | |
| Notes/ Justifications | Key elements of the overall magistracy design. Retain and preserve the surviving original or early historical fabric. | | |

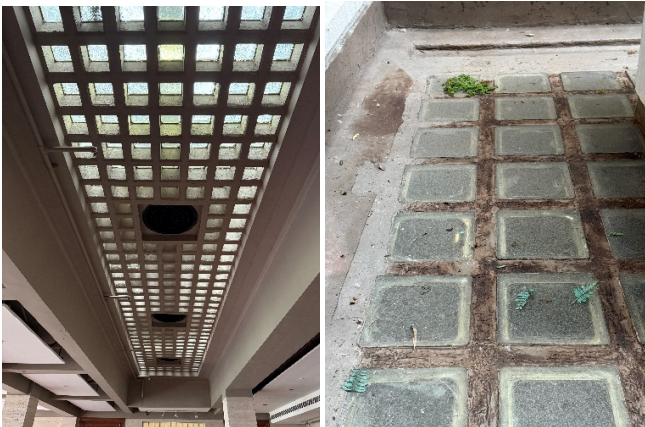
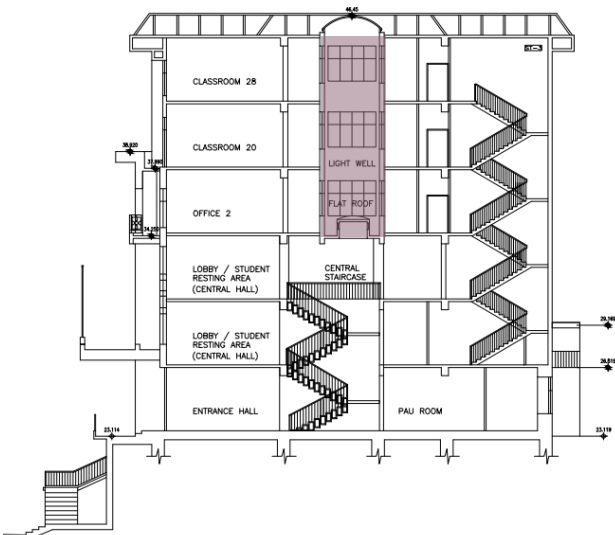
| Item no. | C13 | Level of Significance | High |
|---|---|---|---|
| Description of the Element | <p><u>Central Lightwell</u></p> <ul style="list-style-type: none"> <li>Central Lightwell 3/F, 4/F and 5/F with glass block roof light at 2/F soffit that illuminates the central staircase, and the steel windows around the Lightwell on 3/F to 5/F.</li> </ul> | | |
| Notes/Justifications | Contribute to the overall building design. Retain the glass block and repaired on a like-for-like basis. | | |

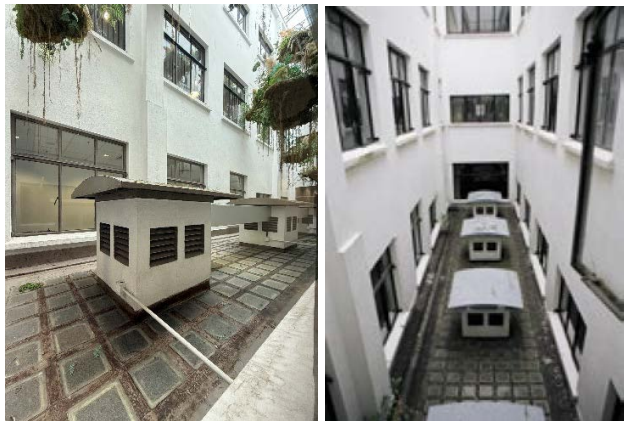
| Description of the Element | <u>Exhaust Fan Housing</u> <ul style="list-style-type: none"> <li>Exhaust fan housings at the Central Lightwell on 3/F.</li> </ul> | | |
| Notes/Justifications | <p>The original exhaust fan units were modified and interconnected through additional ductwork.</p> <p>The exhaust fan housings shall be preserved in situ. Any proposed modifications are subject to justification.</p> | | |

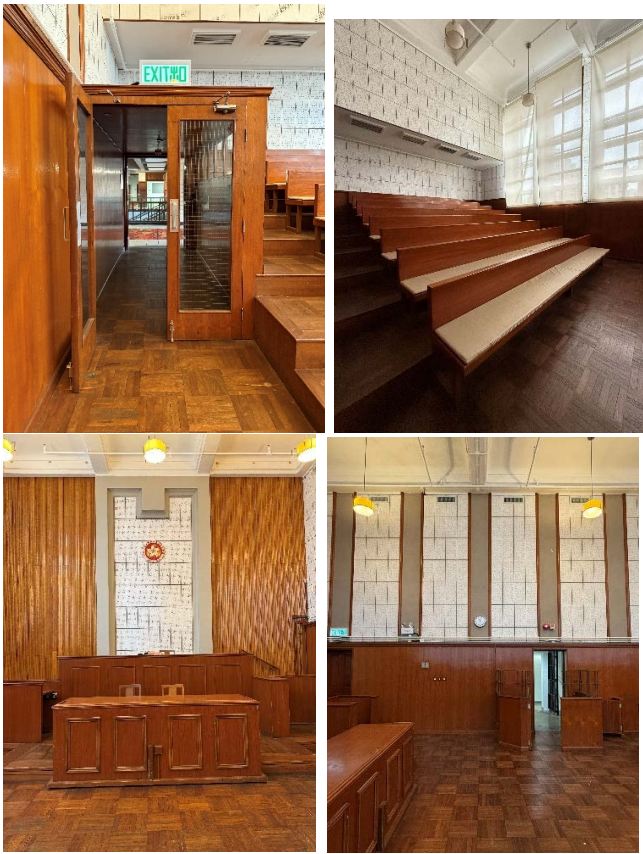
| Item no. | C15 | Level of Significance | High |
|---|---|---|---|
| Description of the Element | <p><u>Court No. 1 (Overall)</u></p> <ul style="list-style-type: none"> <li>The court room was preserved during SCAD revitalization retaining the sound lobby, benches, defendants' dock, clerk's bench, magistrate's bench, as well as the wall and floor finishes.</li> </ul> | | |
| Notes/Justifications | Key elements of the building's judicial history, all surviving features and finishes should be retained and preserved to maintain historical integrity. | | |

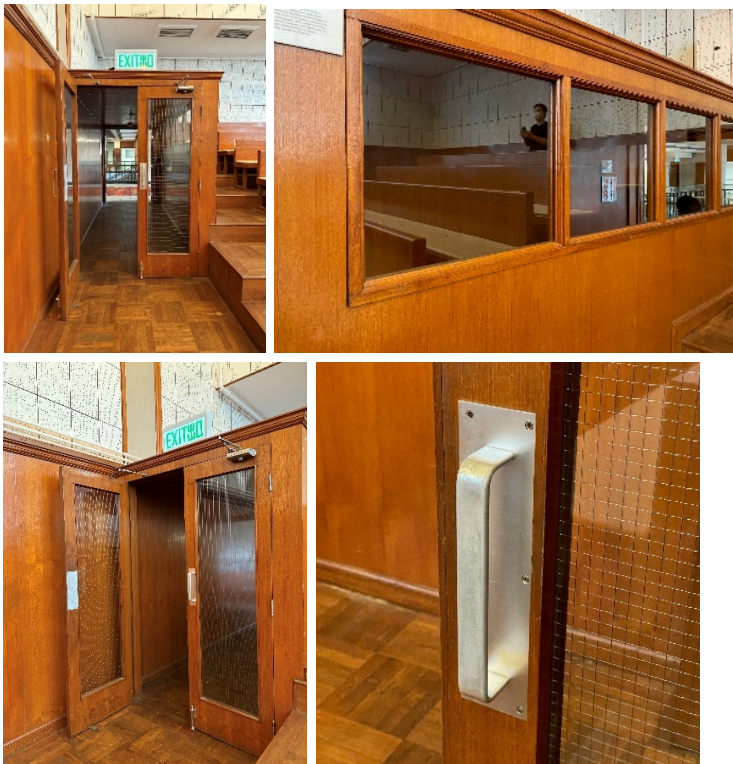
| Item no. | C16 | Level of Significance | High |
|---|---|---|---|
| Description of the Element | <p><u>Sound Lobby and Doors</u></p> <ul style="list-style-type: none"> <li>The sound lobby with wooden ceiling, the upper fixed glass panels and frames, and a pair of wired glass panelled wooden inner doors and door frame.</li> </ul> | | |
| Notes/Justifications | Key elements of the building's judicial history, all surviving features and finishes should be retained and preserved to maintain historical integrity. | | |

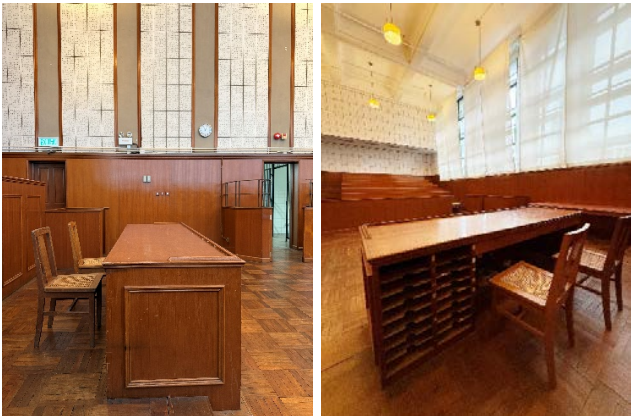
| Description of the Element | <p><u>Clerk's Bench</u></p> <ul style="list-style-type: none"> <li>Clerk's bench, the witness box with wooden chair and court reporter's desk on low wooden raised platform.</li> </ul> | | |
| Notes/ Justifications | Key elements of the building's judicial history, all surviving features and finishes should be retained and preserved to maintain historical integrity. | | |

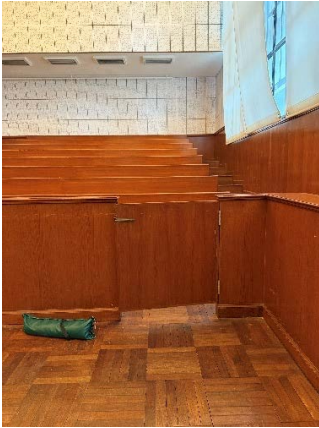
| Item no. | C19 | Level of Significance | High |
|---|---|---|---|
| Description of the Element | <p><u>Wooden Barrier and Swing Doors</u></p> <ul style="list-style-type: none"> <li>The half-height wooden barrier and swing doors separating the public area.</li> </ul> | | |
| Notes/ Justifications | <p>Key elements of the building's judicial history, all surviving features and finishes should be retained and preserved to maintain historical integrity.</p> | | |

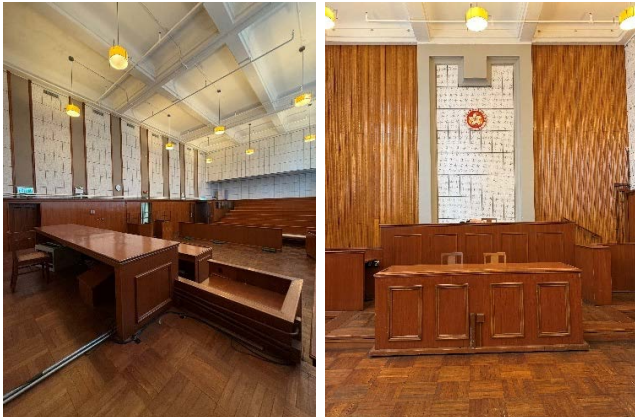
| Description of the Element | <u>Magistrate's Bench</u> <ul style="list-style-type: none"> <li>Magistrate's bench on high wooden raised platform.</li> </ul> | | |
| Notes/ Justifications | Key elements of the building's judicial history, all surviving features and finishes should be retained and preserved to maintain historical integrity. | | |

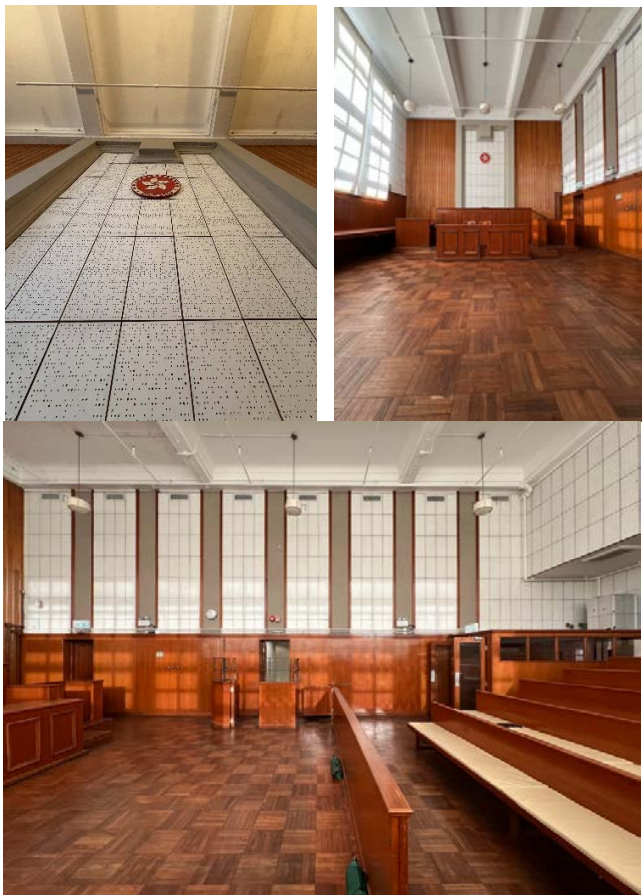
| Item no. | C21 | Level of Significance | High |
|---|---|---|---|
| Description of the Element | <p><u>Wall Features</u></p> <ul style="list-style-type: none"> <li>Wall finishes including the full height wooden wall panelling at back and both sides, and the moulded frame, the acoustic panels and the Bauhinia plaque at the centre.</li> </ul> | | |
| Notes/ Justifications | Key elements of the building's judicial history, all surviving features and finishes should be retained and preserved to maintain historical integrity. | | |

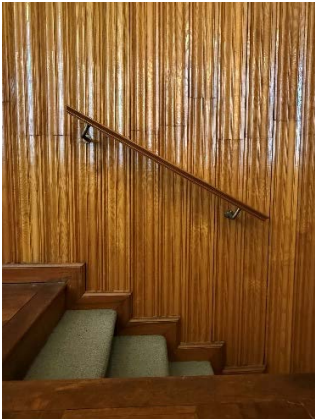
| Description of the Element | <p><u>Timber Steps and Handrail</u></p> <ul style="list-style-type: none"> <li>The wooden steps to the high wooden raised platform and the wooden handrail.</li> </ul> | | |
| Notes/ Justifications | Key elements of the building's judicial history, all surviving features and finishes should be retained and preserved to maintain historical integrity. | | |

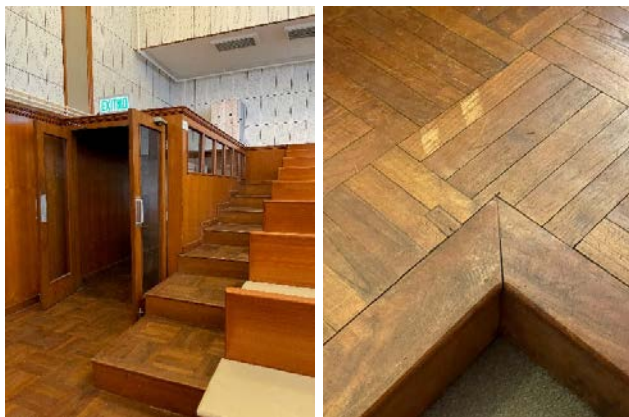
| Description of the Element | <u>Teakwood Flooring</u> <ul style="list-style-type: none"> <li>Timber parquet flooring of the conserved Court No. 1.</li> </ul> | | |
| Notes/ Justifications | Key elements of the building's judicial history, all surviving features and finishes should be retained and preserved to maintain historical integrity. | | |

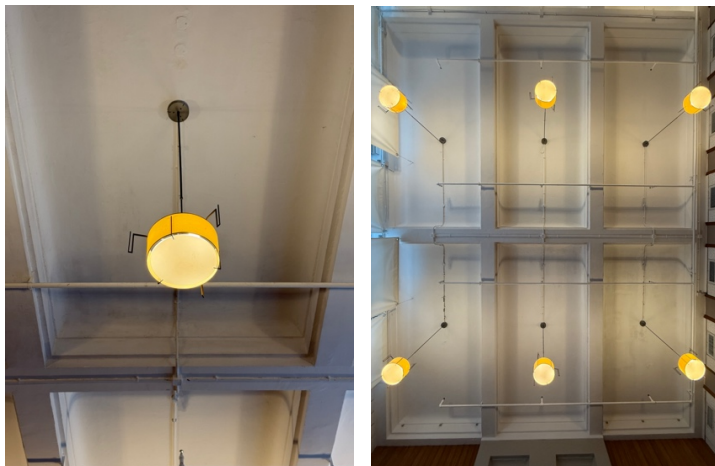
| Description of the Element | <u>Existing Lighting Fixtures at Court No.1</u> <ul style="list-style-type: none"> <li>The existing pendant lights at Court No. 1.</li> </ul> | | |
| Notes/ Justifications | These lighting fixtures were altered during SCAD revitalization. Reuse if feasible, or otherwise, any proposed replacement is subject to justification. | | |

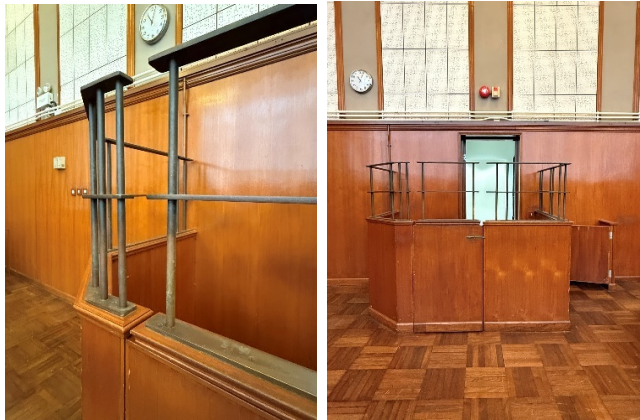
| Description of the Element | <p><u>Defendants' Dock</u></p> <ul style="list-style-type: none"> <li>Defendants' Dock and the security bars at the conserved Court No. 1.</li> </ul> | | |
| Notes/ Justifications | <p>Key elements of the building's judicial history, all surviving features and finishes should be retained and preserved to maintain historical integrity.</p> | | |

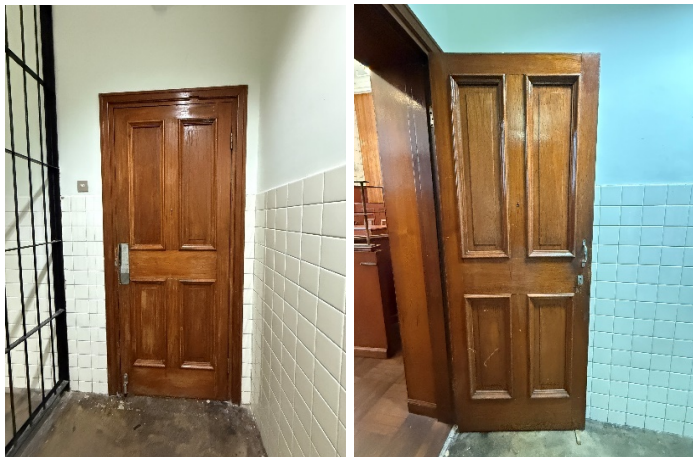
| Item no. | C29 | Level of Significance | High |

| Description of the Element | <p><u>Door of the judge entrance in Court No.1</u></p> <ul style="list-style-type: none"> <li>Wooden panelled door and frame for magistrates to the the court No. 1.</li> </ul> | | |
| Notes/ Justifications | <p>Key elements of the building's judicial history, all surviving features and finishes should be retained and preserved to maintain historical integrity.</p> | | |

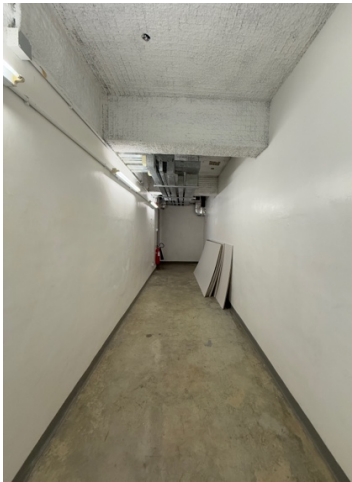
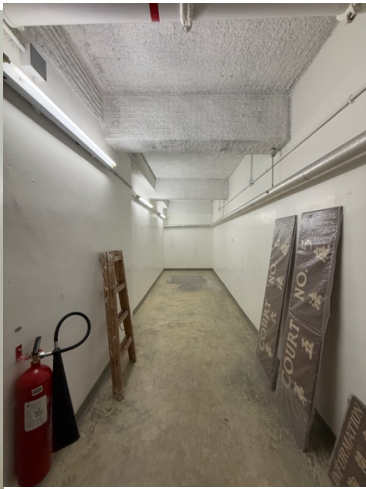
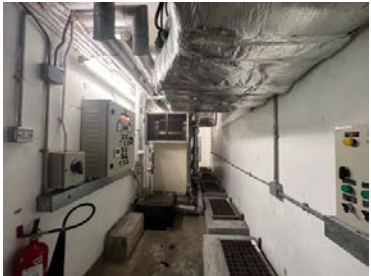
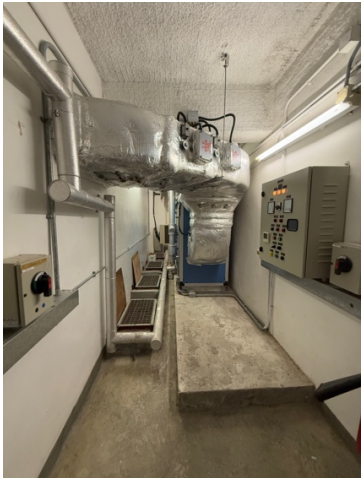
| Description of the Element | <p><u>Old Ducts Room</u></p> <ul style="list-style-type: none"> <li>The configuration with the existing ventilation duct openings on floor to the old court rooms below, the wall openings to the external wall.</li> </ul> | | |
| Photo(s) | <div style="display: flex; flex-wrap: wrap;"> <div style="width: 50%;"> <p>Old Ducts Room (Court No.4)</p> </div> <div style="width: 50%;"> <p>Old Ducts Room (Court No.3)</p> </div> <div style="width: 50%;"> <p>Old Ducts Room (Court No.1)</p> </div> <div style="width: 50%;"> <p>Old Ducts Room (Court No.2)</p> </div> </div> | | |

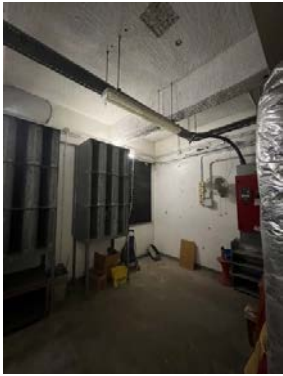
| Item no. | C33 | Level of Significance | Neutral |
|---|---|---|---|
| Description of the Element | <p><u>Mechanical rooms</u></p> <ul style="list-style-type: none"> <li>Plant rooms including pump room, plant rooms, transformer room, FS system and switch room.</li> </ul> | | |
| Notes/ Justifications | <p>These areas have been repeatedly upgraded to accommodate changing building services requirements. Removal of modern elements and change of later altered layouts are generally acceptable.</p> | | |

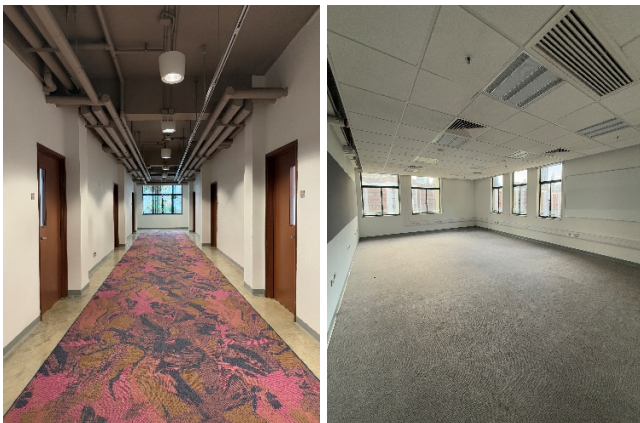
| Item no. | C34 | Level of Significance | Neutral |
|---|---|---|---|
| Description of the Element | <p><u>Classrooms partitions on 4/F and 5/F</u></p> <ul style="list-style-type: none"> <li>The spatial setting of the existing classrooms, which were former offices of other government departments, on the fourth and fifth floors.</li> </ul> | | |
| Notes/ Justifications | <p>This area has been substantially altered between various periods of construction. The new scheme of this area should have regard to the original elements (i.e., Central Lightwell and old metal guard bars).</p> <p>Further modifications including any new structural intervention should consider the existing structural design layout and should be subject to further justification.</p> | | |
| Photo(s) | <p>The photographs show the interior of the classrooms. The left photo is a long, narrow corridor with a vibrant, multi-colored patterned carpet and wooden doors on either side. The right photo is a large, empty room with a carpeted floor and large windows along one wall, providing natural light.</p> | | |

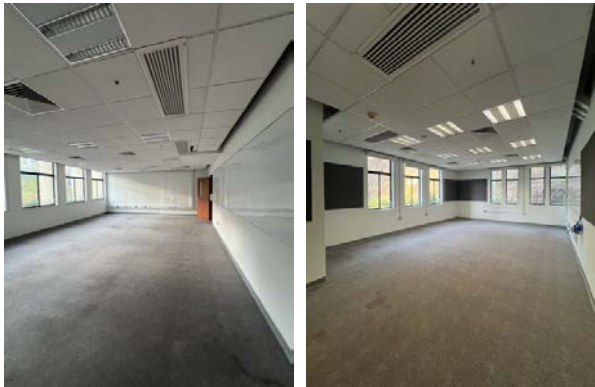
| Description of the Element | <u>Classrooms/offices partitions on 1/F</u> <ul style="list-style-type: none"> <li>The spatial setting of the existing classrooms/offices, which were former Juvenile Court, police offices and other government departments on the first floor.</li> </ul> | | |
| Notes/Justifications | <p>This area has been substantially altered between various periods of construction.</p> <p>Further modifications including any new structural intervention should consider the existing structural design layout and should be subject to further justification.</p> | | |

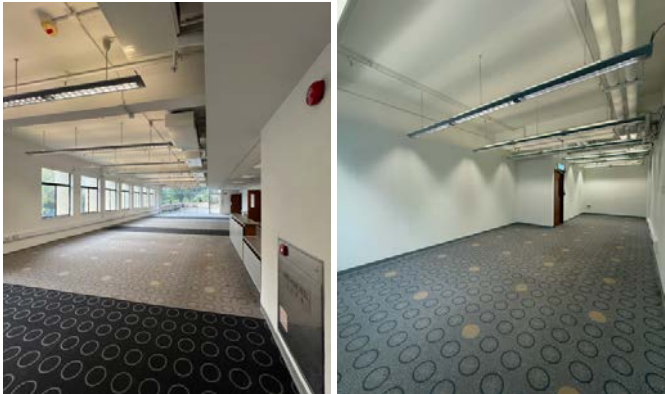
| Description of the Element | <p><u>Libraries and offices on G/F</u></p> <ul style="list-style-type: none"> <li>The spatial setting of the existing libraries, which were former Magistrate's Garage, offices, and storage vaults.</li> </ul> | | |
| Notes/Justifications | <p>This area has been substantially altered between various periods of construction.</p> <p>Further modifications including any new structural intervention should consider the existing structural design layout and should be subject to further justification.</p> | | |

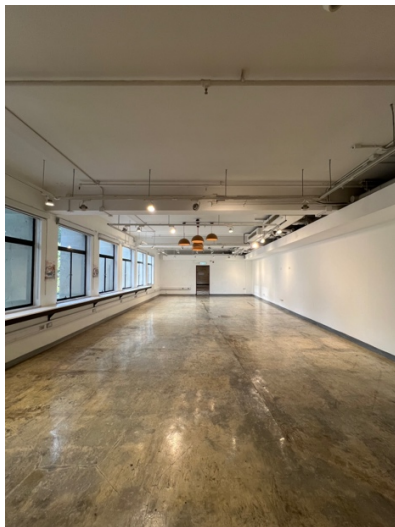
| Item no. | C37 | Level of Significance | Low |
|---|---|---|---|
| Description of the Element | <u>Student Works Exhibition Area on G/F</u> <ul style="list-style-type: none"> <li>The spatial setting of the existing student works exhibition area on G/F.</li> </ul> | | |
| Notes/ Justifications | <p>This area has been substantially altered between various periods of construction. Further modifications including any new structural intervention should consider the existing structural design layout and should be subject to further justification.</p> | | |

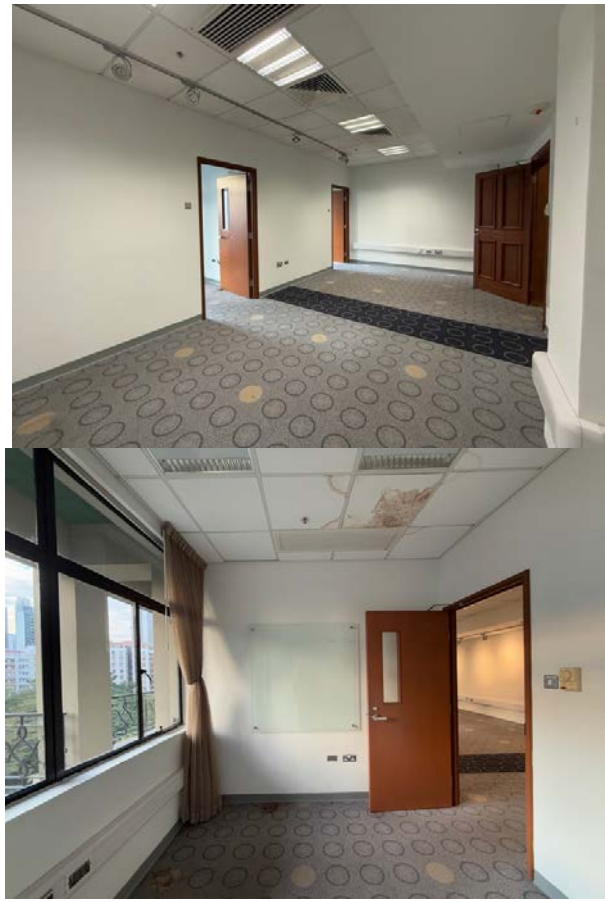
| Item no. | C38 | Level of Significance | Moderate |

| Description of the Element | <u>Magistrate's Office (3/F)</u> <ul style="list-style-type: none"> <li>General spatial setting and location of former magistrate's offices</li> </ul> | | |
| Notes/ Justifications | This area has been substantially repartitioned during last revitalisation. | | |
