## Heritage Impact Assessment

in respect of the Revitalisation of  
Former North Kowloon Magistracy into  
NK Future

Heritage Impact Assessment in respect of the Revitalisation of Former North Kowloon Magistracy  
into NK Future under Revitalising Historic Buildings through Partnership Scheme Batch VI

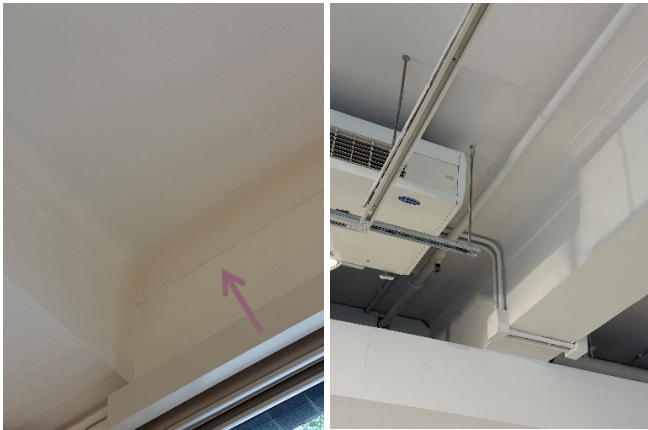
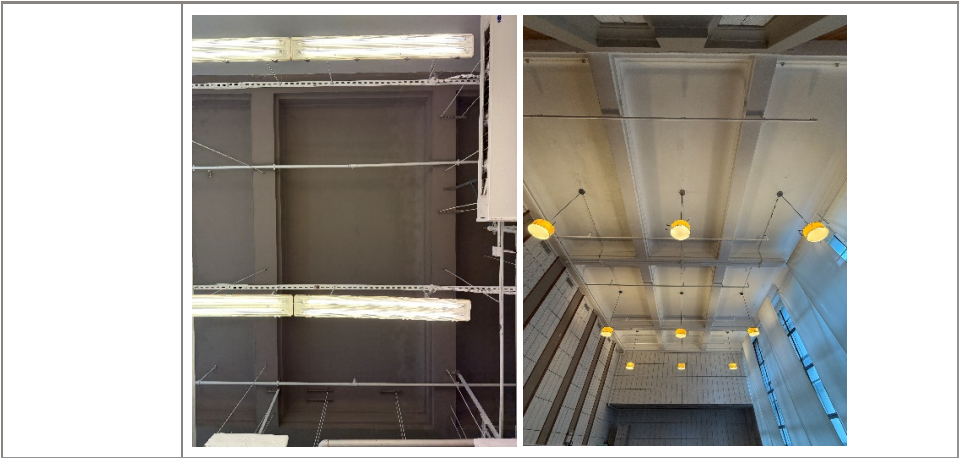
| D. General Interior Features | | | |
|---|---|---|---|
| Description of the Element | <u>Ceiling Cornice</u> <ul style="list-style-type: none"> <li>All splayed and moulded plaster cornices at ceiling.</li> </ul> | | |
| Notes/Justifications | Contribute to the overall building design. | | |

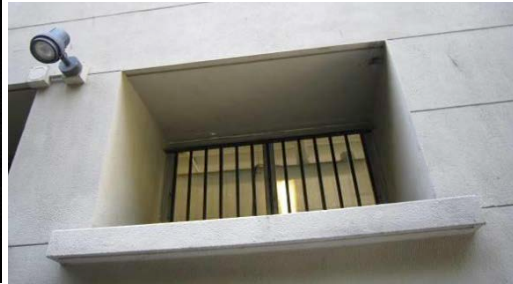
| Item no. | D2 | Level of Significance | Moderate |

| Description of the Element | <u>Old Metal Guard Bars</u> <ul style="list-style-type: none"> <li>Original metal guard bars installed throughout the building.</li> </ul> | | |
| Notes/Justifications | Contribute to the overall building design. | | |

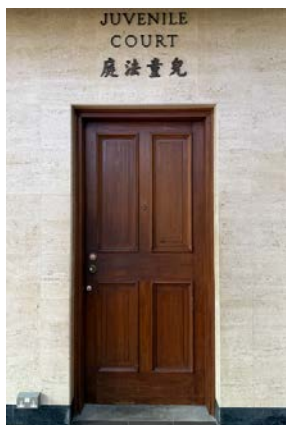
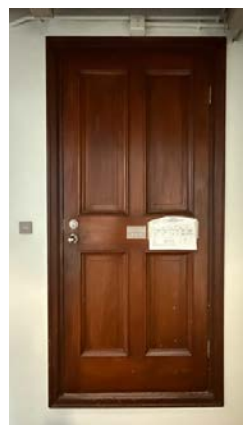
| Item no. | D3 | Level of Significance | Moderate |
|---|---|---|---|
| Description of the Element | <p><u>Old Wooden Doors</u></p> <ul style="list-style-type: none"> <li>Old wooden doors, door frames, and ironmongeries were found date from different periods, including some from the original construction (indicated by the red circle) and others that are not original or had been altered but were designed with reference to the old doors during the period 1961–2008 (indicated by the red dotted circle).</li> </ul> | | |

Original doors

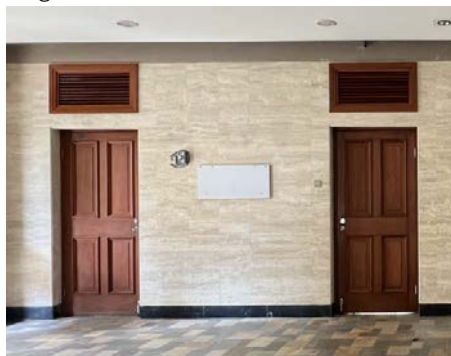
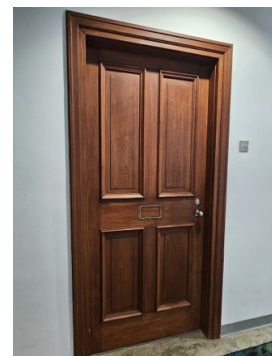
Restored doors with reference to original designs.

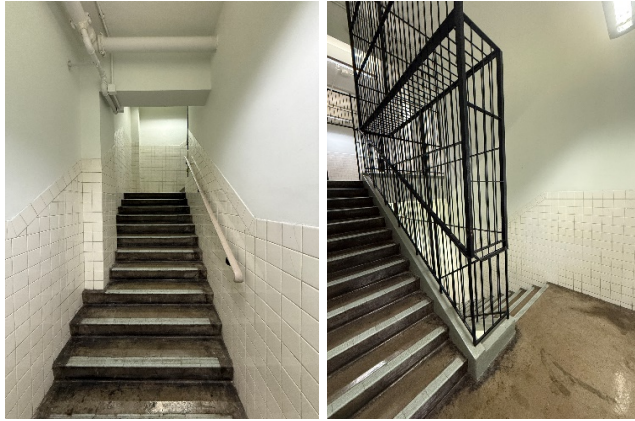
| E. Staircase | | | |
|---|---|---|---|
| Description of the Element | <u>Conserved Defendant Staircase</u> <ul style="list-style-type: none"> <li>Connects the detention cells to Court No. 1, featuring preserved metal grilles, gates, and wall finishes.</li> </ul> | | |
| Notes/Justifications | As a key component of the building's judicial history, all surviving features and finishes should be retained and incorporated into the revitalisation scheme, where feasible, and included in the interpretation strategy for the site. | | |

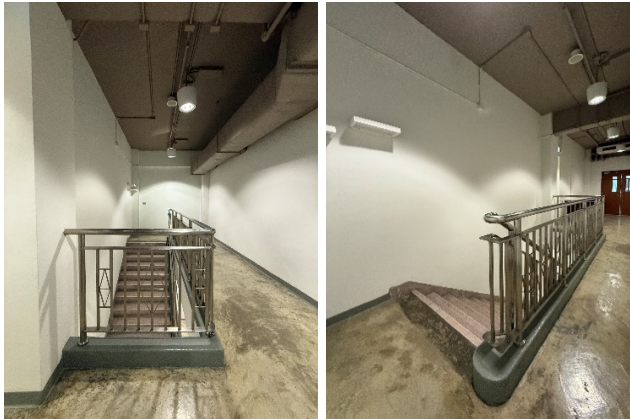
| Item no. | E2 | Level of Significance | High |
|---|---|---|---|
| Description of the Element | <p><u>Conserved Magistrates' Staircase</u></p> <ul style="list-style-type: none"> <li>Connects the old magistrate's rooms on the third floor to Court No. 1 on the second floor, featuring preserved floor finishes and skirting.</li> </ul> | | |
| Notes/Justifications | <p>The staircase configuration was altered during SCAD revitalization.</p> <p>Consider restoring the demolished portion to the ground floor, following the 1960 configuration, where feasible. All repair work should be distinguishable and reversible.</p> <p>As a key part of the building's judicial history, all surviving elements should be retained and incorporated into the revitalisation scheme, with inclusion in the interpretation strategy for the site.</p> | | |

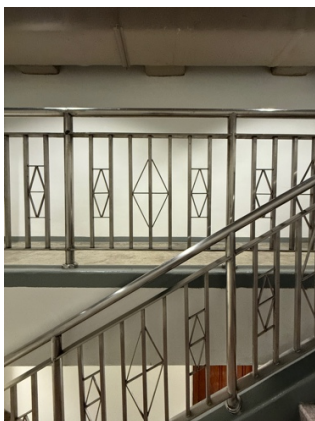
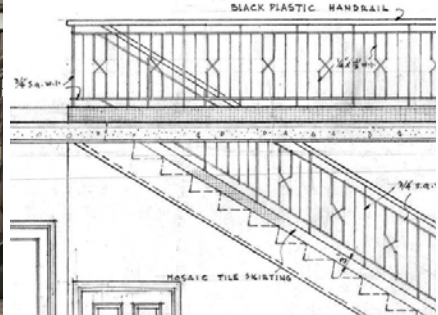
| Item no. | E2a | Level of Significance | Intrusive |
|---|---|---|---|
| Description of the Element | <p><u>The Balustrade of Conserved Magistrates' Staircase</u></p> <ul style="list-style-type: none"> <li>Stainless steel balustrades at the conserved portion of Magistrates' Staircase leading from the conserved Court No. 1 on 2/F to 3/F.</li> </ul> | | |
| Notes/ Justifications | <p>The existing stainless steel balustrades are modern alteration. Consider restoring the original patterned black plastic handrail where feasible.</p> | | |

- The partition wall (near office) of Entrance Hall on the ground floor should be removed and restoring the lobby to the original symmetrical layout.
- The existing stainless steel balustrades of the Conserved Magistrates' Staircase of Court No. 1 should be removed and restored the demolished portion to the ground floor where feasible.

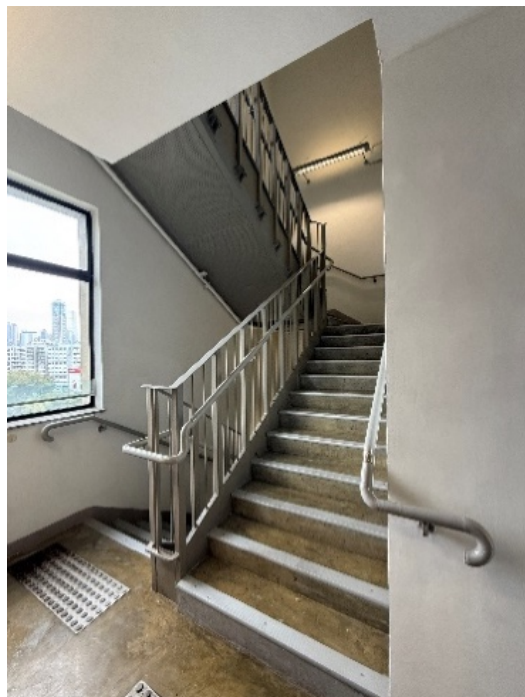
| Item no. | E3 | Level of Significance | Neutral |
|---|---|---|---|
| Description of the Element | <p><u>Staircase 1 (ST-1)</u></p> <ul style="list-style-type: none"> <li>Staircase leading from the LG/F south forecourt to the upper part of the building. The layout of the staircase has undergone several alterations since the building's original construction.</li> </ul> | | |
| Notes/Justifications | The staircase had been reconstructed as a fire escape staircase during SCAD revitalization. | | |

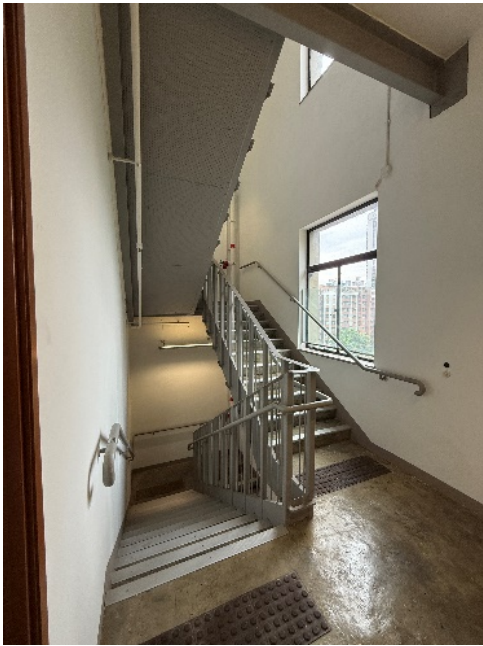
| Description of the Element | <p><u>Staircase 2 (ST-2)</u></p> <ul style="list-style-type: none"> <li>Internal staircase for circulation between the floors and providing discrete access for staff in the past.</li> </ul> | | |
| Notes/Justifications | <p>The staircase 2 (ST-2) was modified during last revitalisation taking over the spaces occupied the original lift and lift lobby. The structure of the staircase was newly constructed.</p> | | |

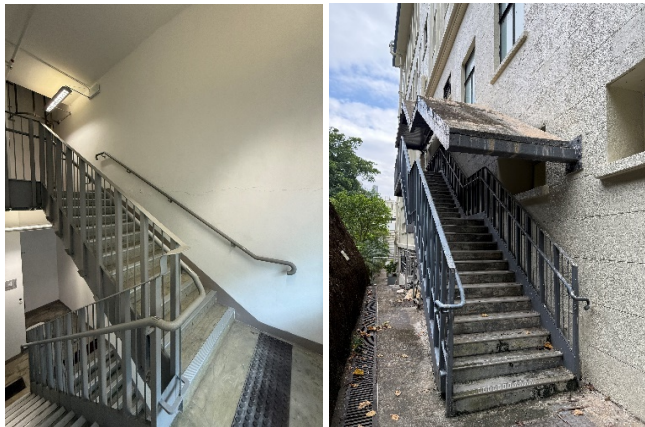
| Item no. | E5 | Level of Significance | Neutral |
|---|---|---|---|
| Description of the Element | <p><u>Staircase3 (ST-3)</u></p> <ul style="list-style-type: none"> <li>Staircase ST-3 was originally designed to provide private circulation between the rear of the building and the 1/F, offering discreet access for staff.</li> </ul> | | |
| Notes/Justifications | <p>The existing staircase, both external and internal parts, is newly constructed in modern materials and was reconstructed as a fire escape staircase during the SCAD revitalisation.</p> | | |

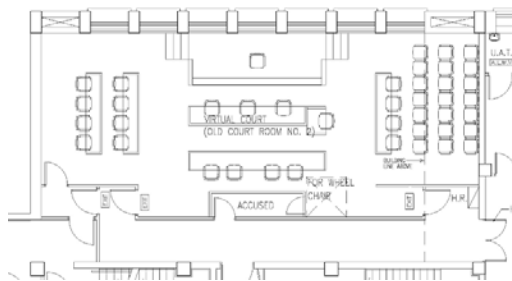
**Figure 86** Proposed layout of Court No.2.

The space of the original Court No. 2 will be reinstated based on the design of contemporary courtrooms. augmented reality/virtual reality (AR/VR) or other digital technologies will be utilised to provide judicial education and heritage interpretation materials. Additionally, part of the side wall of the corridor on 3/F will be transformed into a balcony, allowing visitors to view the courtroom from above while it is in use, thus expanding the possibilities in usage. The backdrop would be designed as operable panels, revealing the original windows behind for appreciation and interpretation.

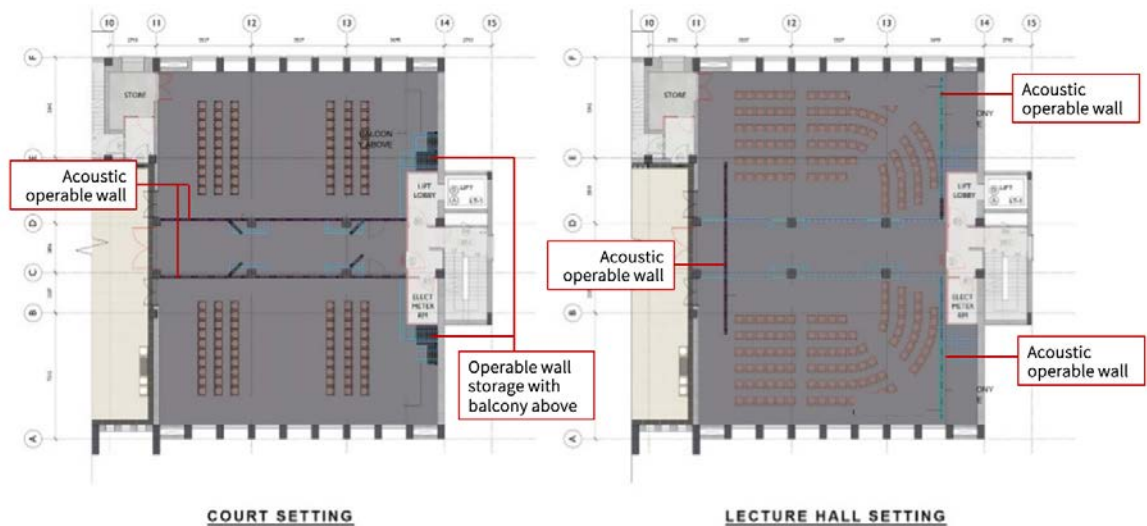
**Figure 89** 2/F Part Plan Grid 10-15.

The original Courtrooms No. 3 and No. 4 were demolished during the previous revitalization project and converted into classrooms of varying sizes. The new design aims to reinstate the original spatial divisions and the high-ceiling quality of these two courts, while preserving the original decorative mouldings on their ceilings.

The reinstated space will comprise two smaller halls separated by an acoustic operable wall, which can be opened to form a larger combined area, offering flexibility for various uses.

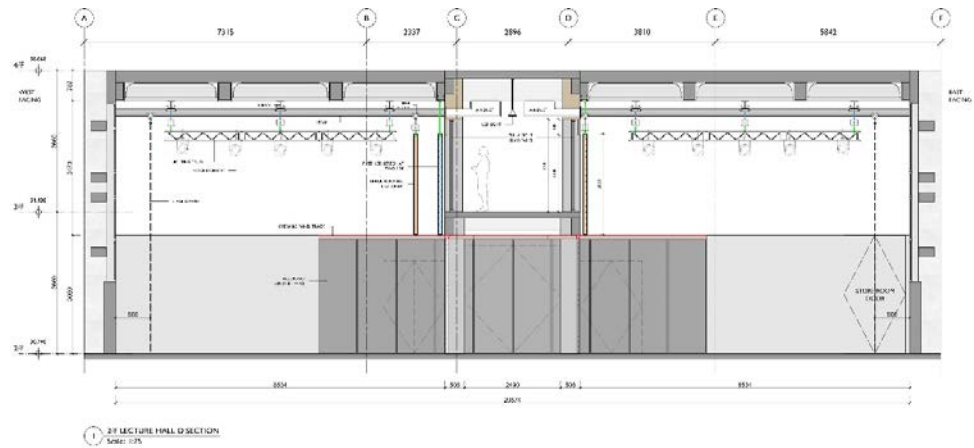
**Figure 90** Section of 2/F Lecture Hall D.

The lecture hall design will modify the walls along the 3/F corridor into metal balustrades, with a track-mounted LED screen incorporated in the central section to display multimedia content. This modification will enable the 3/F corridor to function as an observation area overlooking the Lecture Hall when the LED screen tracked away. This flexibility is further enhanced in the central section, where the metal balustrade can physically and visually interface with Lecture Hall D. By tracked away the LED screen, the design facilitates a direct, seamless connection between these two court in 3/F area, allowing Lecture Hall D to serve as a natural extension or an overflow gallery for the main event space.

Both sides of the opening will be enclosed with full-height glass panels to ensure enhanced acoustic isolation when the hall is divided into two smaller spaces. Transparent LED displays will be installed on the exterior surface of these glass walls, creating a seamless and continuous display along the entire outer wall of the corridor for greater flexibility.

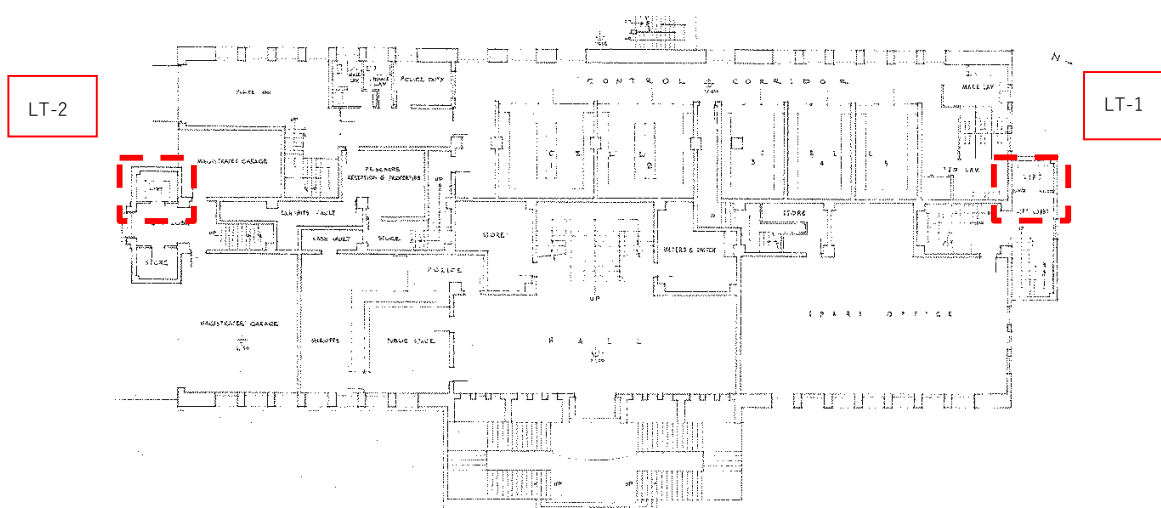
*Figure 91 Location of lifts in 1960 design.*

Currently, there is only one lift (LT-1) located at the south open forecourt for the existing building, which serves as an accessible lift and fireman's lift. Public can access the LT-1 through the ramp with 1:21 gradient at outdoor area (south open forecourt). Through reviewing the history of the North Kowloon Magistracy, it is determined that the current location of LT-1 is the same as the one in 1950s and the LT-2 had been demolished at the north side of the building.

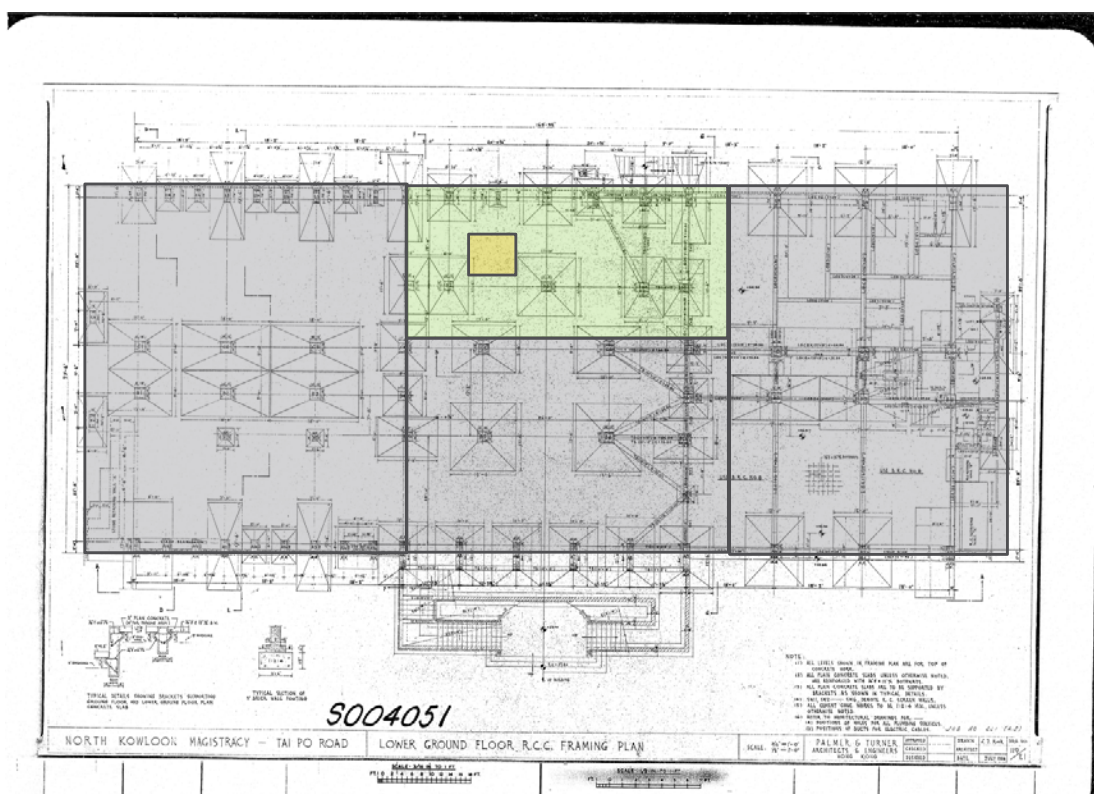
Figure 92 Location of the proposed new service lift.

The original LT-2 was located at the north side of the building for the design in 1950s. By reviewing the existing structural elements, for instance, size of lift well, lift footing and depth of lift pit, lifts with rated load between 630 and 680 kg could be adopted. However, the required staircase (ST-2) will need to be redesigned and relocated since the installation of a lift in the previous LT-2 location (refer to the Fig. 86 'LT-2') will occupy the area occupied by ST-2. If the ST-2 were to be relocated, it will require an additional vertical space within the building (from ground floor to the fifth floor) which will be an undesirable major alternation to the original fabric of the historic building, and it will inevitably affect the Character Defining Elements (CDE), especially the Court No. 1 and 2. Therefore the team concludes that the original location of LT-2 in 1950s cannot satisfy the proposed needs and contemporary statutory and requirements and conservation standards, and therefore it was deemed not feasible.

The new service lift shall provide access to every floor of the building. However, to preserve the historical elements and avoid irreversible alterations to the building, a vertical extension outside the façade—which would significantly impact the building’s elevation—was deemed unsuitable. Additionally, the North, Middle-South, and South portions of the building were excluded from consideration due to the impact to the court rooms (see hatched areas in Fig. 87).

As advised by the Structural Engineer, the existing footing must remain unaltered to avoid clashes. Given the limited feasible area (indicated by green hatching in Fig. 87), the proposed location of new service lift was selected based on structural feasibility. For further details on structural modifications, please refer to Section 6.5.2.3 (Part A).

Because the position of the new service lift is strictly dictated by these existing foundation constraints, the newly proposed lift shaft will inevitably block the existing door openings to the toilet and service spaces on the 2/F.

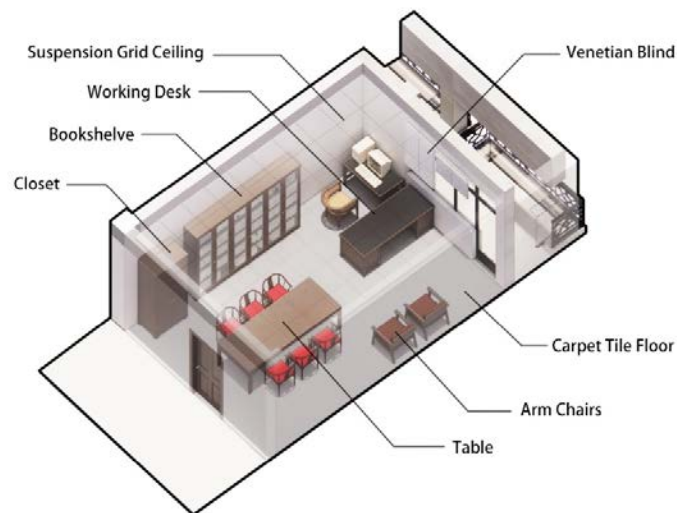
**Figure 94** Diagram of Magistrates' office according to Mr. Li's verbal description.

The design proposes reinstating a Magistrates' office on the 3/F to allow visitor tours. Although no record drawings were found, an interview was conducted with former Judge of The High Court Mr. Patrick Li Hon-leung (前高等法院法官李瀚良先生), who served at North Kowloon Magistracy from 1995 to 1996. He provided a detailed description of the office layout, serving as valuable oral history material.

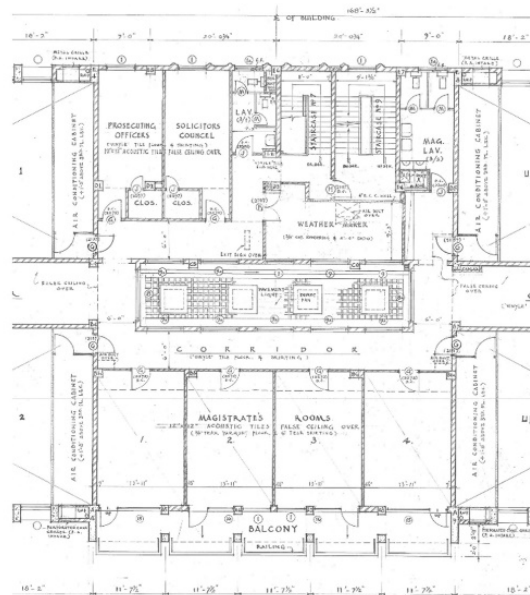
**Figure 95** 1960s 3/F Part Plan Grid 5-11.

According to the 1960s 3/F layout plan, the area originally contained four Magistrates' Offices, each with its own dedicated entrance door. The current design reinstates two entrance doors along the lightwell corridor to restore historical access arrangements. Internally, the partition walls will be reconfigured to reinstate one single Magistrates' Office, while the remaining space will be repurposed as dressing room facilities.

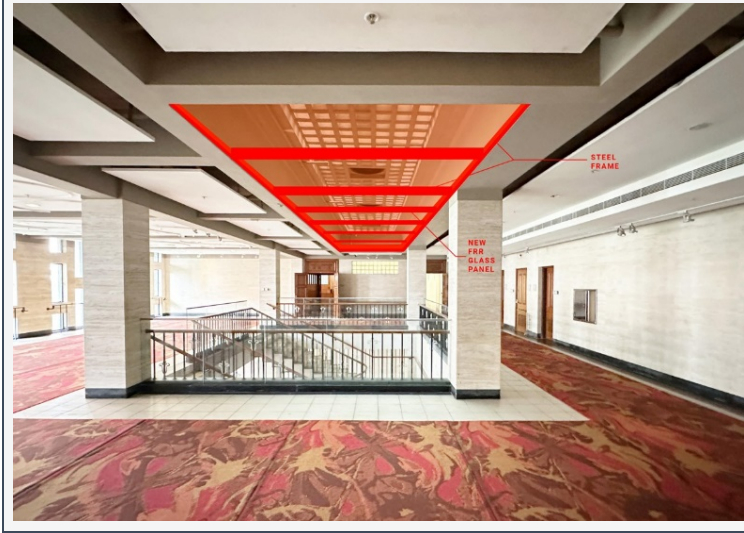
| Proposal | Description |
|---|---|
| | <p><b>Option A</b></p> <p>The ceiling on the 2/F, located beneath the Lightwell, will be enclosed with FRR glazing supported by a steel frame</p> |

Among the five options presented above, Options A, B, and C involve construction beneath the floor slab and doghouses, with fire shutter boxes installed. Upon reviewing the structural drawings, a recess was identified in the existing beam, which has been covered with bricks. Due to the uncertainty of the existing condition, open-up checks and further investigations are required.

It is noted that the floor slab with glass blocks and the doghouses on 3/F are Character Defining Elements (CDEs). Options A, B, and C would affect their appearance to a certain degree, as sub-frame works are required for FRR glazing, together with guiding tracks and shutter boxes for the fire shutter. For Option D&E, although some open-up checks and strengthening works are required, such works would not affect the CDEs and can be reversed at any time. From the viewing angle at 2/F, the appearance of the CDEs would remain the same as the current condition. However, for Option D, FRR Promatect-H boards are required to be installed inside the existing exhaust fan housing to separate the fire compartments. This arrangement will have no visual impact on the CDEs.

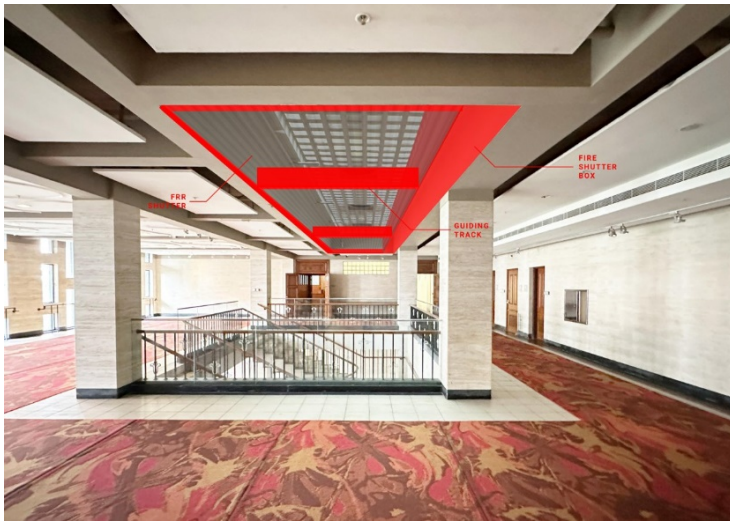
| Proposal | Description |
|---|---|
| | <p><b>Option B</b></p> <p>A fire shutter is proposed beneath the Lightwell to provide separation between the 2/F and 3/F, complete with guiding tracks and shutter boxes.</p> |

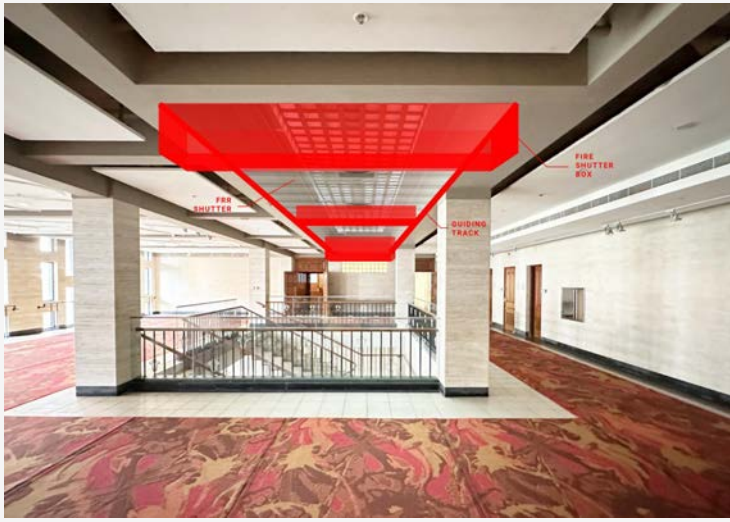
| Proposal | Description |
|---|---|
| | <p><b>Option C</b></p> <p>The proposal is similar to Option B, but repositioned to the shorter side of the Lightwell. It incorporates a convex-downward design to preserve the visibility of the glass block.</p> |

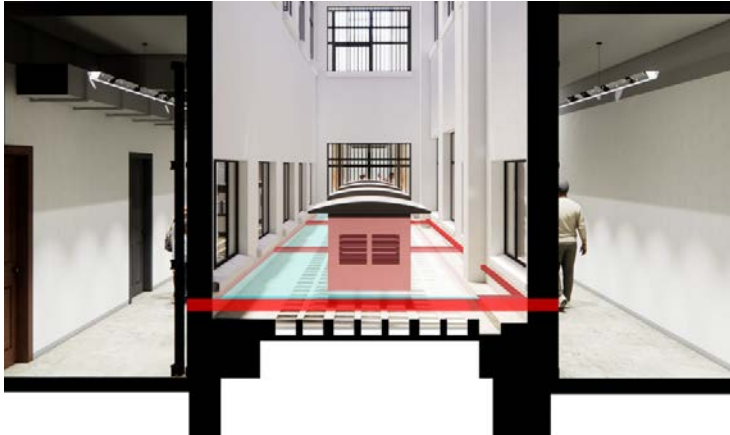
| Proposal | Description |
|---|---|
| | <p><b>Option D</b></p> <p>FRR-certified glazing will be installed above the existing glass blocks on a painted GMS sub-frame. FRR Promatect-H boards will be installed inside the exhaust fan housings to minimise visual impact.</p> |

When considering Option D&E, destructive testing, open-up checks, and structural investigations are required to verify the existing condition. As advised by the Structural Engineer, localized strengthening works are required on both sides to distribute the additional loads to the existing column and beam (refer to the Figure 99 with red hatching and green clouds). The loading imposed by the new elements will be transferred to the existing structure by additional brackets on the wall and columns adjacent to the Lightwell. The exact locations and numbers of the strengthening works is subject to the result of further testing and design.

To conclude, after careful consideration of the above design options and their associated impacts, the consultant team believe that Option D represents the most appropriate solution. This option not only provides a proper and effective method for rainwater discharge but also ensures that the Character Defining Elements (CDEs), including the floor slab with glass blocks and doghouses, remain unaffected.

Furthermore, the proposed works under Option D is structurally feasible, with localized strengthening measures that are both reversible and concealed, thereby preserving the visual integrity of the heritage fabric. In addition, the external appearance, particularly from the 2/F viewing angle, would remain consistent with the current condition, thus maintaining the architectural authenticity of the building.

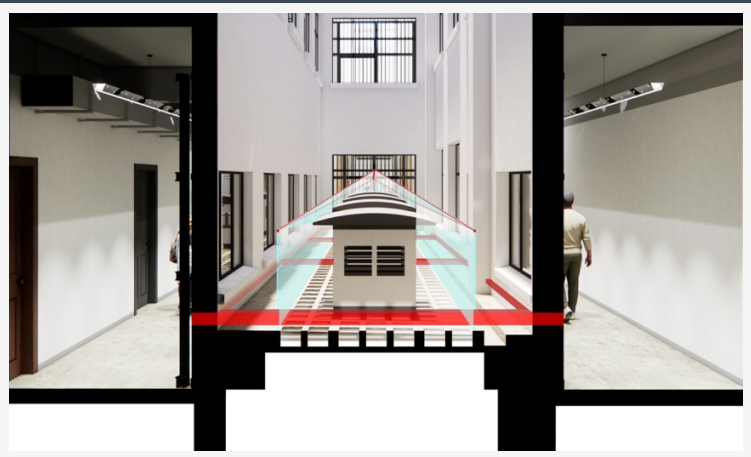
| Proposal | Description |
|---|---|
| | <p><b>Option E</b></p> <p>A new skylight with FRR-certified glazing to be constructed to cover up the existing slab with glass block and exhaust fan housings, completed with new water gutter connecting to the existing floor drains.</p> |

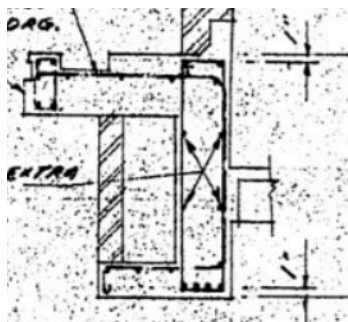
**Figure 98** Record drawing of structural detail.

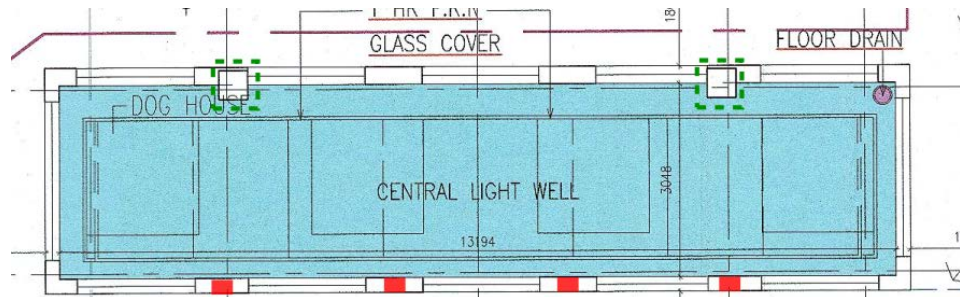
**Figure 99** Proposed strengthening works for Option D & E.

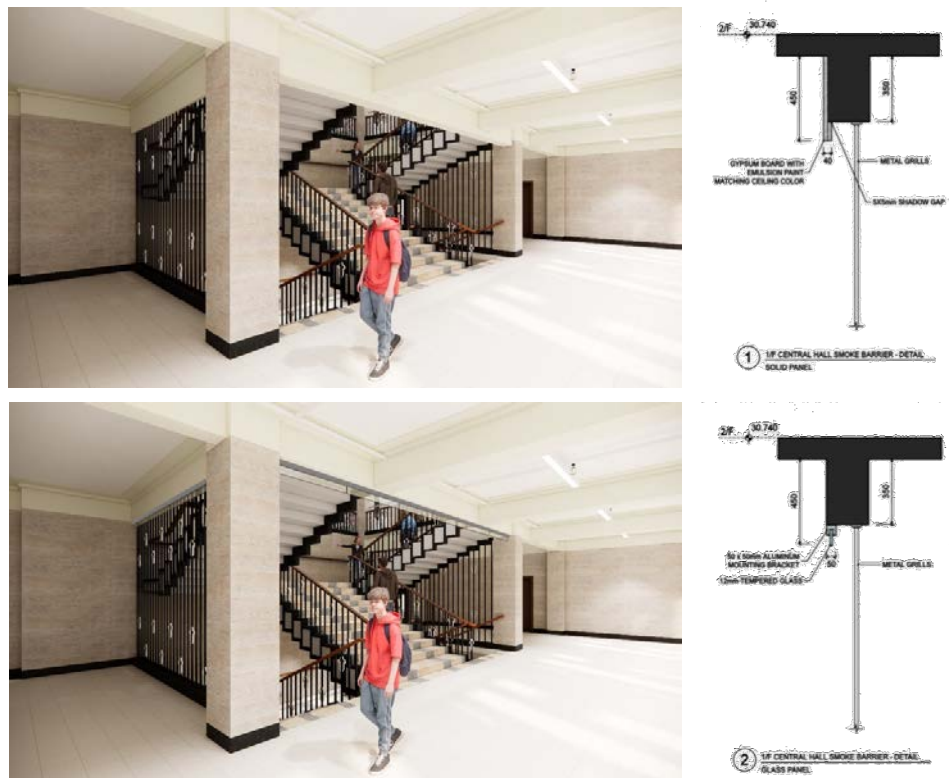
On the 1/F, smoke barriers are required for the main staircase atrium, as the surrounding beams do not meet the 450mm statutory depth requirement. To achieve compliance, a furring matching the finish and colour of the ceiling will be installed to extent the depth of the beam to 450mm. The design team had considered the option for using glass panels instead of solid furring. However, the glass panels would require a metal frame for fixing and would actually create more visual disturbance than using a solid design. The new additions shall be carried out in a reversible manner.

**Figure 100** Comparison of smoke barrier design options on 1/F of solid furring (above) and glass panels (below).

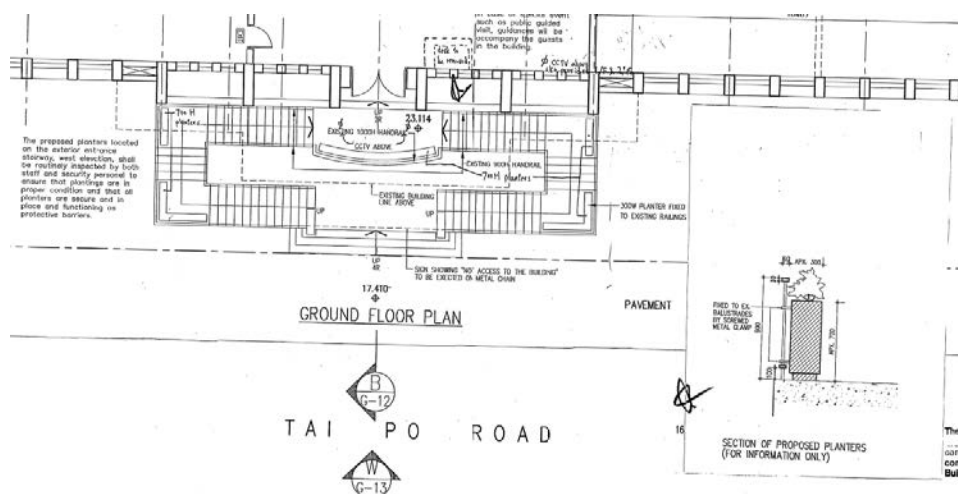
Figure 101 Previous approved GBP.

A protective barrier measuring 900mm in height was observed along the internal 'grand staircase' and the external staircase adjacent to Tai Po Road, which contravenes the Building Ordinance requirement of 1100mm. Additionally, passages for articles exceeding 100mm in their smallest dimension were noted in the existing building. According to the approved General Building Plan, drawing no. 'G-3', modifications were granted by the Buildings Department with specific conditions. The approved approach of using planters as protective barriers shall be maintained, and the planters shall be replaced with new ones of similar design that do not disturb the balustrades.

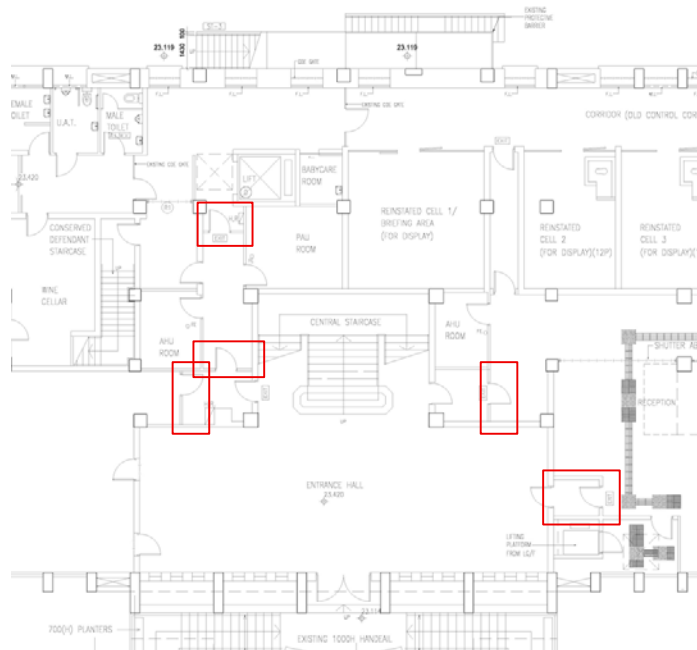
**Figure 102** Location of FRR partition and doors related to the above discussed works on G/F.

Apart from the aforementioned F.S system, fire extinguishers and heat detectors are provided inside the pump room and emergency lighting and exit signs are installed in the existing building. In order to satisfy requirements in fire compartmentations on the G/F and 1/F, alteration works such as the installation of FRR doors and partitions will be conducted. For the two doors between the future Fine Dining Restaurant and the Entrance Hall, The added first shutter will be installed offset from the restored doors, and will not impact the element. For the other areas, the fire compartmentation can be achieved through modified partitions inside the rooms. No historic doors (doors that are CDEs) will be affected by the works to satisfy the statutory requirements for fire compartmentation.

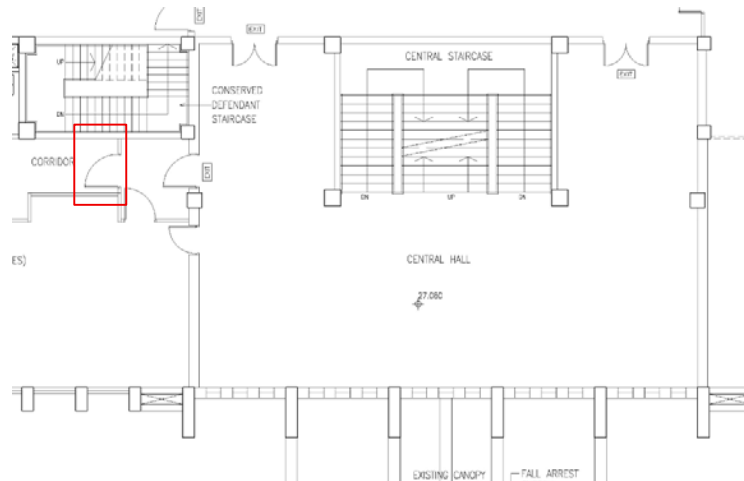
**Figure 103** Location of FRR partition and doors related to the above discussed works on 1/F.

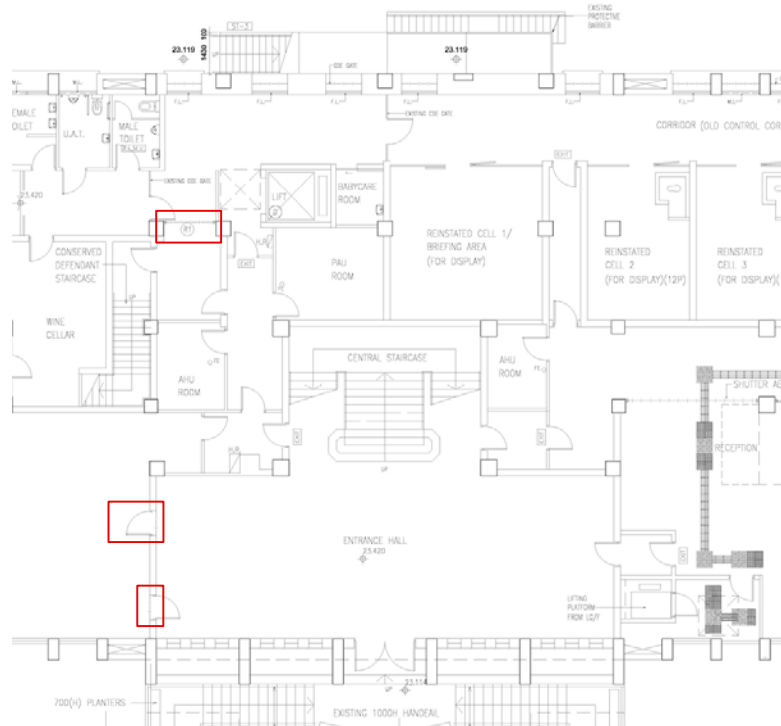
**Figure 104** Location of fire shutters on G/F.

A fire shutter in the Controlled Corridor is needed for fire compartment separation between the Conserved Defendant Staircase and the Controlled Corridor. The provisions for fireman's lift for the building will remain unchanged, ie. LT-1 will continue to serve as the fireman's lift.

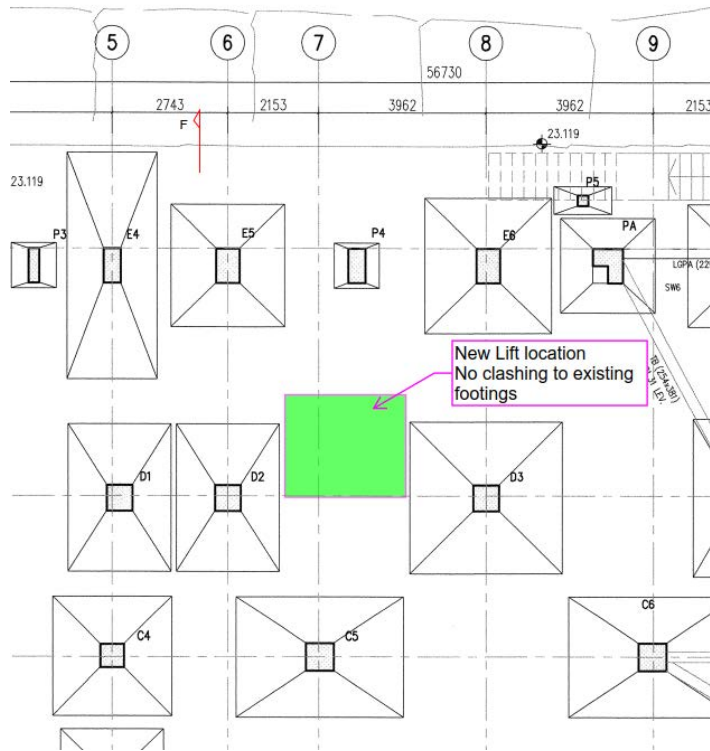
**Figure 105** LG/F  
Framing plan (partial)  
for the proposed new  
lift

Structural alteration shall be in a minimal design to avoid disturbance to the existing historic elements such as the building footings and the walls of the front façade as far as it is technically possible. The construction should be designed in such a way so that impacts to the historic elements are kept at minimum. For the lift pit construction, a certain extent of the existing on-grade slab will be temporary removed. The proposed footing will be located between the existing footings, thus there is no adverse effect to the existing footing.

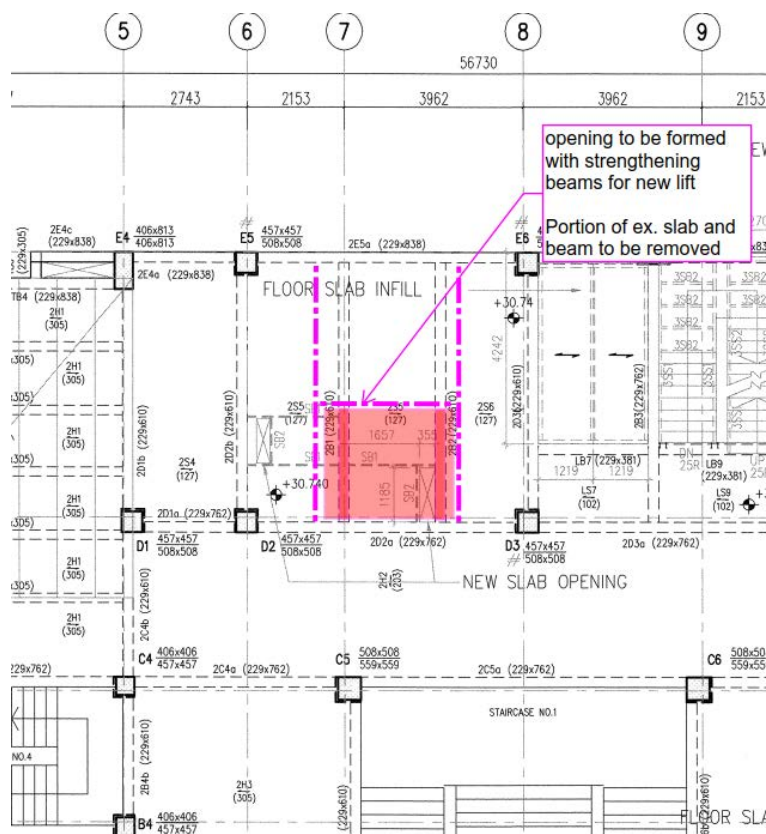
**Figure 107** 2/F Framing plan (partial) for the proposed new lift.

Red shade: Location of lift  
Red solid: existing beam to be cut and removed  
Purple line: proposed reinforcement beams

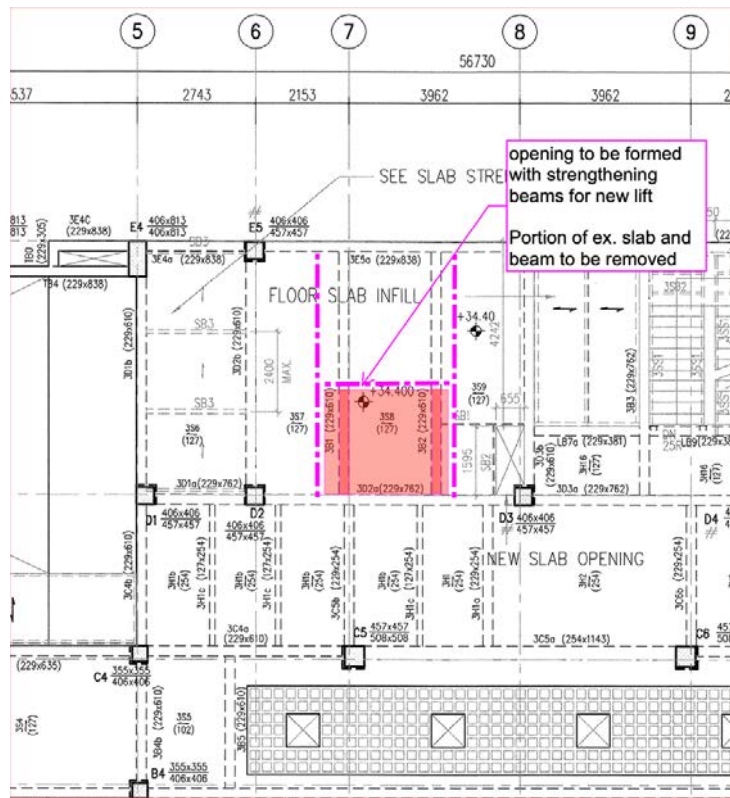
**Figure 108** 3/F Framing plan (partial) for the proposed new lift.  
Red shade: Location of lift  
Red solid: existing beam to be cut and removed  
Purple line: proposed reinforcement beams

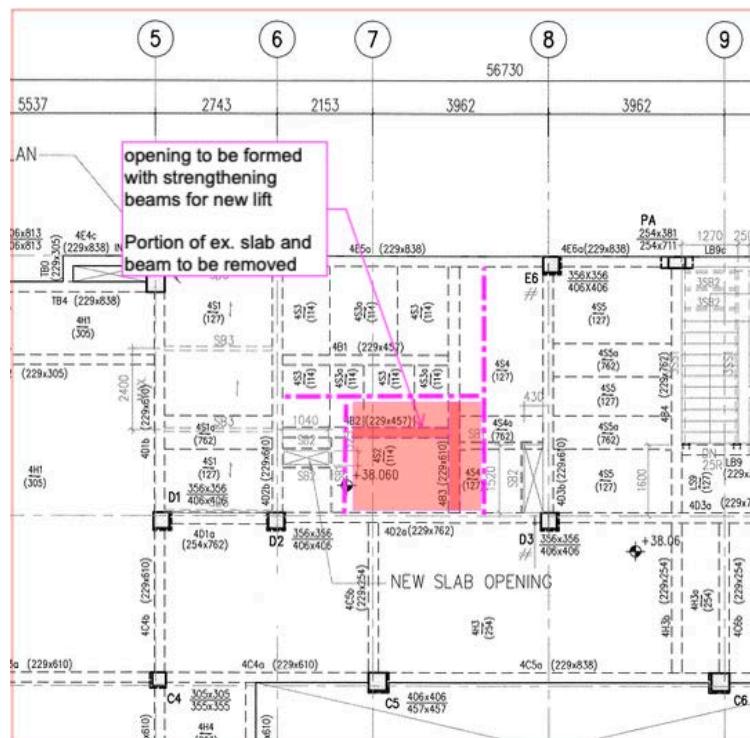
**Figure 109** 4/F Framing plan (partial) for the proposed new lift.  
Red shade: Location of lift  
Red solid: existing beam to be cut and removed  
Purple line: proposed reinforcement beams

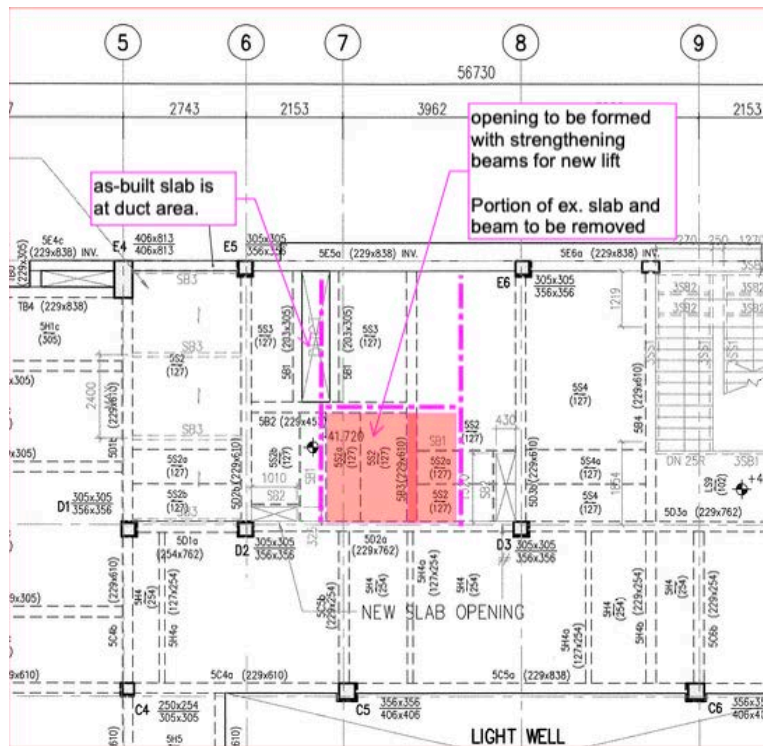
**Figure 110** 5/F Framing plan (partial) for the proposed new lift.  
 Red shade: Location of lift  
 Red solid: existing beam to be cut and removed  
 Purple line: proposed reinforcement beams

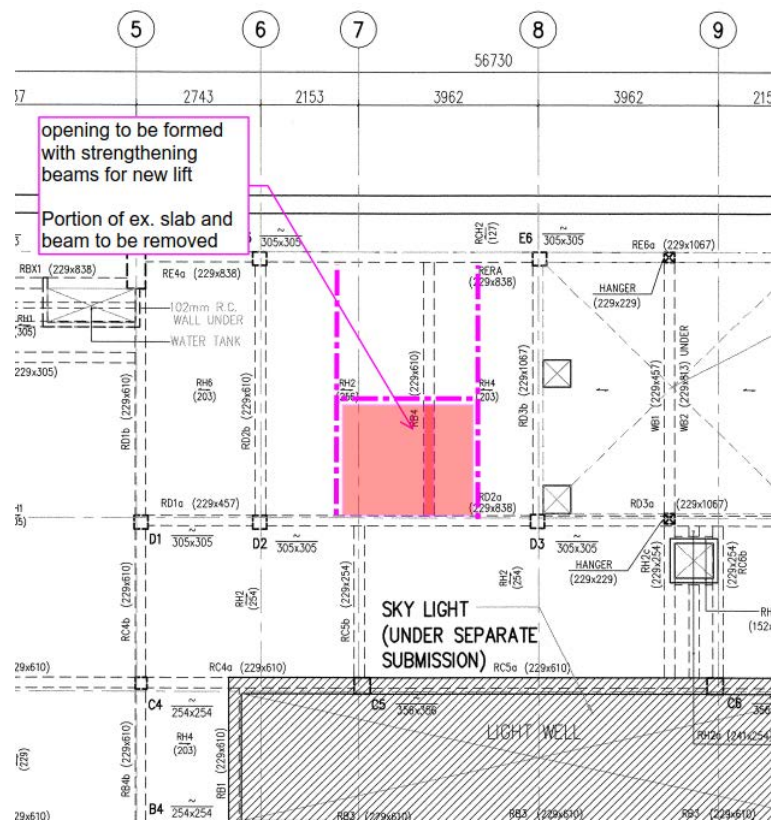
**Figure 111** Roof framing plan (partial) for the proposed new lift.  
 Red shade: Location of lift  
 Red solid: existing beam to be cut and removed  
 Purple line: proposed reinforcement beams

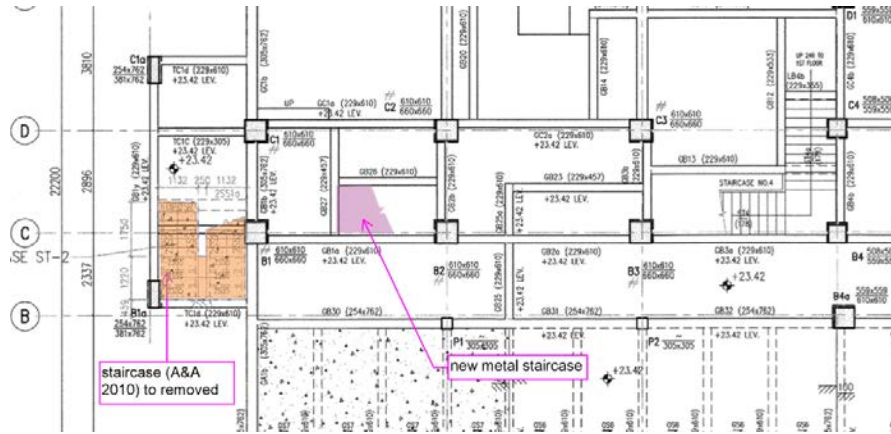
Figure 112 G/F Framing plan (partial) for the proposed alteration of staircases.

The reinstatement of the magistrates' staircase in steel is considered more reversible and less invasive than a new reinforced concrete structure. The steel staircase will follow the original form, proportions and layout of the historic stair, with refined, restrained detailing and muted finishes that minimize visual contrast with the surrounding fabric.

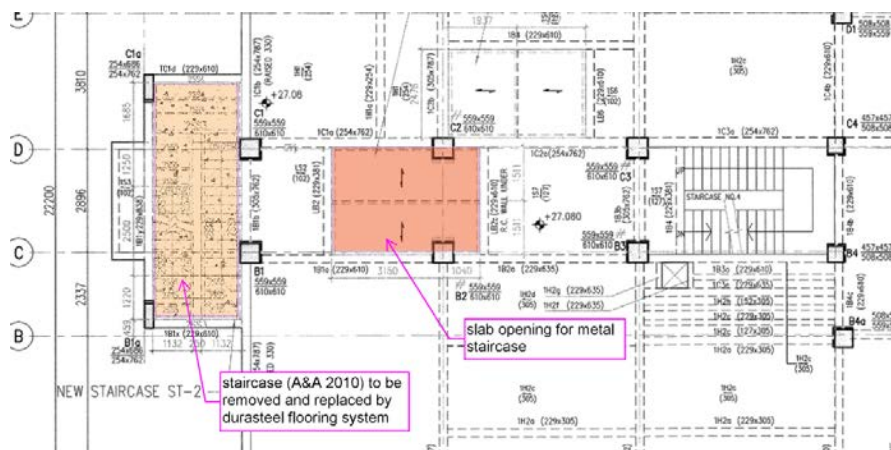
The modification of ST-2 will reinstate the original 1960 circulation of staircase and provide code-compliance means of escape (MOE). The floor slab infill and staircases under structural works (2010) will be removed or modified to suit latest layout plan. The new floors / staircase will be constructed in structural steel works with durasteel flooring/staircase system. For the Magistrate staircase at Grid 2-3 from G/F to 3/F would be also in structural steel subject to the structure stability checking found satisfactory.

Figure 113 1/F Framing plan (partial) for the proposed alteration of staircases.

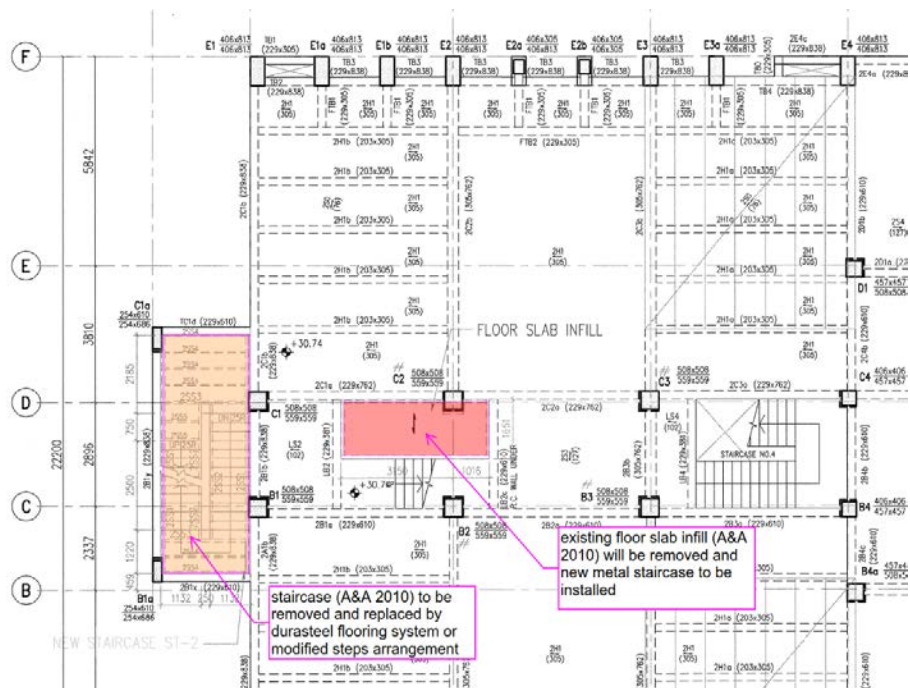
Figure 114 2/F Framing plan (partial) for the proposed alteration of staircases.

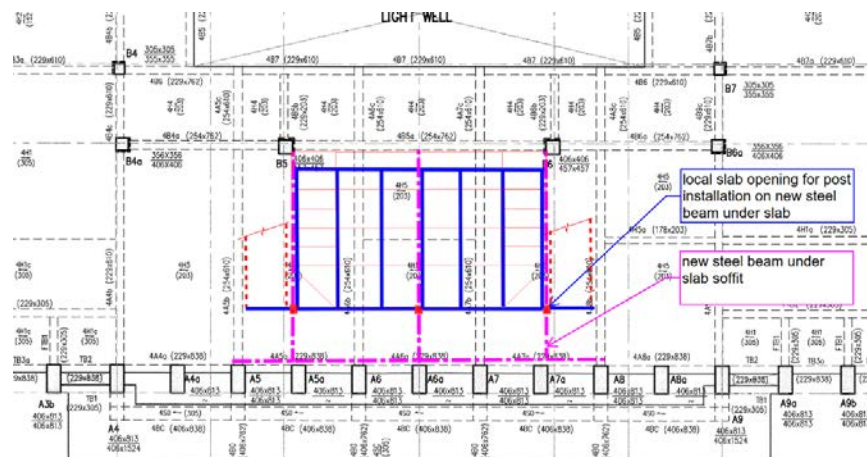
For new steps platform, it will be considered with light-weight material with steel structure. It will be supported by post and supported by new steel beams installed underneath 4/F slab and then the loading transferred to existing main beams or columns. In the current design, the structure supporting the steps will overlap slightly at the corners of windows on 3/F. The design team is currently working on a modified design that will minimise the overlapping. The new supporting beams shall also set back from the windows so as to minimize visual disturbance to the outlook of the building. As far as it is technically feasible, the beam shall be designed as compact as possible, and shall be hidden by false ceilings to minimize visual disturbance to the interior spaces, especially the reinstated Magistrate's Office.

Figure 115 4/F Framing plan (partial) for the proposed removal of slabs. Purple lines: new reinforcement beams for slab opening; blue lines: location of structural beams for new staircase
