## Heritage Impact Assessment

in respect of the Revitalisation of  
Former North Kowloon Magistracy into  
NK Future

Heritage Impact Assessment in respect of the Revitalisation of Former North Kowloon Magistracy  
into NK Future under Revitalising Historic Buildings through Partnership Scheme Batch VI

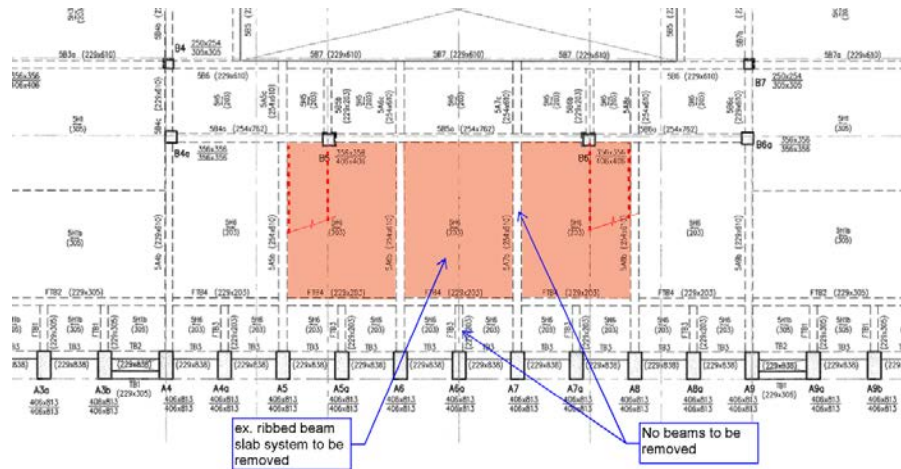
Figure 116 5/F Framing plan (partial) for the proposed removal of slabs.

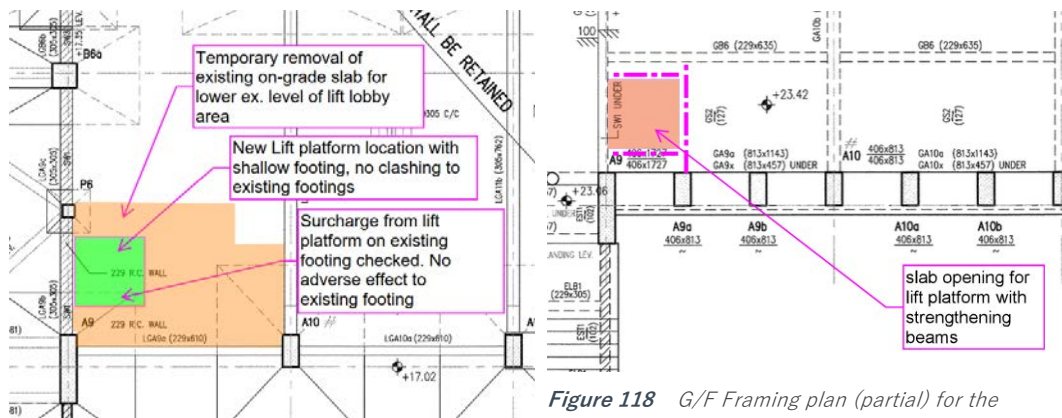
To suit latest layout plan, a new BFA lifting platform is required and to be installed from LG/F to G/F. Portion of existing slab will be removed to form the lift opening. The reminded slab will be supported by the new strengthening beams and then supported by existing beams. No impact to the existing footings, walls, and front façade will be induced.

Figure 117 LG/F Framing plan (partial) for the proposed new BFA lifting platform.

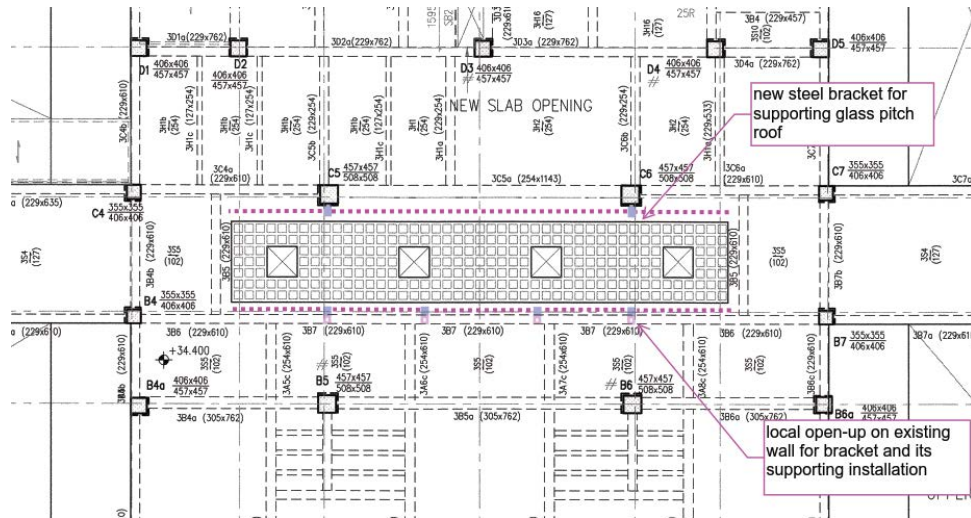
The fire-separation will be construction with fire rated glass panel and supported by new steel frame structure. The new steel frame structure will be supported by the existing columns / beams. No structures will be attached on the existing light wall slab & exhaust fan housings. The shape of new steel frame will be further confirmed.

**Figure 119** 3/F Framing plan (partial) for the proposed new fire rated glass panel. Purple dotted line: Hollow section along the main frame of the fire-separation.

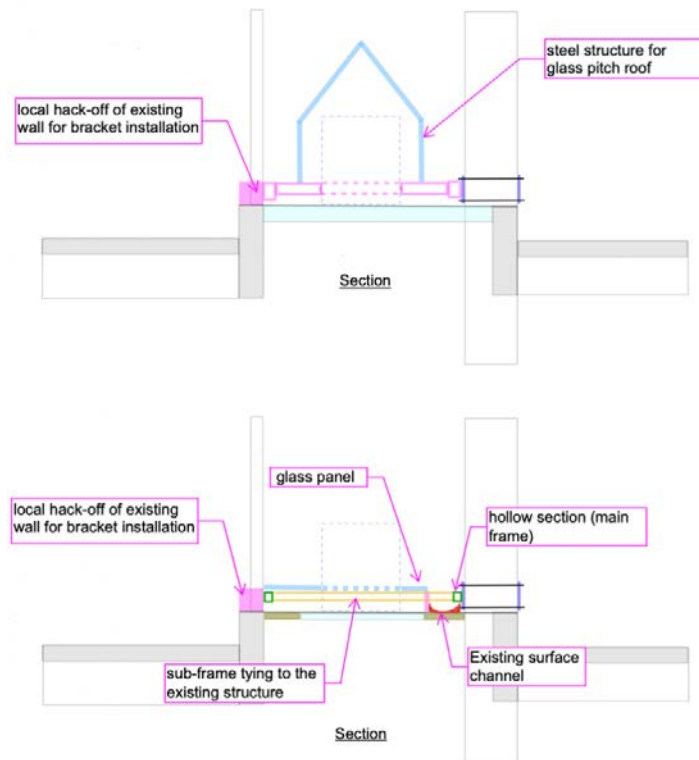
**Figure 120** Sectional diagrams for the proposed new fire rated glass panel. (Above: Option E; Below: Option D)

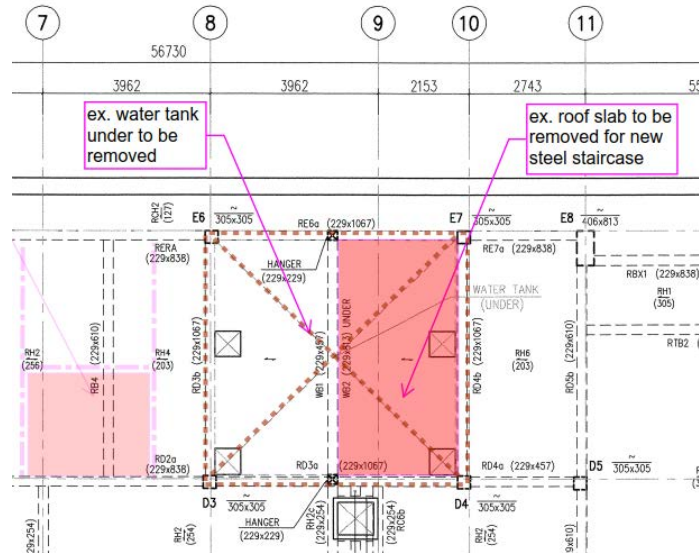
The ST-03 is extended to the roof floor for maintenance purpose and as a statutory requirement. For the new extension from 5/F to Roof, it will involve removal of existing water tank structure hanged at Roof soffit, removal of existing roof slab. The new staircase will be formed with steel structure member or light-weight construction material. The new staircase and its cover will be supported by the existing beams.

**Figure 121** Roof framing plan (partial) for the proposed extension of staircase. Brown dotted lines: location of existing water tank Red shade: location of existing roof slab to be removed

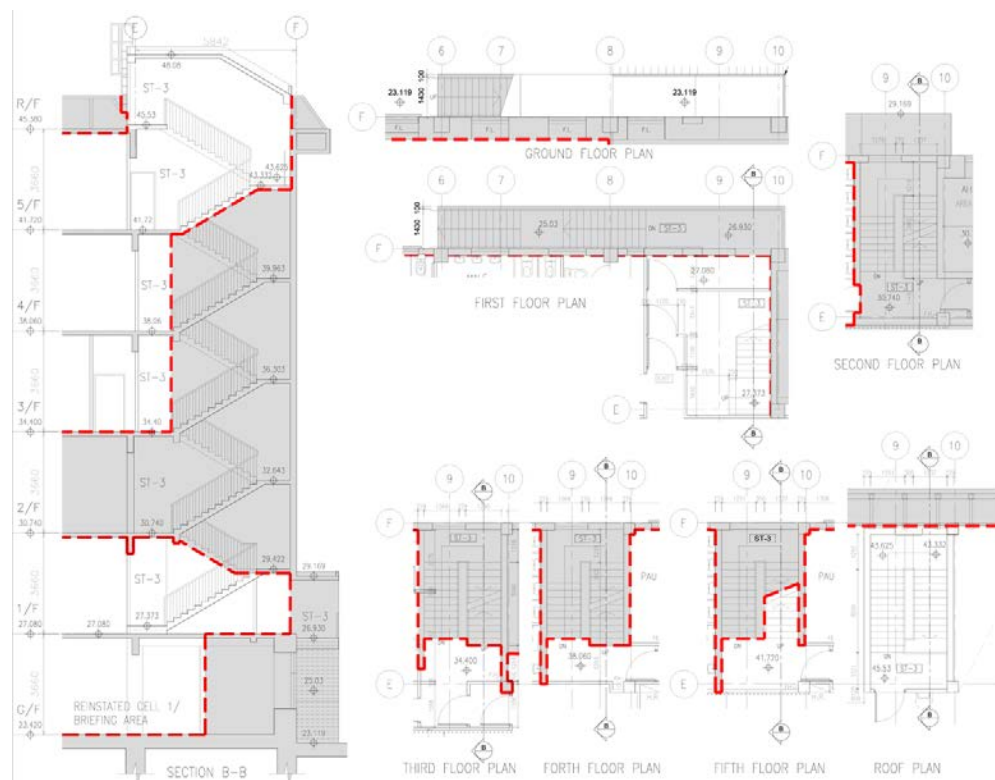
**Figure 122** Proposed design of staircase ST-3.

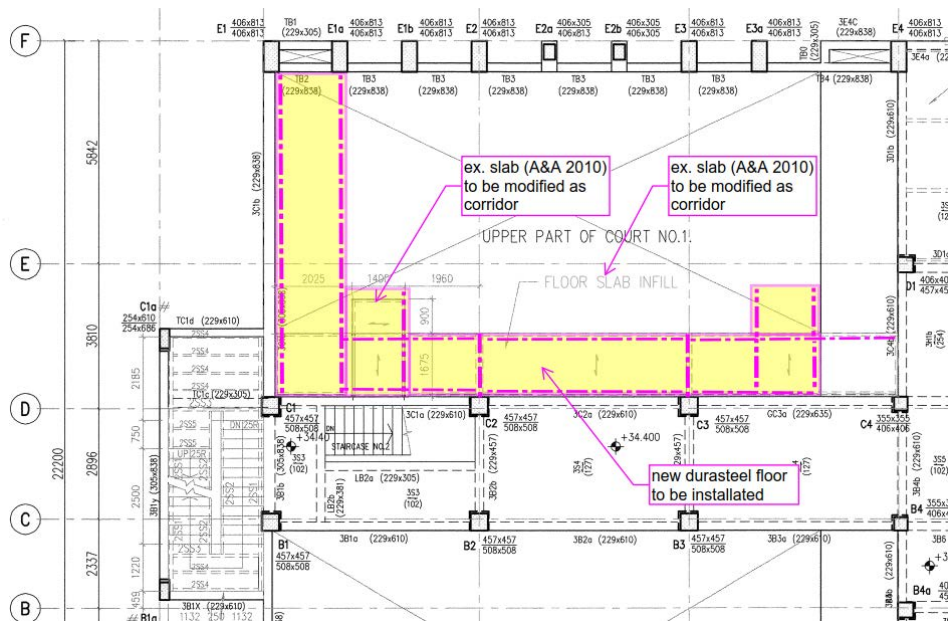
Figure 123 3/F Framing plan (partial) for the proposed new corridor.

The new corridor at 3/F will involve the removal of existing floor slab infill and new steel beams structures with durasteel flooring system. The new beams will be supported by the existing main beam / columns then down to foundation.

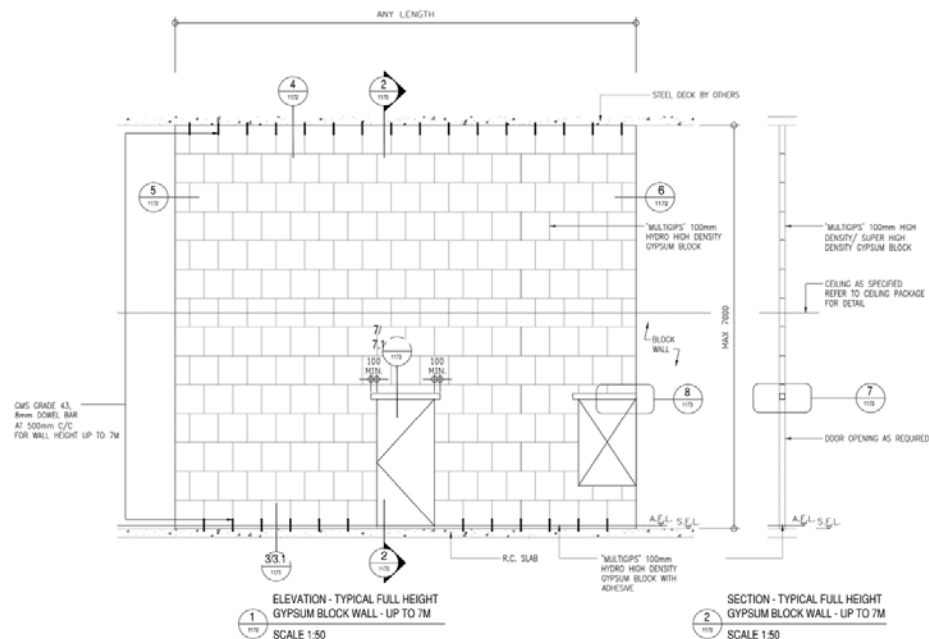
The partition should be the light weight gypsum block wall will be applied for the newly added structure to minimize the additional loading.

Figure 124 Proposed installation details of the re-partitioning works.

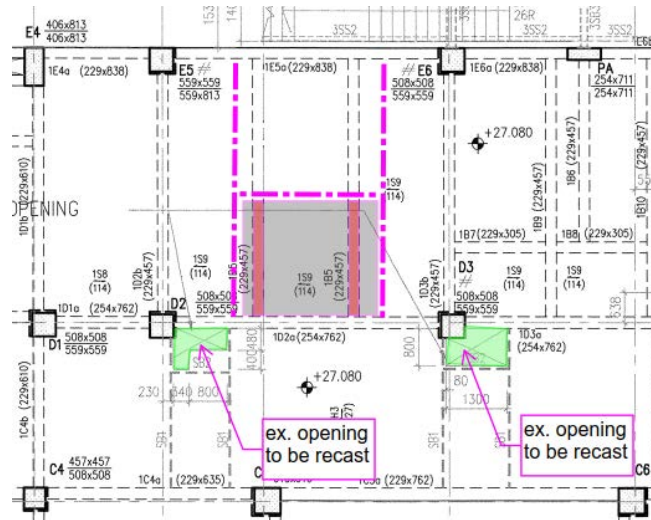
The existing pipe duct openings will be recast to suit latest layout. Some existing steel beam clashed with new steel beam installation for new lift construction; The existing steel beams will be cut and connected to new steel beams. After conducting detailed structural and technical assessments, reinforcement steel beams for previous openings will be reinstated if it is structurally and technically feasible.

*Figure 125 1/F Framing plan (partial) for the proposed works*

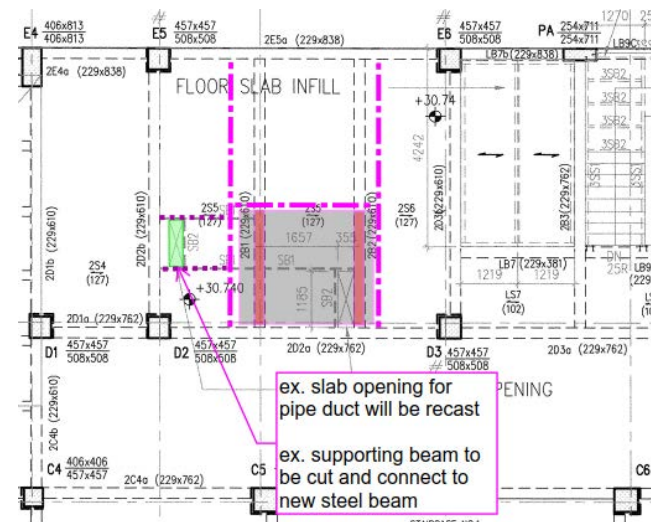
*Figure 126 2/F Framing plan (partial) for the proposed works*

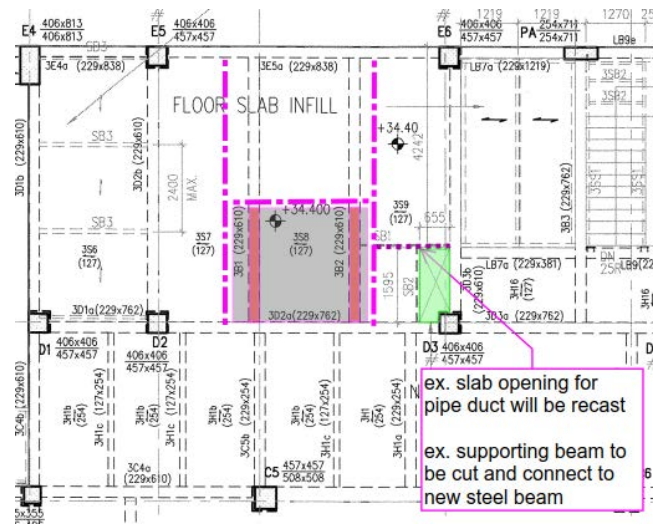
Figure 127 3/F Framing plan (partial) for the proposed works

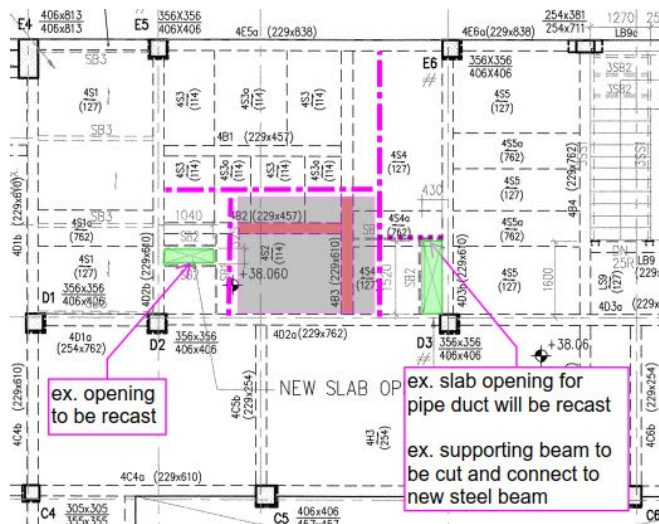
Figure 128 4/F Framing plan (partial) for the proposed works

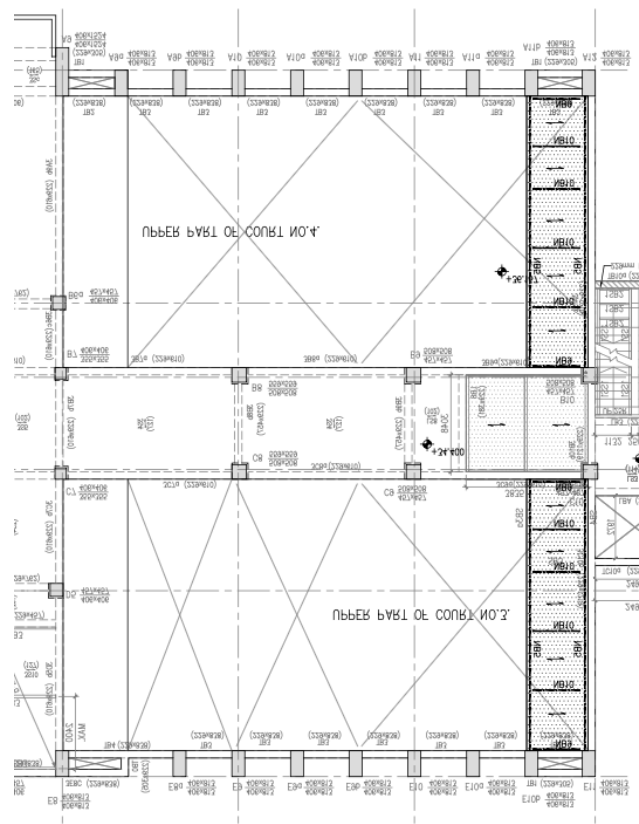
New structural steel beam and Durasteel floor slab will be needed for construction of the new Control Rooms for Lecture Hall D (Court No.3 and No.4). The new structure will be connected to existing columns and beams.

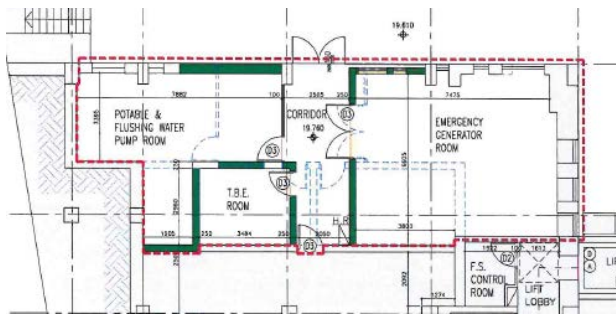
**Figure 131** Proposed E&M Layout Plan (LG/F).

Due to the upgrading of the generator set on the LG/F, the layout of E&M rooms in LG/F need to be modified. The proposed design will modify the existing later-added louvers behind the historic metal gates on the east elevation. The new design will not affect the historic metal gate. Therefore, in comparison with the current condition, the proposed design will not cause additional visual impact on façade.

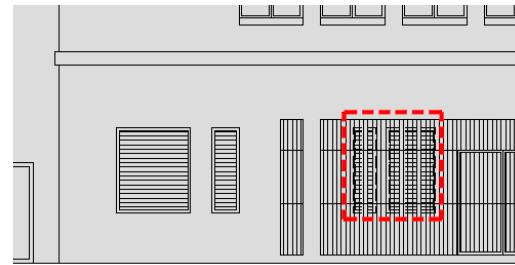
**Figure 132** Modified louvers for emergency generator

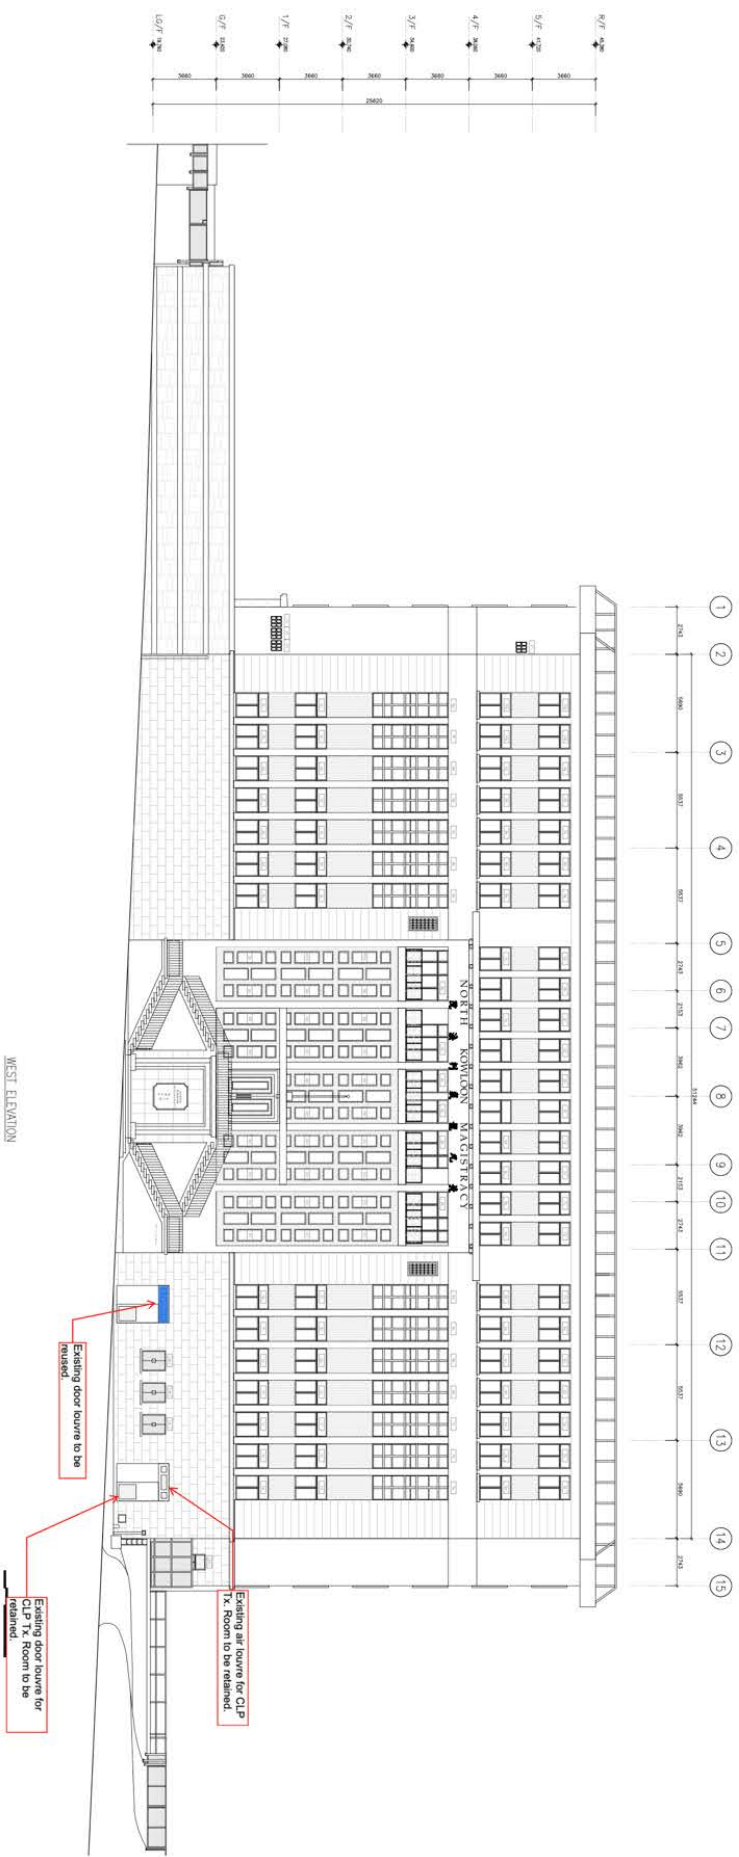
**Figure 135** Locations of new louvers (red) and existing louvers to be reused (blue) at West Elevation.

The proposed addition or replacement of E&M conduits will utilize existing openings and locations in areas that are defined as CDE as far as feasible. For reinstated cell 1 to 5, E&M provision would keep existing and remain unchanged. Existing wall openings to be

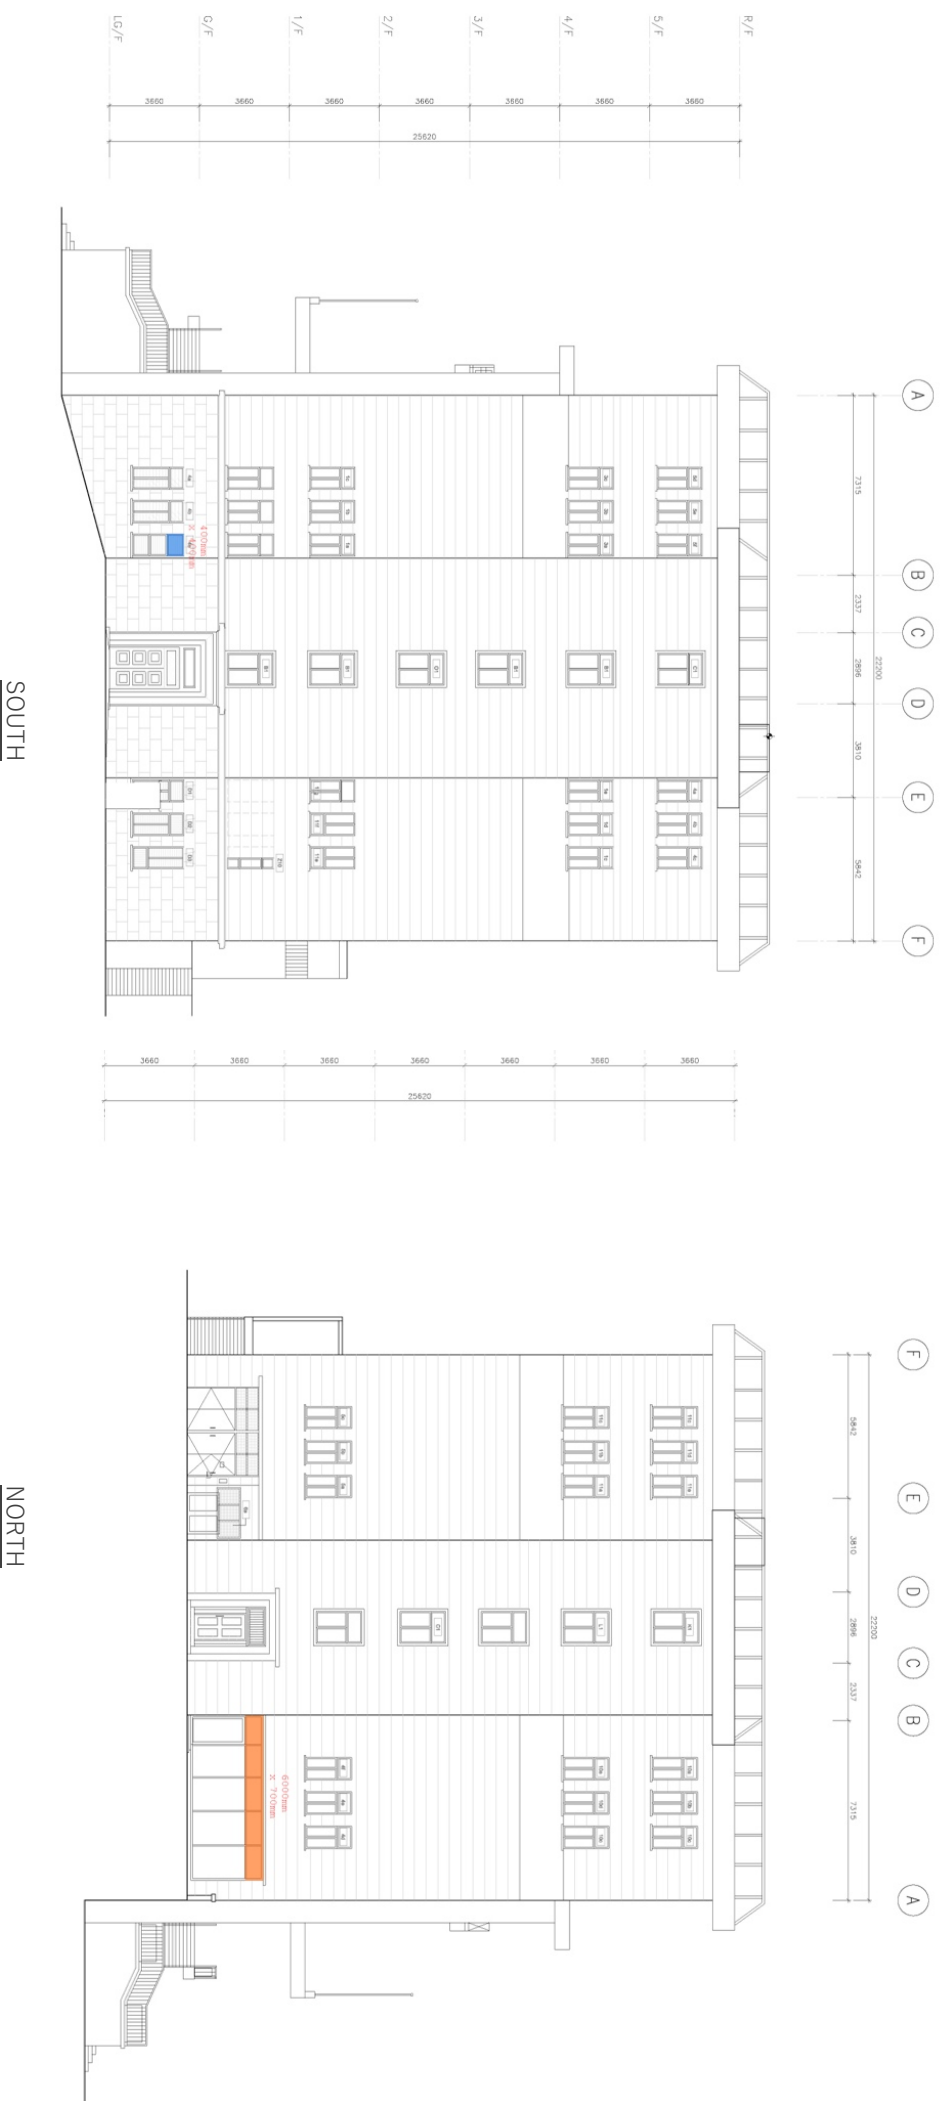
**Figure 136** Locations of new louvers (orange) and existing louvers to be reused (blue) at side elevations.

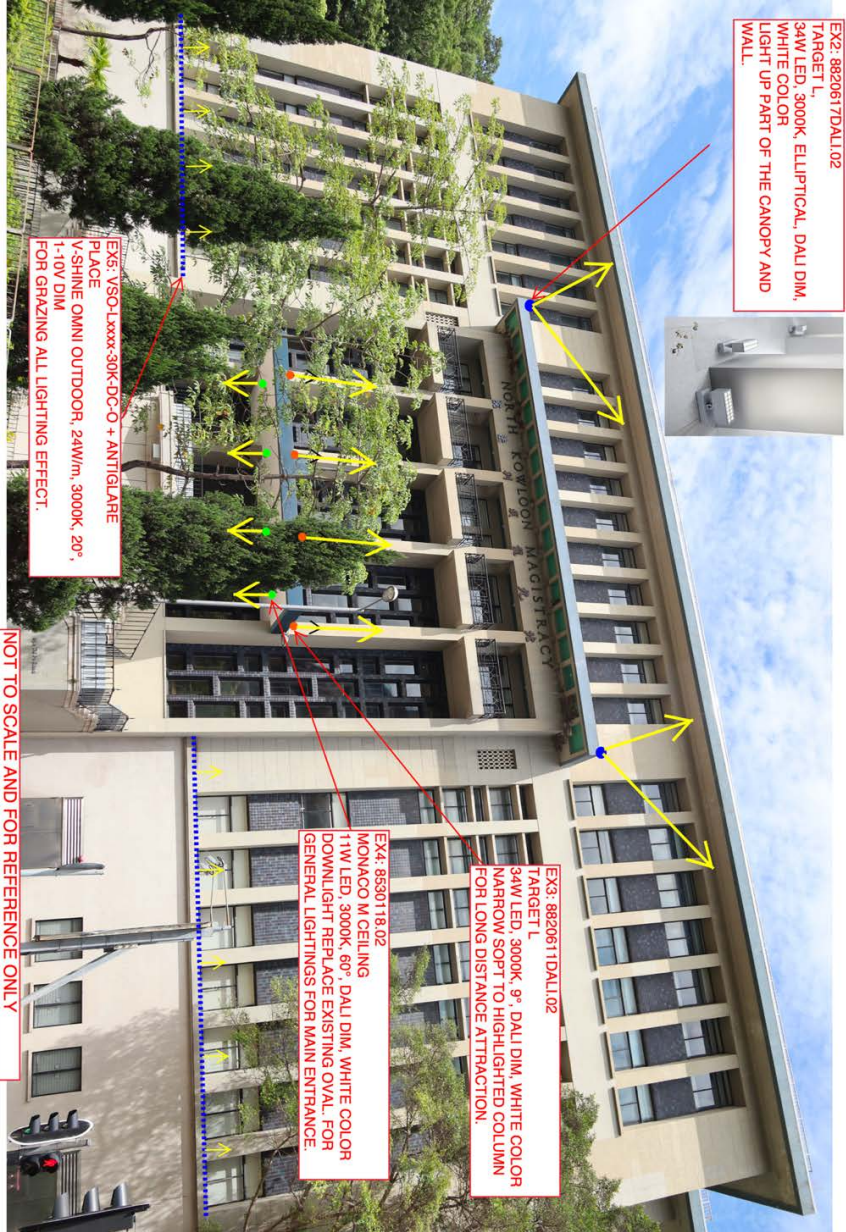
Figure 137 Proposed location of façade lighting.

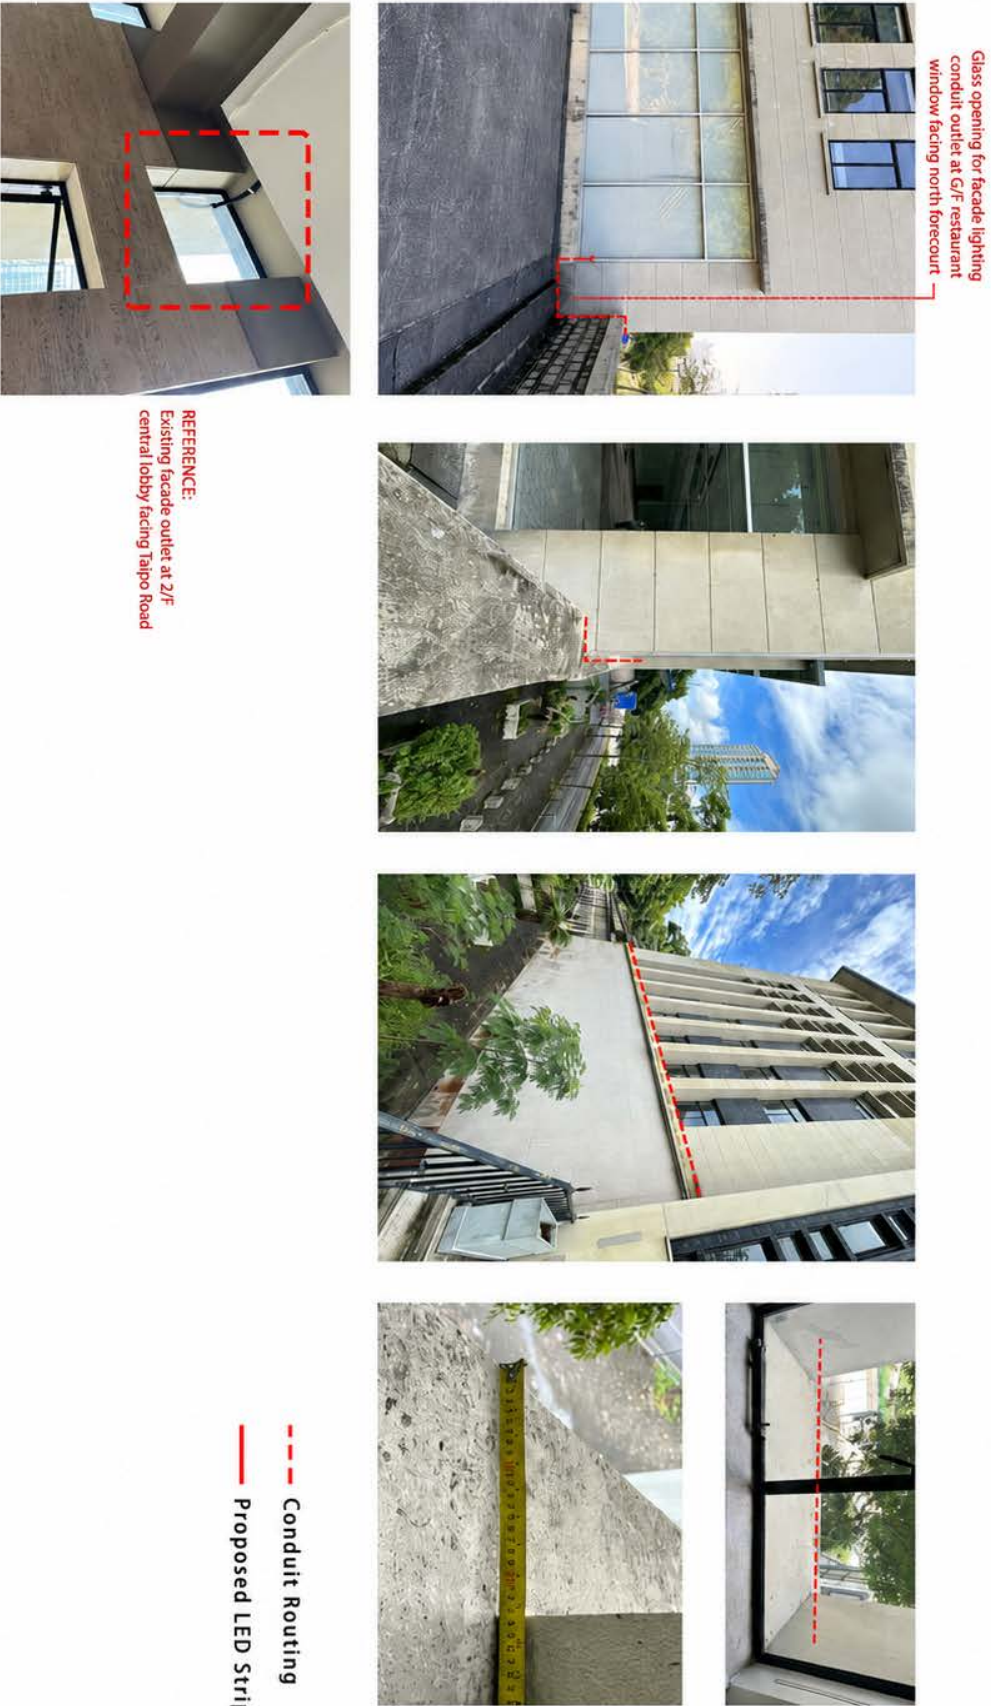
**Figure 138** Proposed routing of electrical conduits for facade lighting (along the Northern side)

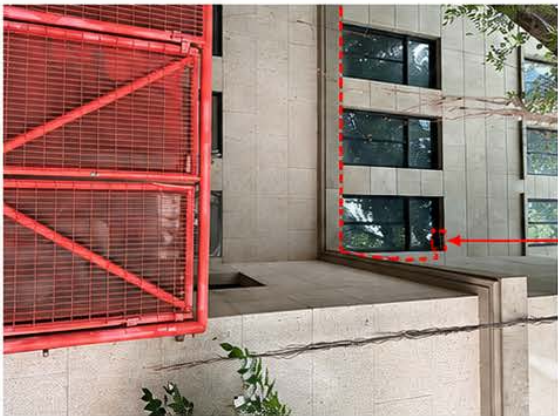
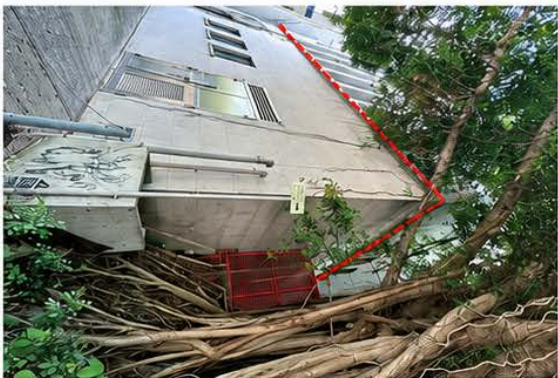
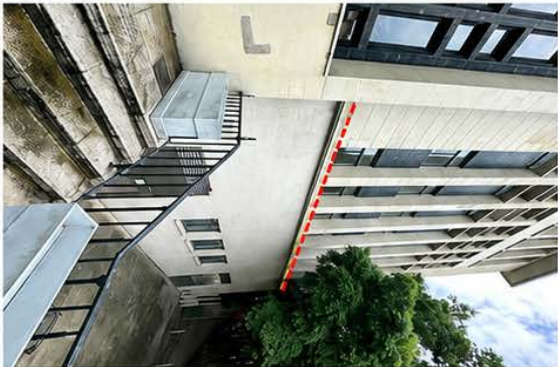
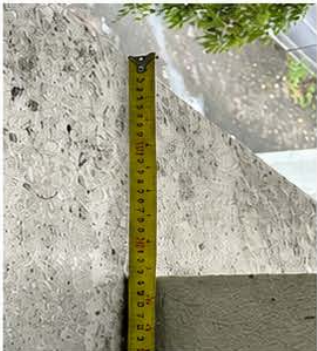
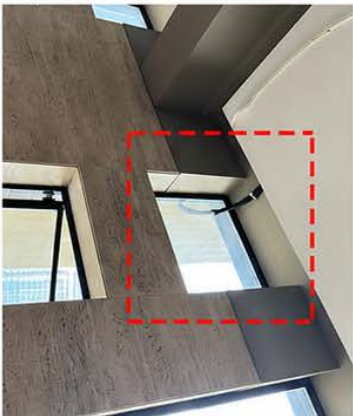
Glass opening for facade lighting  
conduit outlet at G/F cafe  
window facing south forecourt

--- Conduit Routing  
— Proposed LED Strip

REFERENCE:  
Existing facade outlet at 2/F  
central lobby facing Taipo Road

Figure 139 Proposed routing of electrical conduits for facade lighting (along the Southern side)

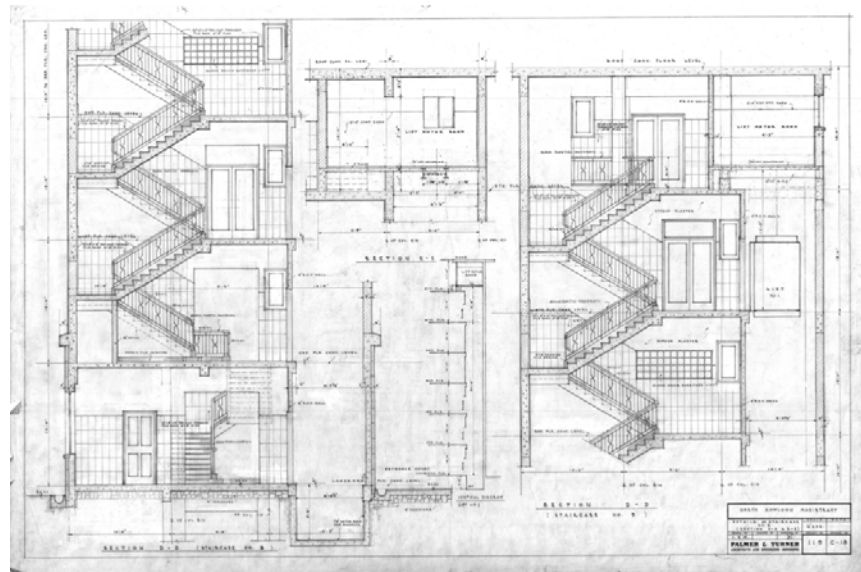
The current proposal will seek to restore and reinstate the staircase, reinforcing its historical significance and preserving the intended spatial hierarchy of the magistracy. This restoration will enhance the authenticity of the building's judicial function and strengthen its heritage value. A detailed inspection will be conducted to verify the existing

structure against historical records. The reinstatement will be constructed in steel structure instead of concrete to avoid imposing excessive load to the existing structure, and to minimise the need for excessive structural reinforcements. The steel structure will be encased to mimic the design of the original concrete staircase. The finish of the staircase will take reference from the existing portion of the staircase, and use the same or similar materials as far as it is technically possible. The reinstated element is modern intervention and interpretation that mimics but remains distinguishable from the original heritage fabric. The design will be compatible in appearance to minimise visual impact. The detailed design will be submitted to the AMO for approval in later stages of the project.

**Figure 140** *The original design of the Magistrate's Staircase.*

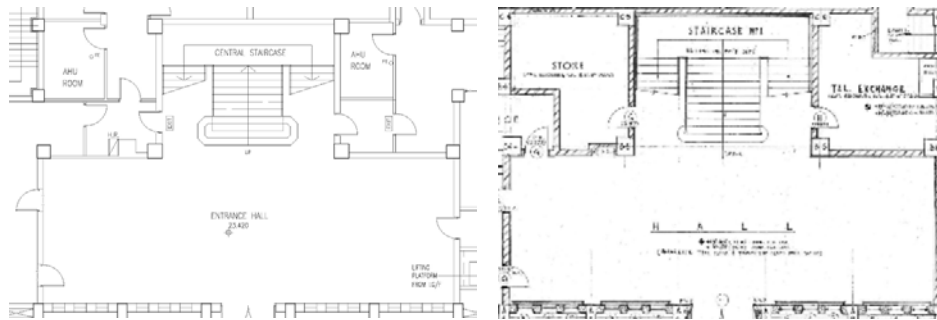
**Figure 141** The proposed design (left) and the original design (right) of the Entrance Hall.

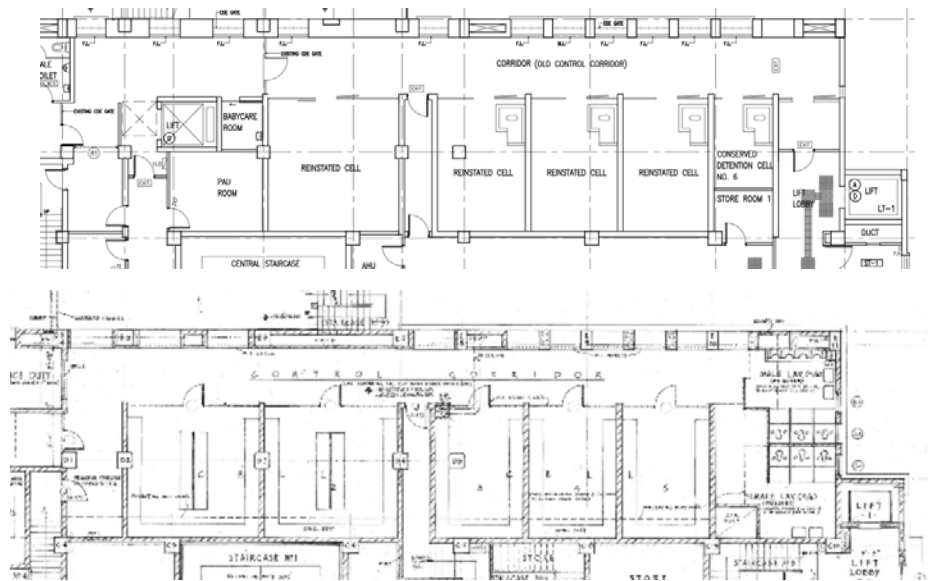
The layout of detention cell was modestly altered between various periods of construction, in particularly removal of the benches, the addition of glass panels on near the grills, the covering up of the squat toilets etc. during the SCAD revitalization to adopt the uses of staff office. Given the detention space's significance to the building's judicial history, All surviving features and finishes should be retained and preserved. In addition, reinstatement the layout of part of the detention cells following the 1960 configuration, with one large cell, and three medium-sized cells beside the existing conserved detention cell. The removed concrete benches, squat toilets and its partition will also be reinstated to reveal the historic atmosphere during the early years of the historic building.

**Figure 142** The proposed design (above) and the original design (bottom) of the reinstatement of cells.

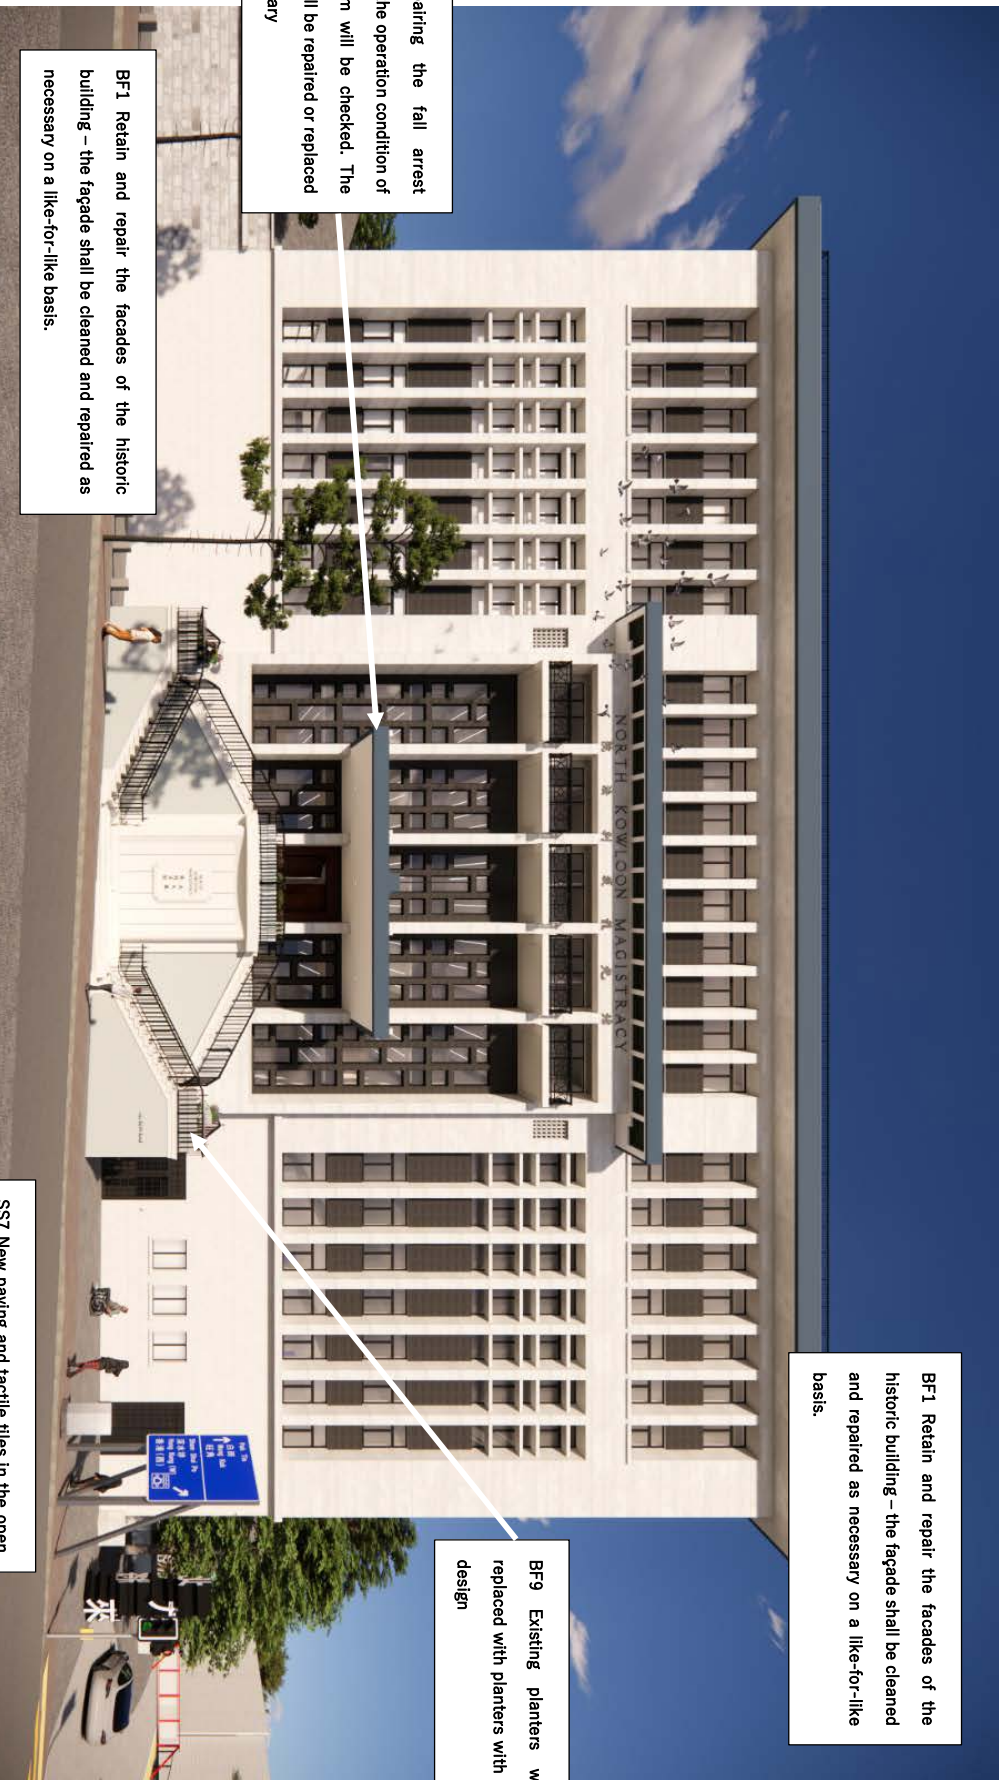
BF1 Retain and repair the facades of the historic building – the façade shall be cleaned and repaired as necessary on a like-for-like basis.

BF9 Existing planters will be replaced with planters with similar design

*Figure 143 Artist impression of the Main elevation of the North Kowloon Magistracy.*

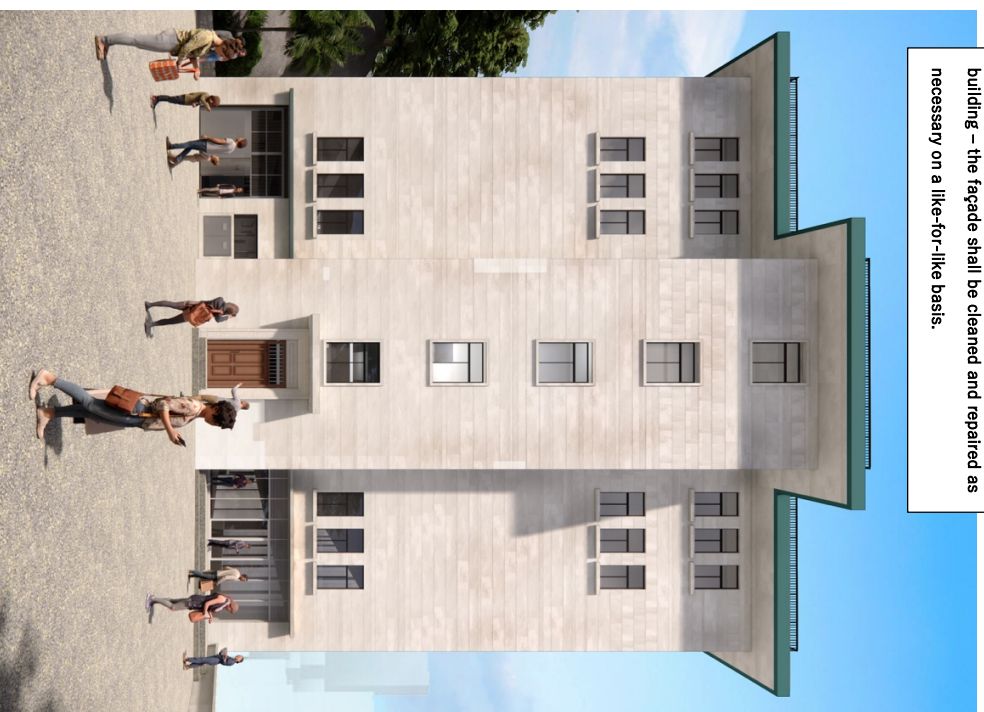
BF1 Retain and repair the facades of the historic building – the facade shall be cleaned and repaired as necessary on a like-for-like basis.

**Figure 144** Artist impression of the North elevation of the North Kowloon Magistracy.

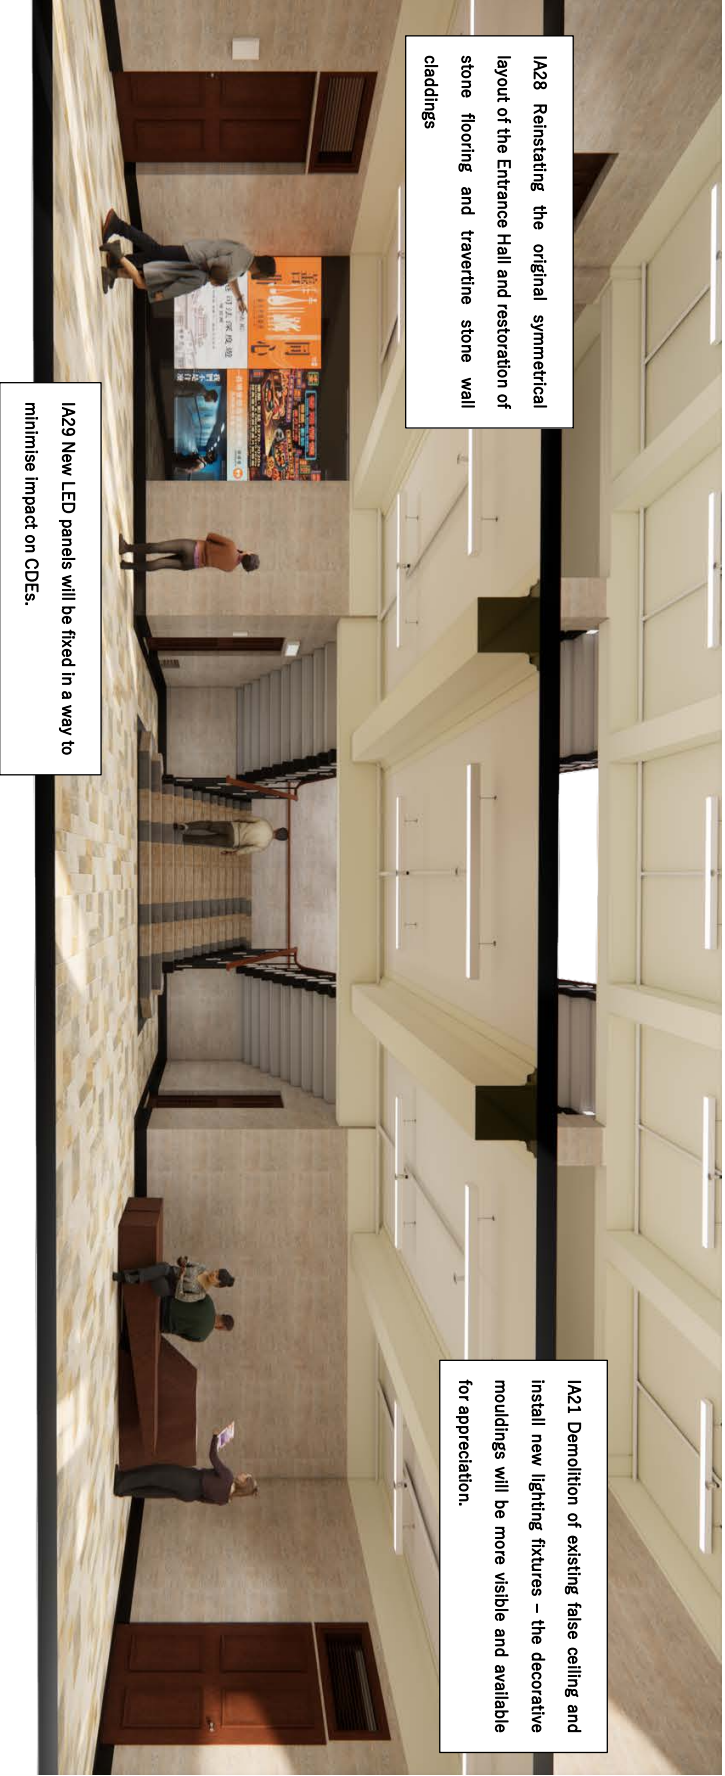
IA28 Reinstating the original symmetrical layout of the Entrance Hall and restoration of stone flooring and travertine stone wall claddings

IA29 New LED panels will be fixed in a way to minimise impact on CDEs.

IA21 Demolition of existing false ceiling and install new lighting fixtures – the decorative mouldings will be more visible and available for appreciation.

Figure 149 Artist impression of the Entrance Hall (G/F)

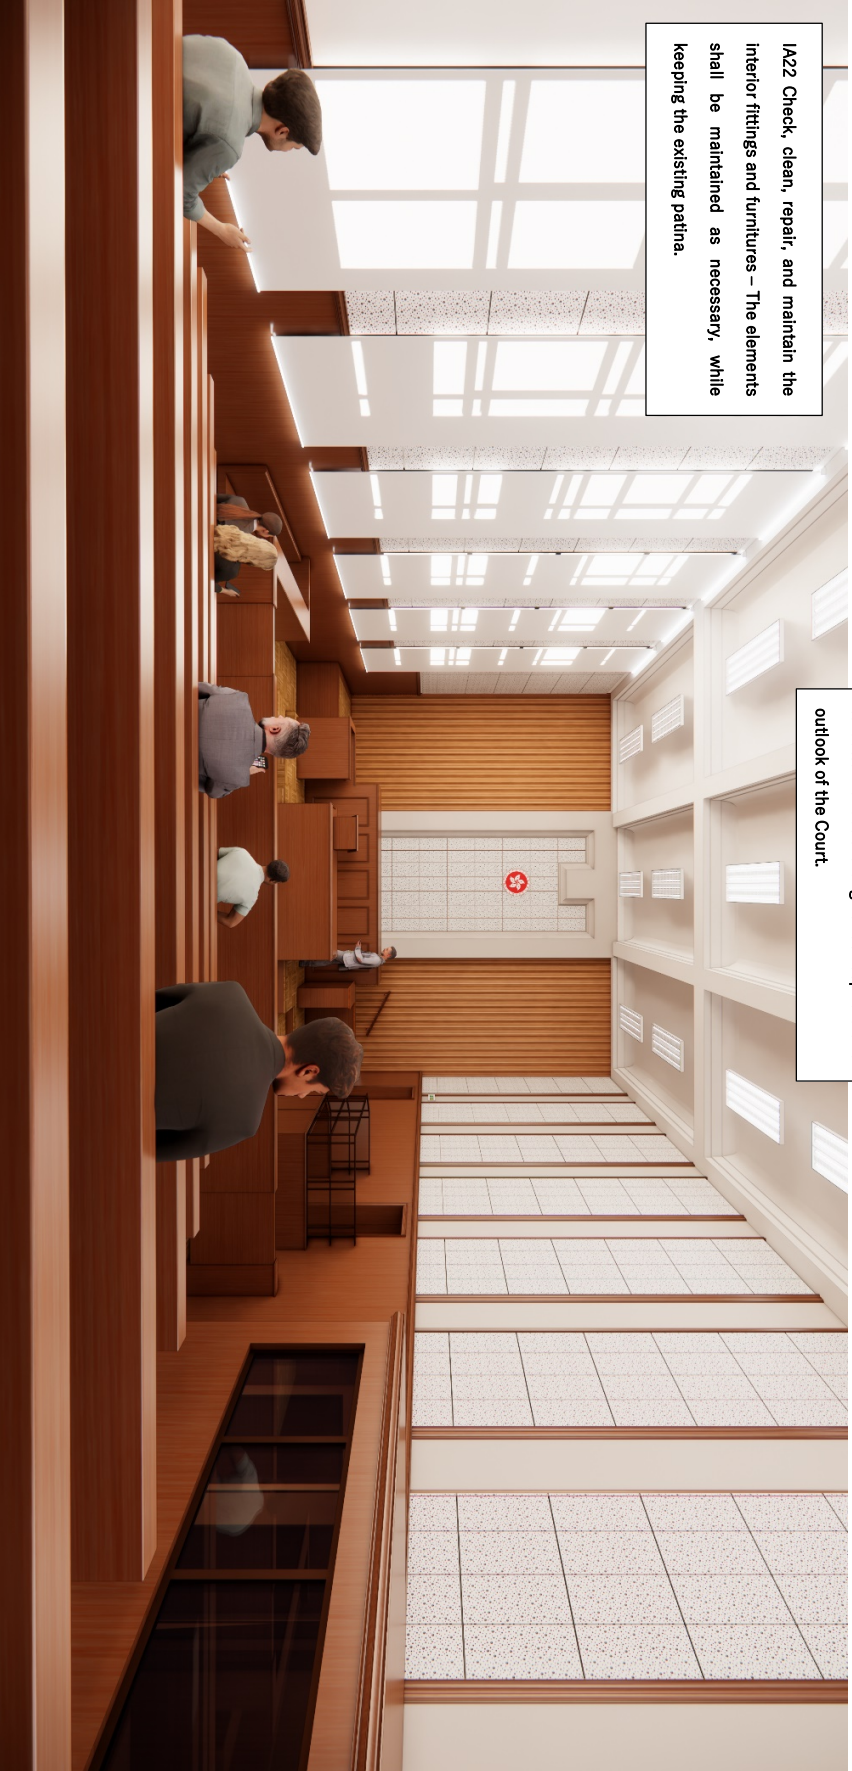
IA22 Check, clean, repair, and maintain the interior fittings and furnitures – The elements shall be maintained as necessary, while keeping the existing patina.

IA23 Replacement of lighting fixtures - The existing ceiling light fixtures will be replaced to better reflect the original atmosphere and outlook of the Court.

**Figure 151** Artist impression of the Conserved Court No. 1.
