## Heritage Impact Assessment

in respect of the Revitalisation of  
Former North Kowloon Magistracy into  
NK Future

Heritage Impact Assessment in respect of the Revitalisation of Former North Kowloon Magistracy  
into NK Future under Revitalising Historic Buildings through Partnership Scheme Batch VI

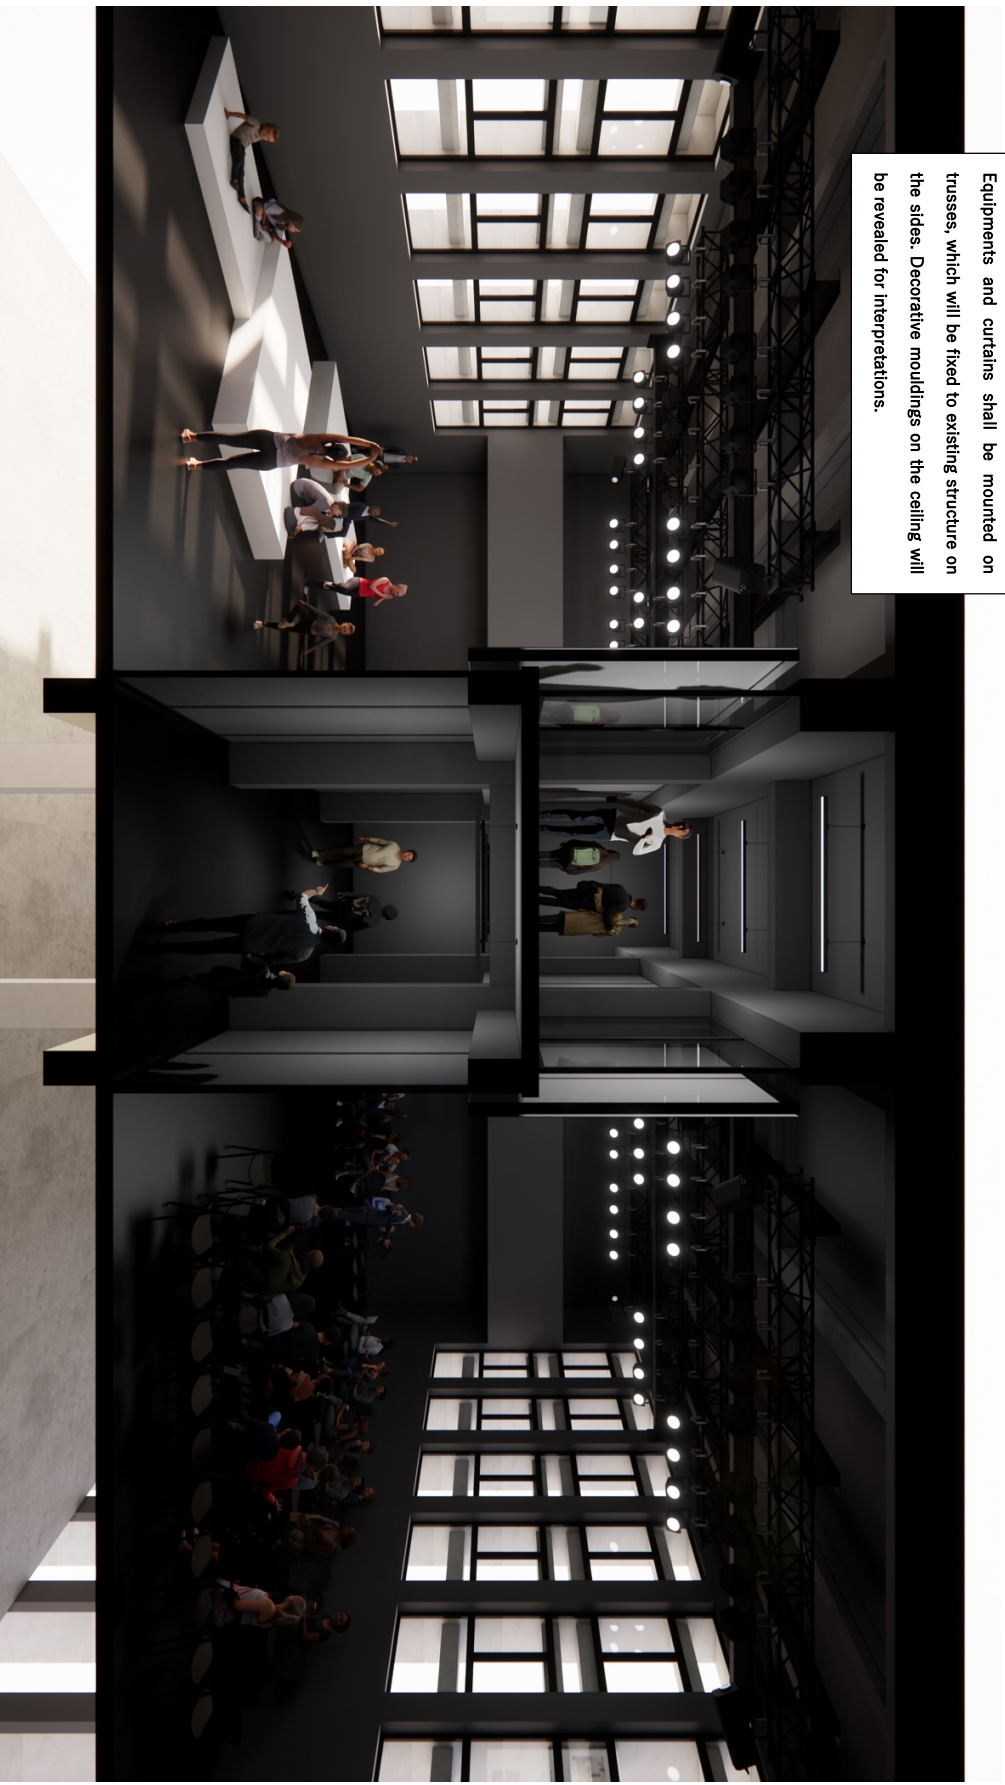
IA7 Conversion of existing Courtrooms (Court No.3 and No.4) and corridor into a Lecture Hall – Equipments and curtains shall be mounted on trusses, which will be fixed to existing structure on the sides. Decorative mouldings on the ceiling will be revealed for interpretations.

**Figure 152** Artist impression of the Lecture Hall D (Split Mode).

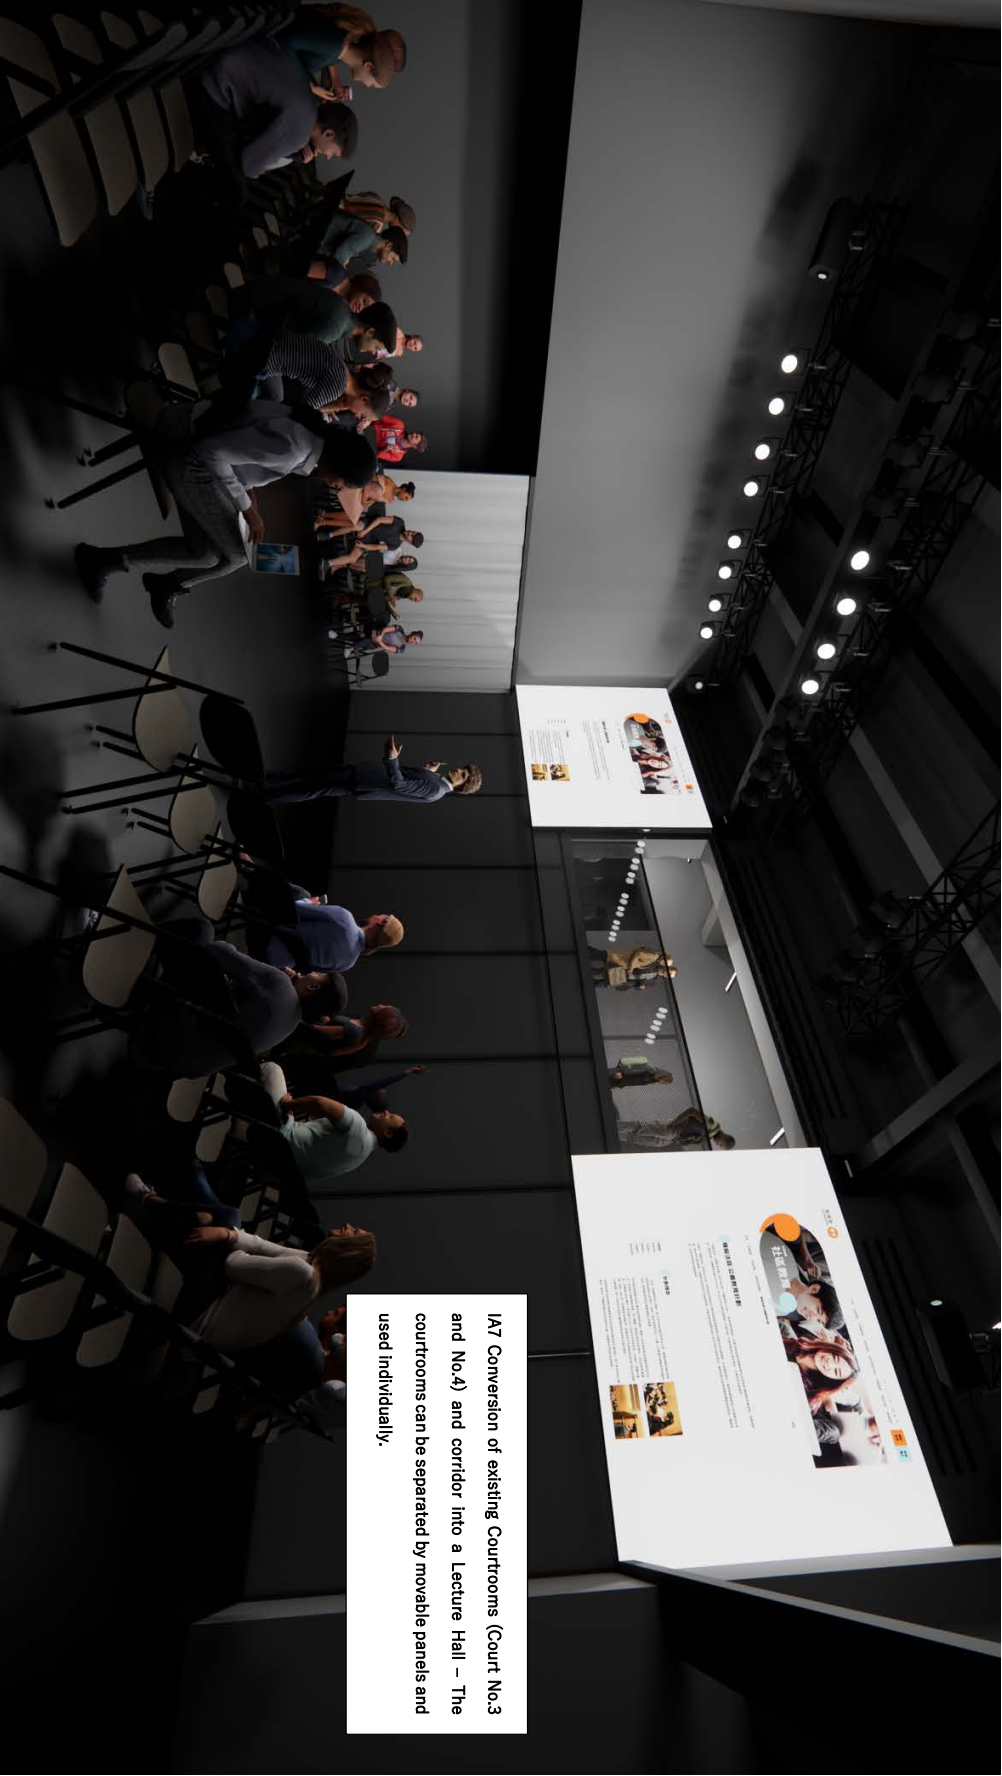
IA7 Conversion of existing Courtrooms (Court No.3 and No.4) and corridor into a Lecture Hall – The courtrooms can be separated by movable panels and used individually.

**Figure 153** Artist impression of the Lecture Hall D (Seminar Mode).

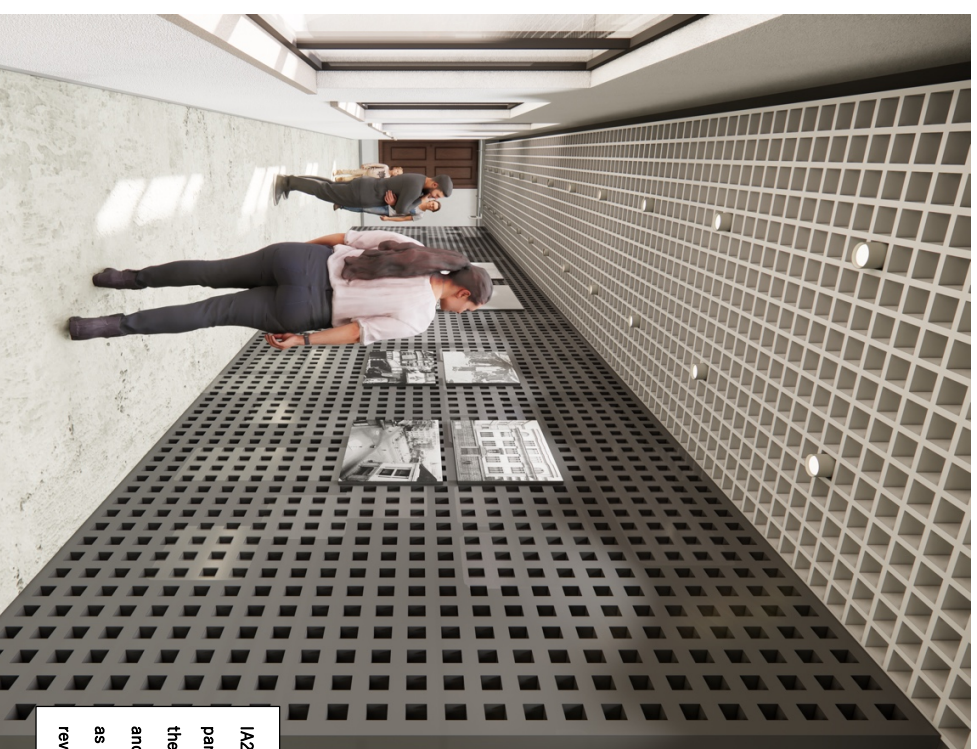
IA20 Installation of wall panels – The panels can minimise the drilling on walls of the corridor when installing interpretation and other display materials. It is acceptable as long as the panels are installed in a reversible manner.

**Figure 154** Artist impression of the Corridor at the Third Floor.

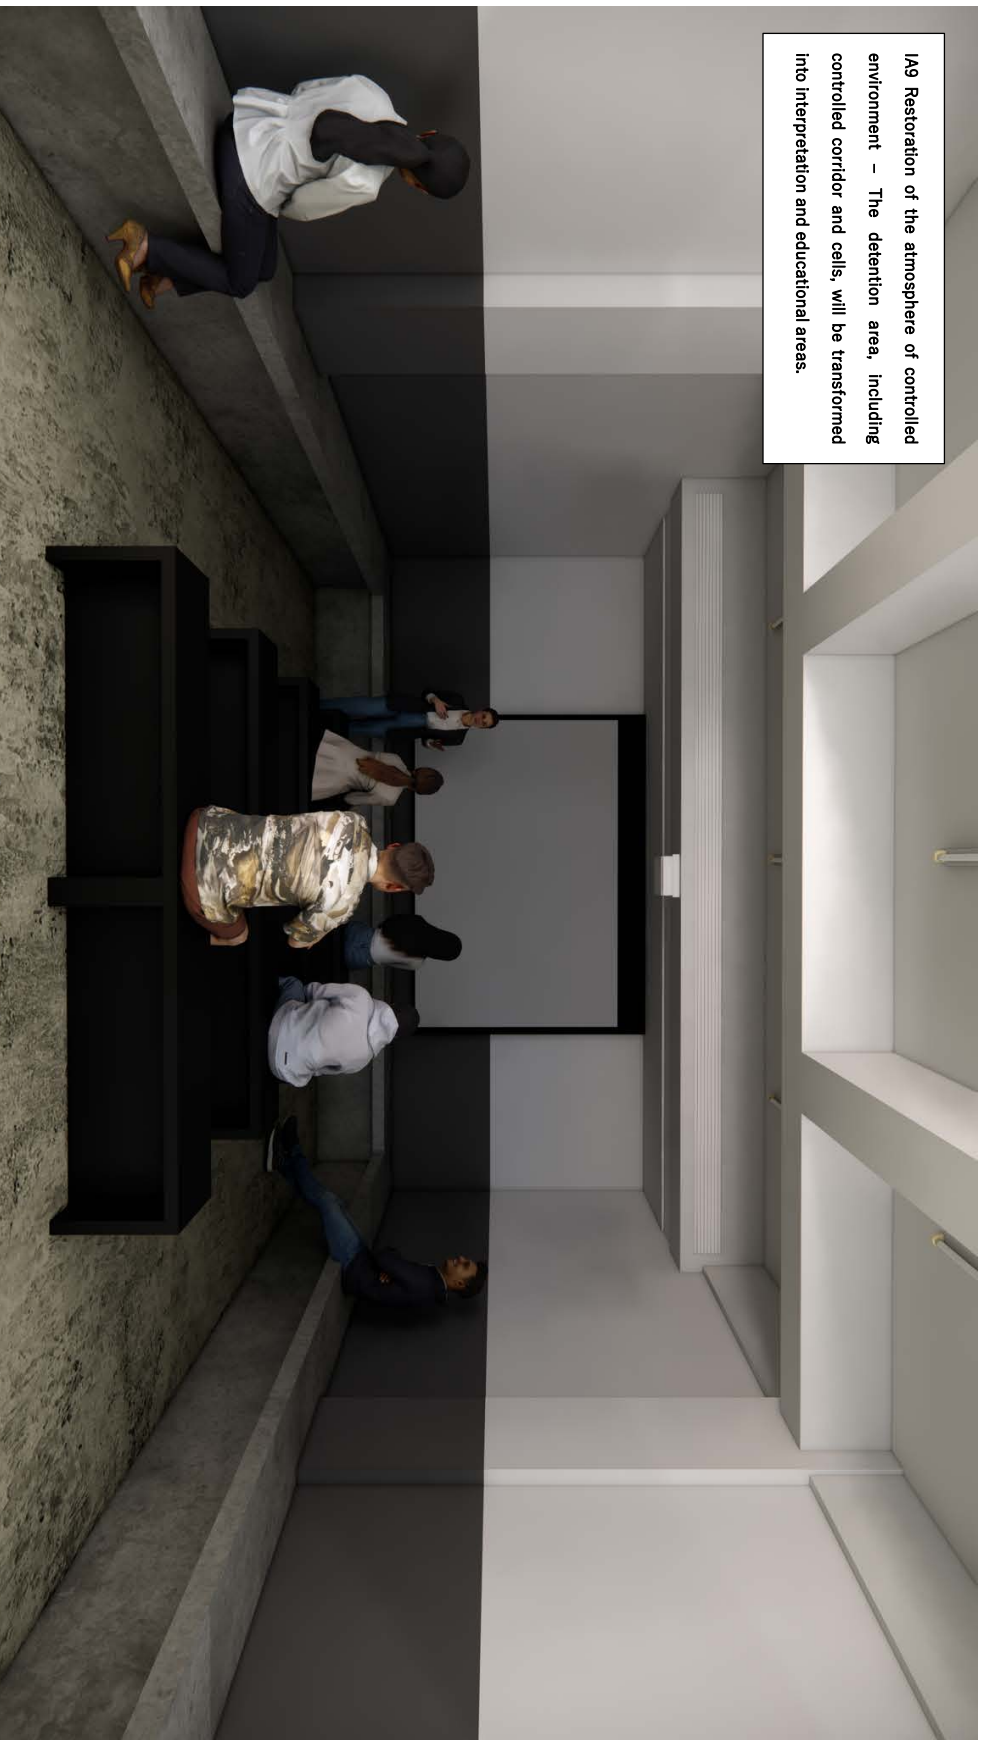
IA9 Restoration of the atmosphere of controlled environment – The detention area, including controlled corridor and cells, will be transformed into interpretation and educational areas.

**Figure 159** Artist impression of reinstated detention cell (to be used as briefing area for tours) at G/F

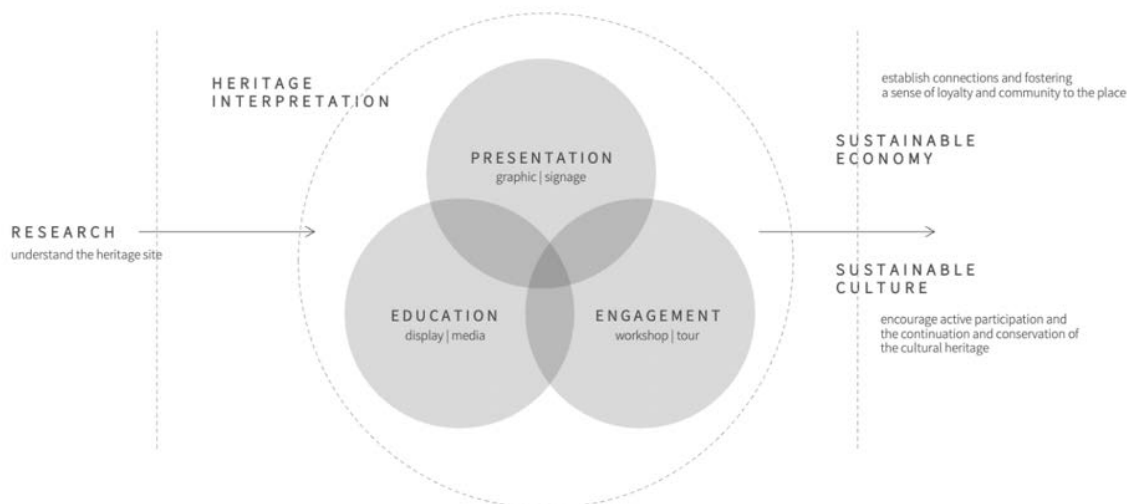
**Figure 160** Diagram of heritage interpretation strategies.

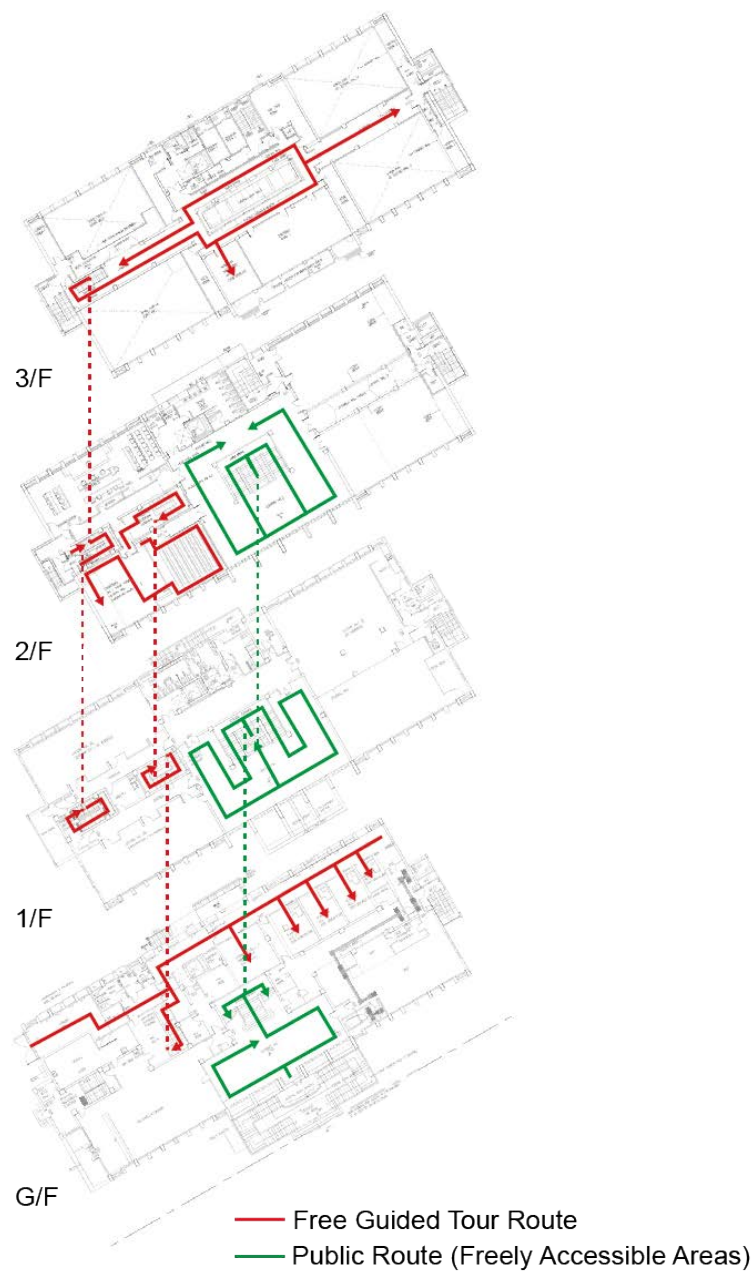
**Figure 161** Diagram of Free Guided Tour Route and Public Route
